Archaeological Excavation of the Priest Quarters, Mission San Francisco de la Espada, 41BX4, San Antonio, Texas

Center for Archaeological Research
The University of Texas at San Antonio
Archaeological Survey Report, No. 295
2000

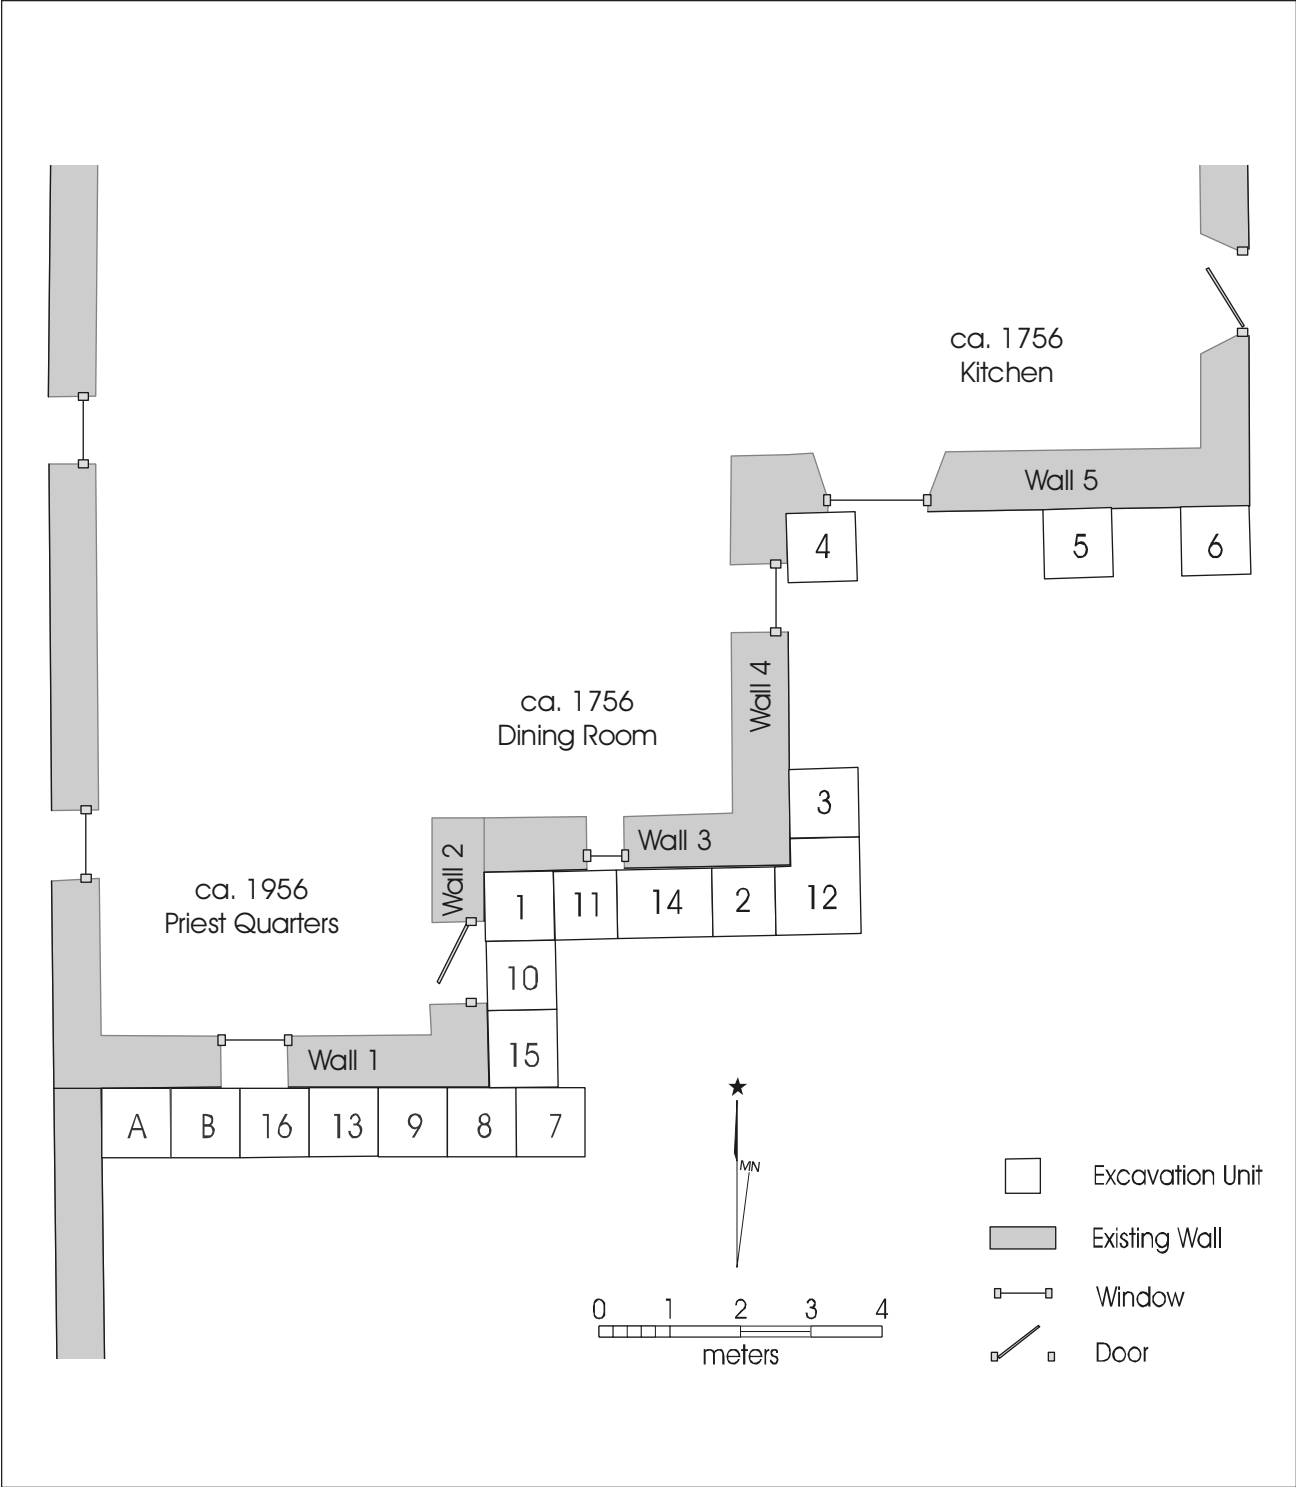
Figure 2. Project Area Plan Map

the edges of the five existing southern-most walls of the Priest Quarters. Figure 2 represents an isolated view of the project area, and indicates the units which were excavated in 1998 (A and B) and those excavated in 1999 (1-16). In addition to these excavations, a monitoring program was also designed for the unexcavated areas along Walls 4 and 5. This monitoring work was carried out during the months of October and November 1999.

While excavations conducted along Walls 1, 2, and 3 were contiguous, excavations along Walls 4 and 5 were staggered (refer to Figure 2). The general contractor eventually removed the soils from the unexcavated areas, under the supervision of a staff archaeologist from CAR-UTSA. The monitoring work performed in these areas was designed to ensure that any unknown cultural features would not be adversely impacted by the removal of soil for the repair of the foundation.

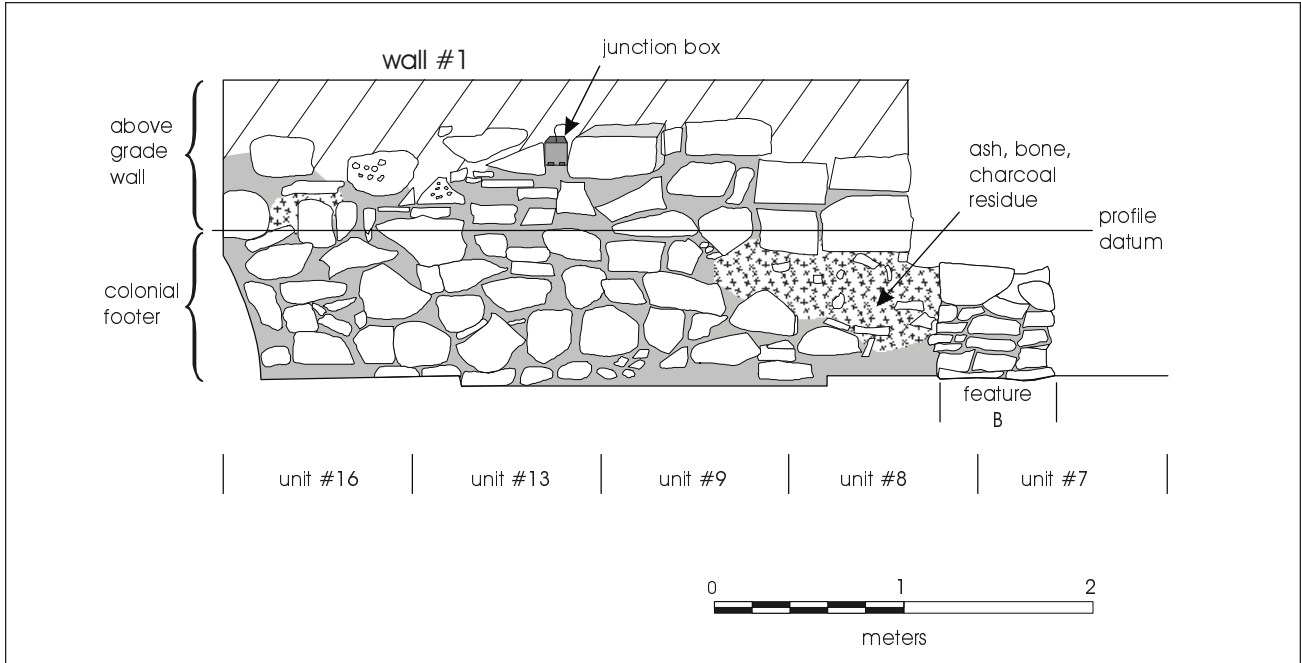
Figure 9. Wall 1 Footer, North Profile Units 16, 13, 9, 8, and 7.

The 1999 excavations of Units 16, 13, 9, 8, and 7, continued noting the presence of disturbed deposits along Wall 1. The unit levels were fairly consistent: Levels 1-3 (0-30 cm bs) noted disturbed loamy soils with mixed deposits; Levels 4-5 (30-50 cm bs) noted disturbed loamy soils with few artifacts; Level 6 (50-60 cm bs) located a sandy loam with either few or no artifacts; and Levels 7-9 (60-90 cm bs) noted a layer of Houston black clay with either few or no artifacts.

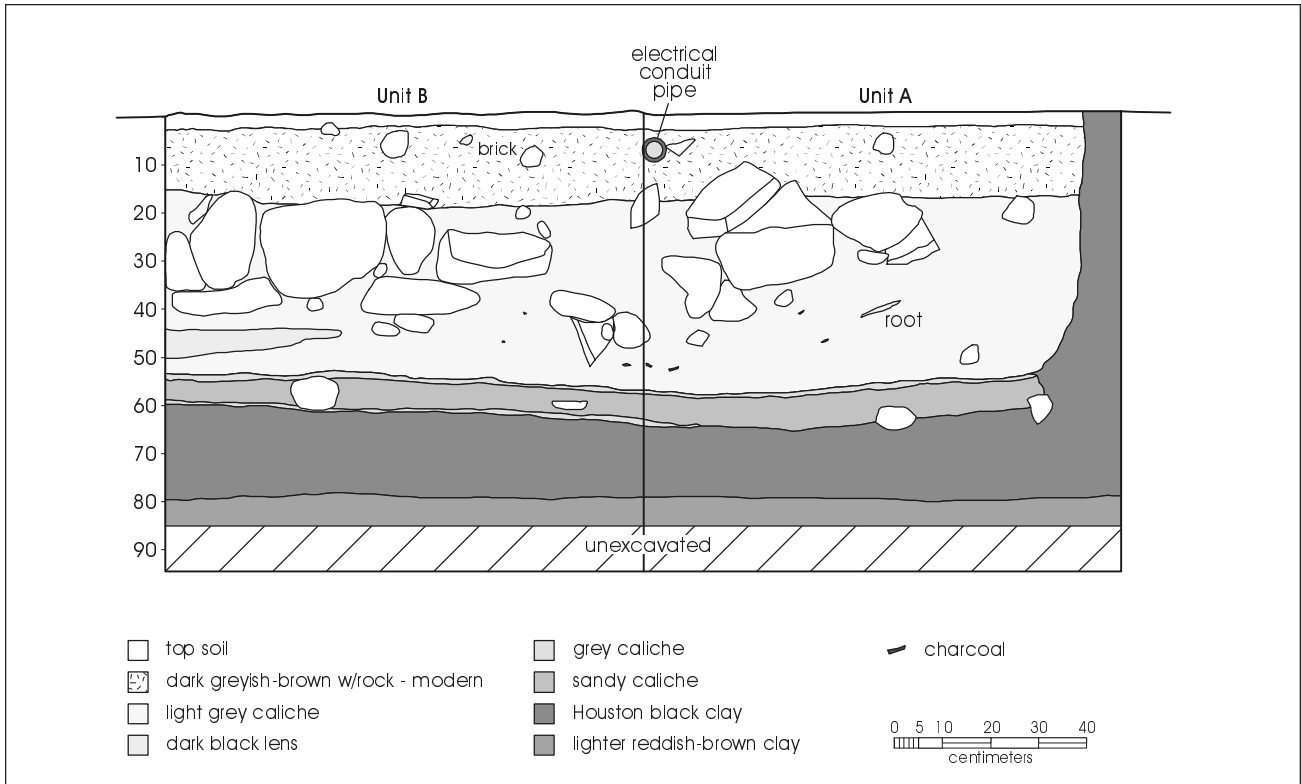
Figure 10. Units A and B – South Profile.

Wall rubble was found in the south wall of Units A and B, and was also picked up on the south wall of Units 16 and 13. Figure 10 serves to illustrate the disturbance encountered in the excavated units. The wall fall, or construction debris, was located between 15 and 40 cm below surface, and was oriented in an east-west direction. In 1998, Meissner mentioned this anomaly in her monitoring notes, and speculated that it might be a north to south wall alignment

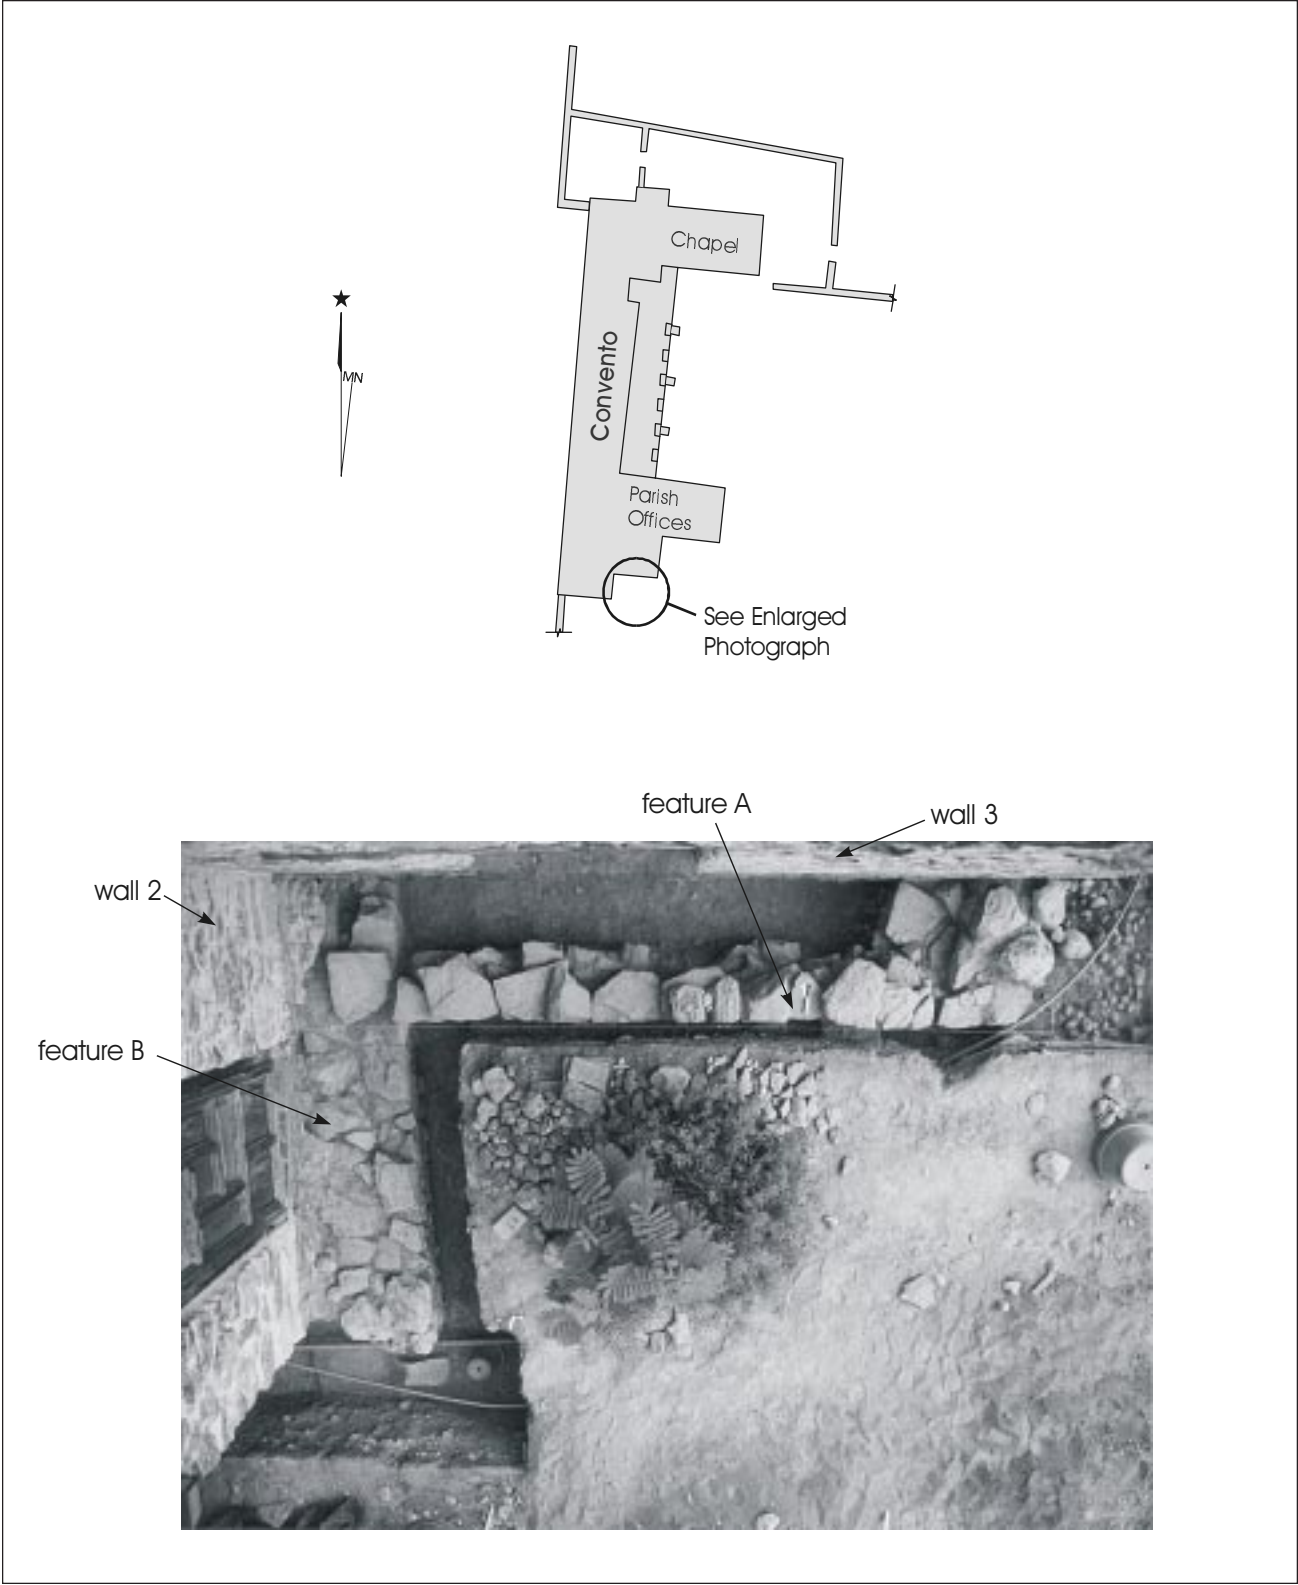
Figure 11. *Features A and B – Bird's-eye View.*
Note: Taken from ca. 12 ft. above surface (not to scale)

bs, and also extending into Units 11 and 14. Although the encountered depth and width of Feature A varied between units, this feature was located at approximately 10 cm bs and extended to 68 cm bs, and was 80 cm wide where intact. The upper-most layer of Feature A consisted of eight large stones (ca. 25-40 cm wide and 10-15 cm thick); most of these stones exhibited at least one perfectly flat side. Excavation of Units 7, 8, 10, and 15 (discussed above) located Feature B and noted its association with Feature A. Feature B, another wall feature, was located at approximately 20 cm bs and extended to 85 cm bs, and was 60 cm wide. The bird's-eye view shown in Figure 11 illustrates the relationship between Feature A and Feature B.

Features A and B were located at between 10 and 20 cm below surface, and extended to between 68 and 85 cm below surface. The width of these features varied. Feature A varied in width in areas due to missing stones—where all stones were intact it measured 80 cm wide, while Feature B was 60 cm wide and appeared to be intact. Their construction was composed of three to five courses of rock and, prior to their removal both of the features were extensively photo-documented and illustrated.

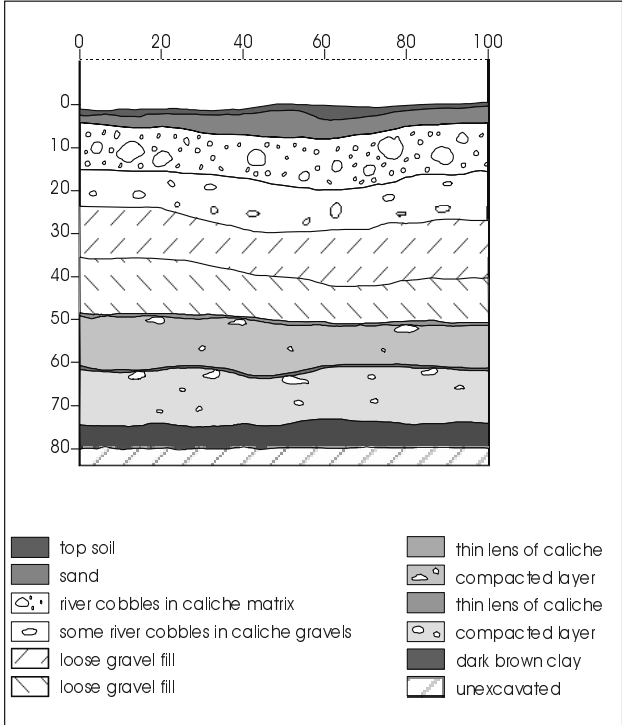
Figure 12. Unit 12 - East Profile.

Excavations along the east-end of Wall 3 found that the Wall 3 foundation extended about 30 cm to the east, in Units 12 and 3. This wall extension was located at approximately 25 cm bs. This stub and the foundation that it ties into both appear to be Colonial. A close examination of Smith's 1934 measured drawings failed to locate evidence of this feature (AA-APL, Measured Drawings 1-24-34).

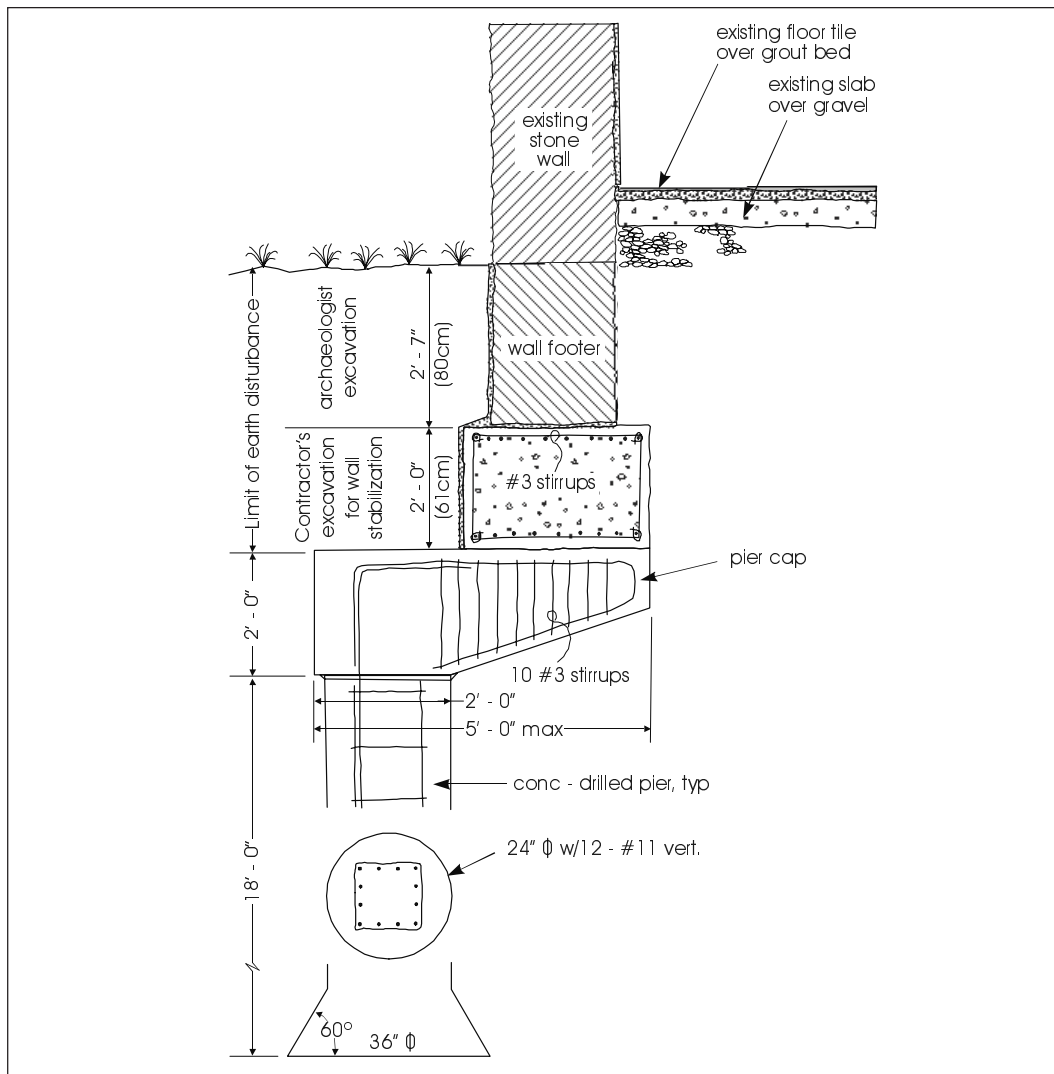
Figure 14. *Wall Stabilization Detail.*
(from Ford, Powell, and Carson 1999)

The monitoring portion of the project began once the eight piers and pier caps were in place and the wall stabilization crew proceeded to undercut the existing foundations. The required undercutting was six inches beyond the width of the existing foundations and was to be completed in four-foot sections. A concern was the possibility that the proposed undercutting might

compromise the structural integrity of the buildings. This concern was based on the knowledge that these wall foundations are typically constructed of no more than 50 cm of rock rubble, mud packed into a trench usually the same width as the above-grade wall. These walls were constructed of roughly shaped local stone, set in a sand and lime mortar (Fox and Hester 1976).

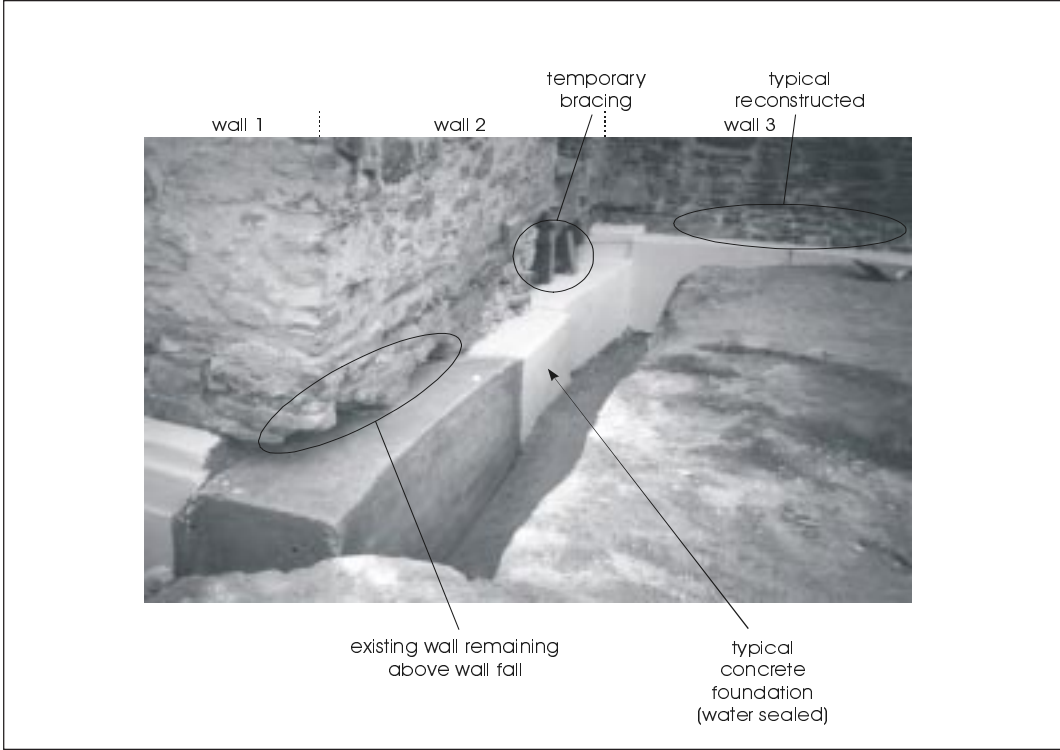
Undercutting of the foundation and installation of four-foot sections of concrete beam continued over a four-week period, and additional sections of wall foundation were lost in the process. As sections of foundation failed, the remaining stones were temporarily braced while the concrete beam was poured. Once the poured concrete section had hardened, the stones that had fallen were replaced. Some bone fragments and ceramic sherds were recovered during the undercutting, but these came from the soils along the interior of the foundations. No other features were noted during this phase of construction.

Figure 15a. *Walls 2 & 3.*
 Typical Undercutting and New Concrete Foundation.

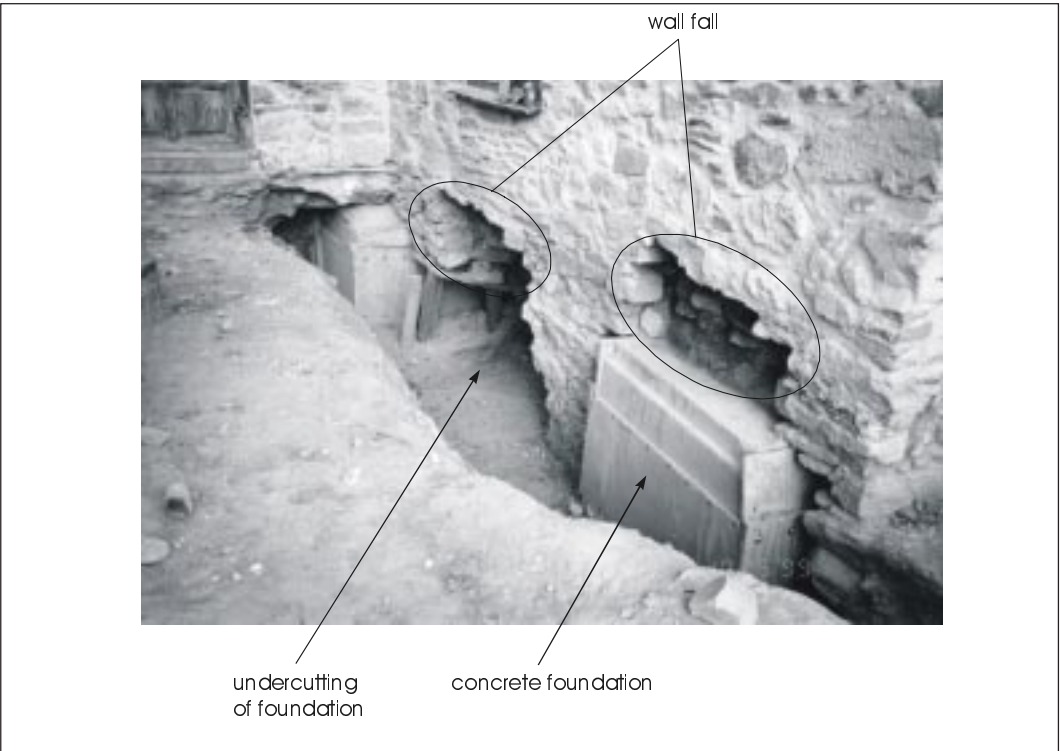
Figure 15b. *Wall 3 – Typical Undercutting and New Foundation.*
 Note: Wall fall above undercutting.

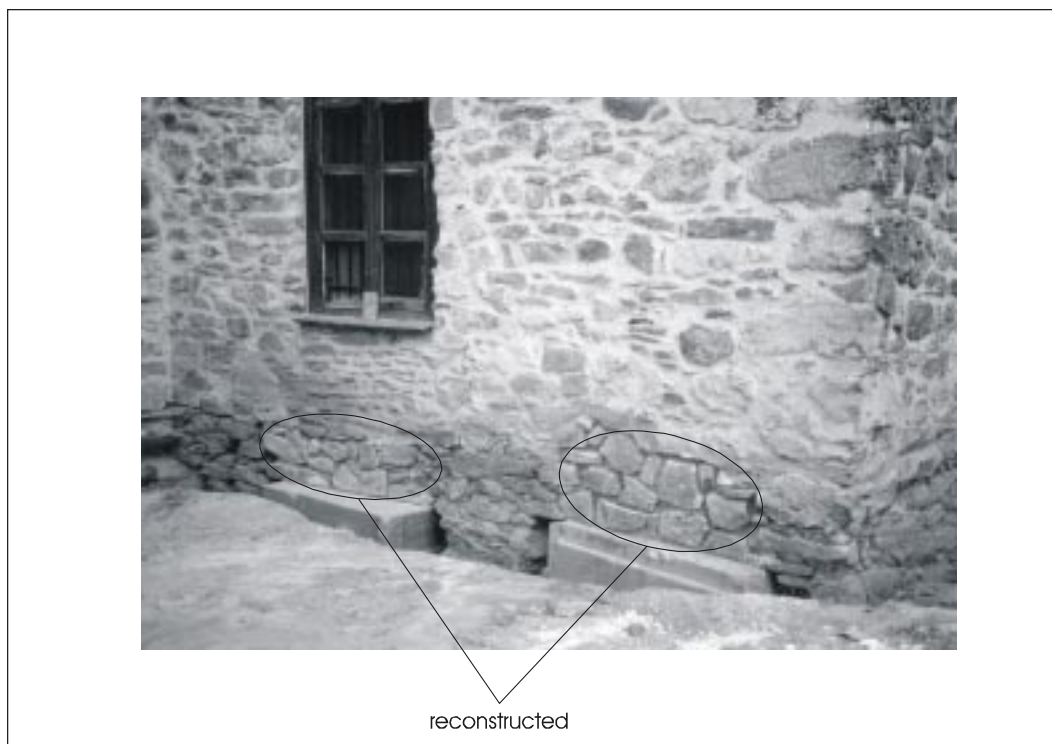
Figure 15c. Wall 3 – Typical Reconstructed Wall Fall.

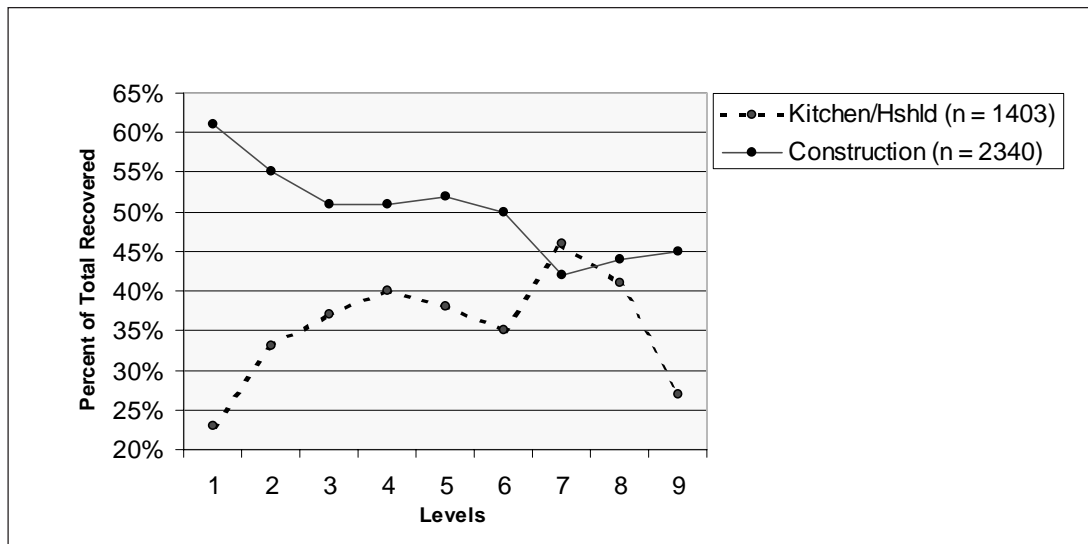
Figure 16. Density of Kitchen and Construction Artifacts, Walls 1 and 2.

the last 60 cm excavated. The Figure 16 data also indicates that the occurrence of kitchen-related items remained relatively low, between 23% and 46%, throughout the entire 90 cm excavated.

As noted in the Results section, the area along Walls 1 and 2 has been heavily impacted by construction-related activities over the years; this was clearly illustrated in Figures 16 and 18. In contrast, the area along Walls 3 and 4 has not been as heavily impacted and, as illustrated in Figure 19, the deposition appears to be somewhat intact. An analysis of the Wall 5 data failed to reveal any definite depositional patterns. This is probably owing to the comparatively smaller area excavated and the low number of artifacts recovered.

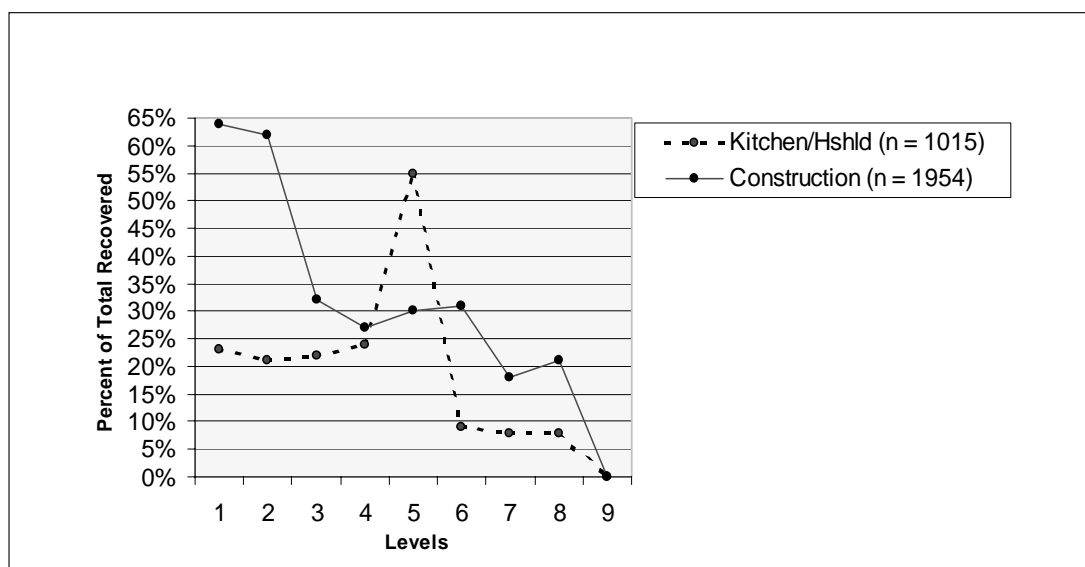
Figure 17. Density of Kitchen and Construction Artifacts, Walls 3 and 4.

In contrast, the Figure 17 data indicates a steady decline of construction-related items between Level 1 (64%) and Level 8 (21%). If not for a sharp increase at Level 5, the data for the kitchen-related items would have also shown a steady decrease, between Level 1 (23%) and Level 8 (8%). The unit level form (Unit 3, Level 5) notes a soil disturbance along the west-end of the unit. This is probably what accounts for the large number of glass fragments (n=266) which caused the sharp increase in kitchen-related items and skewed the data for Level 5.

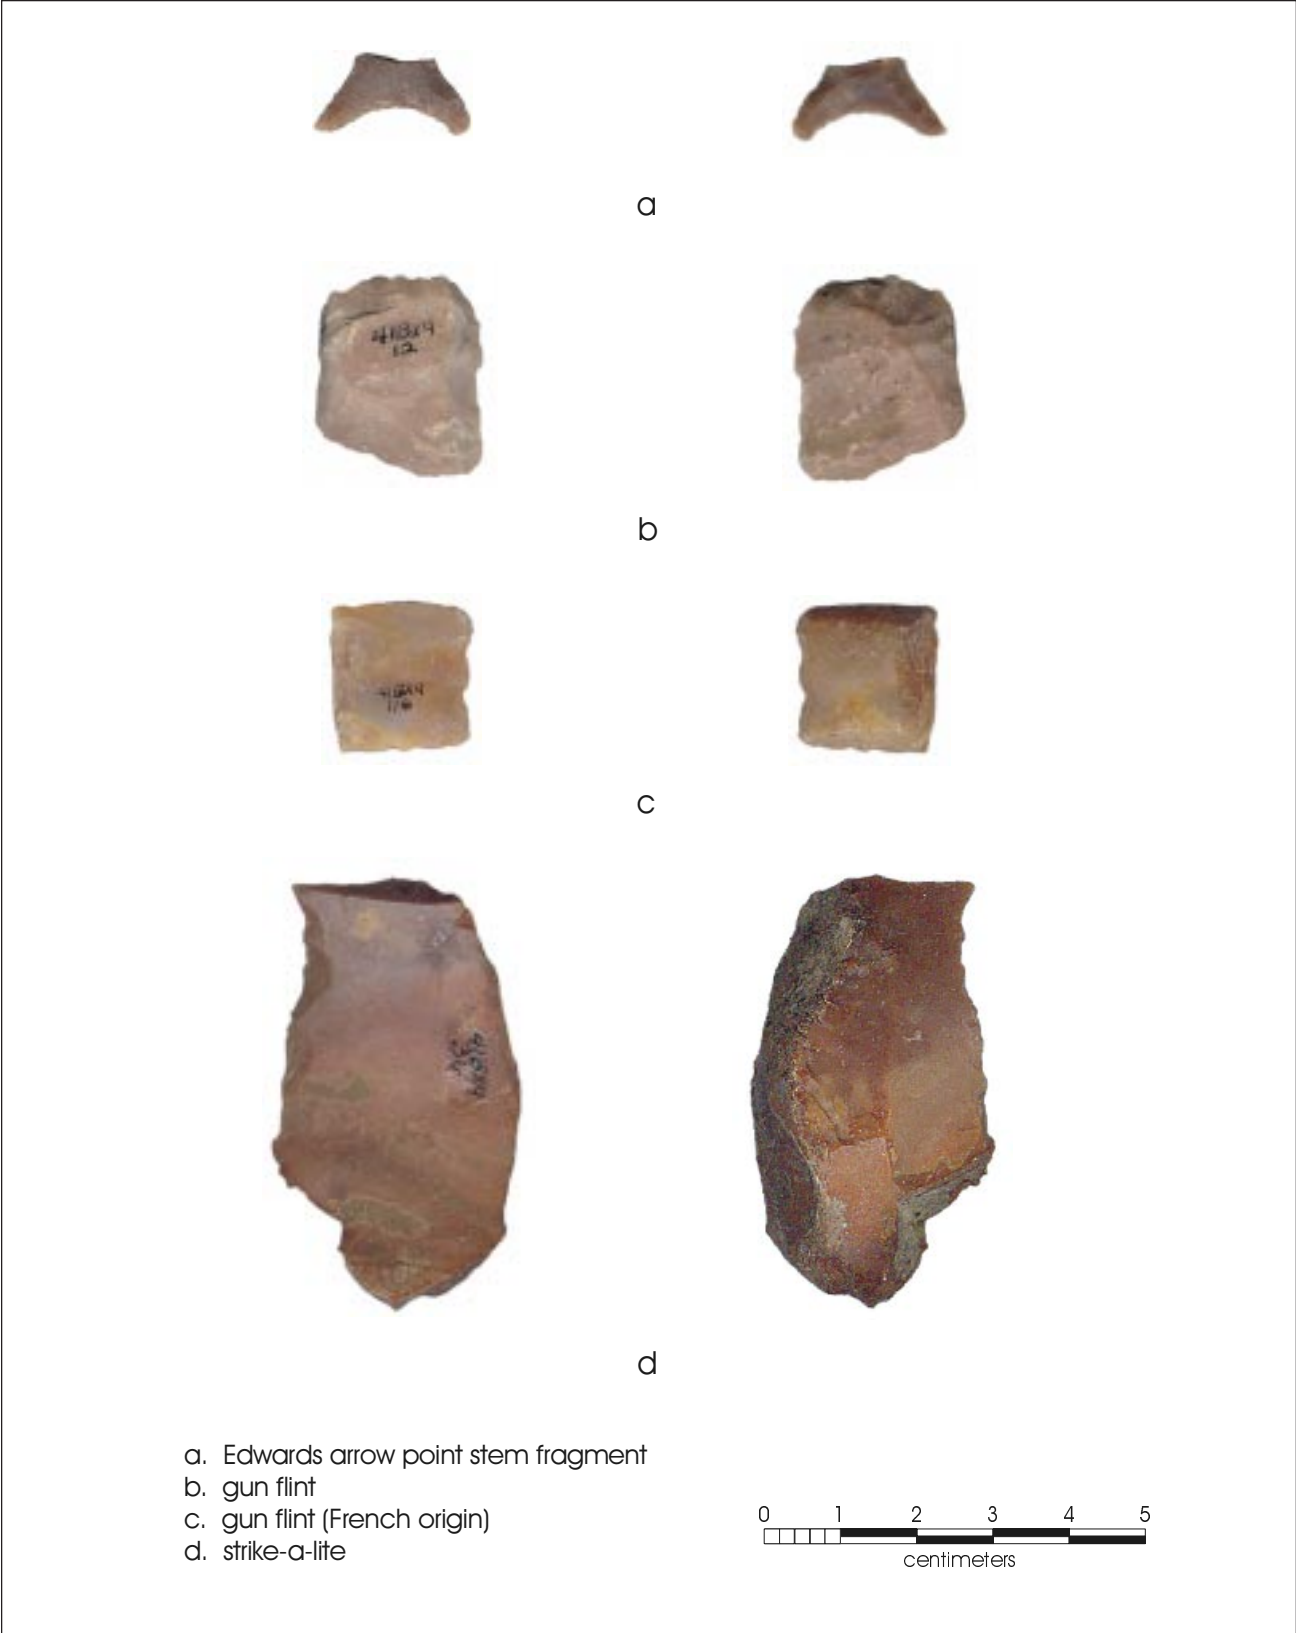
a. Edwards arrow point stem fragment
b. gun flint
c. gun flint (French origin)
d. strike-a-lite

Figure 20a-d. *Chipped Stone from the current project.* a) Edwards Arrow Point and Stem Fragment; b) Gunflint; c) Gunflint (French origin); d) Strike-a-lite.

A single stem fragment is classified as an arrow point. It was recovered from Level 3 (20-30 cm bs) in Unit 6 (Figure 20a). Judging from its widely expanding stem, its concave base, and narrow neck, it is likely to

Five gunflints and four strike-a-lites were identified. Three of the gunflints have a roughly rectangular shape and are made on tertiary (n=2) and secondary (n=1) hard hammer stone flake blanks (Figure 20b). They are only marginally retouched, most of the invasive flake scars that penetrate the face of the specimens result from use. A fourth specimen is a bifacially flaked trapezoidal gunflint. Use-related crushing is evident along all edges and moderate polish is present on flake scar ridges of both faces. These four gunflints are made of locally available tan to brown colored fine-grained chert. The final gunflint is made on a nearly square midsection of a trapezoidal blade (Figure 20c). The four edges are unifacially retouched on the dorsal face and form steep angles. Use-related step fracturing is present on the ventral face of the specimen only along one edge. In terms of morphology and manufacture

Three of the four strike-a-lites are unifacially retouched artifacts representing recycled Prehistoric scrapers. All three are of fine-grained dark gray to brown chert blades or blade-like flakes. Dorsal cortex is present on all specimens and may be a purposeful design feature to enhance gripping. The multiple “working-edges” on all three specimens are characterized by heavy crushing verging on rounding distributed along the dorsal face of the artifacts. A few isolated irregularly spaced flake scars are also present on the ventral face of the specimens but are not evident along all utilized edges. The fourth strike-a-lite is a longitudinally curved distal blade fragment (Figure 20d). Crushing and step-fractured flake scars are distributed along the ventral face of one longitudinal edge. The opposite edge appears to also have been used although use-wear is light. The corticate dorsal surface adjacent this edge may have prevented the generation of sparks along this edge.

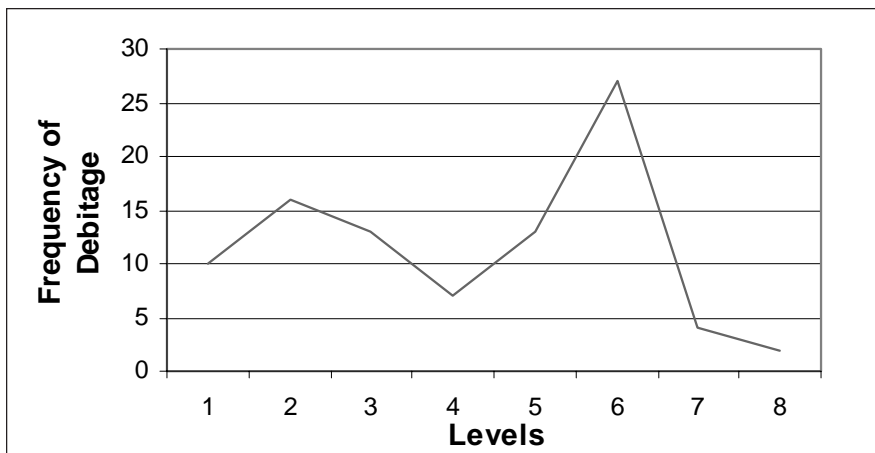
Figure 21. *Distribution of Unmodified Lithic Debitage by Level.*

Of the 79 specimens one came from trench fill. The level by level distribution of the remaining 78 specimens has a bimodal pattern (Figure 21). A smaller peak of 13 specimens is present in Level 2 below whichdebitage counts decrease through Levels 3 and 4. Counts begin increasing in Level 5 peaking with 23 specimens in Level 6. At least two explanations may account for this pattern. A single occupation zone buried between 50-60 cm below surface is present at the site and the smallerdebitage peak in Level 2 represents specimens translocated through post-depositional disturbance (e.g., construction activities) from the original construction of the Priest quarters. Alternatively, the twodebitage peaks represent distinct occupation zones with the deeper zone potentially dating to the early part of the Late Prehistoric period (e.g., Edwards point) and the upper zone representing the Protohistoric/mission era occupation.
