ARCHAEOLOGICAL INVESTIGATION TO LOCATE
THE NORTHWEST CORNER OF
MISSION CONCEPCIÓN
SAN ANTONIO, BEXAR COUNTY, TEXAS

Anne A. Fox

Center for Archaeological Research
The University of Texas at San Antonio®
Archaeological Survey Report, No. 212

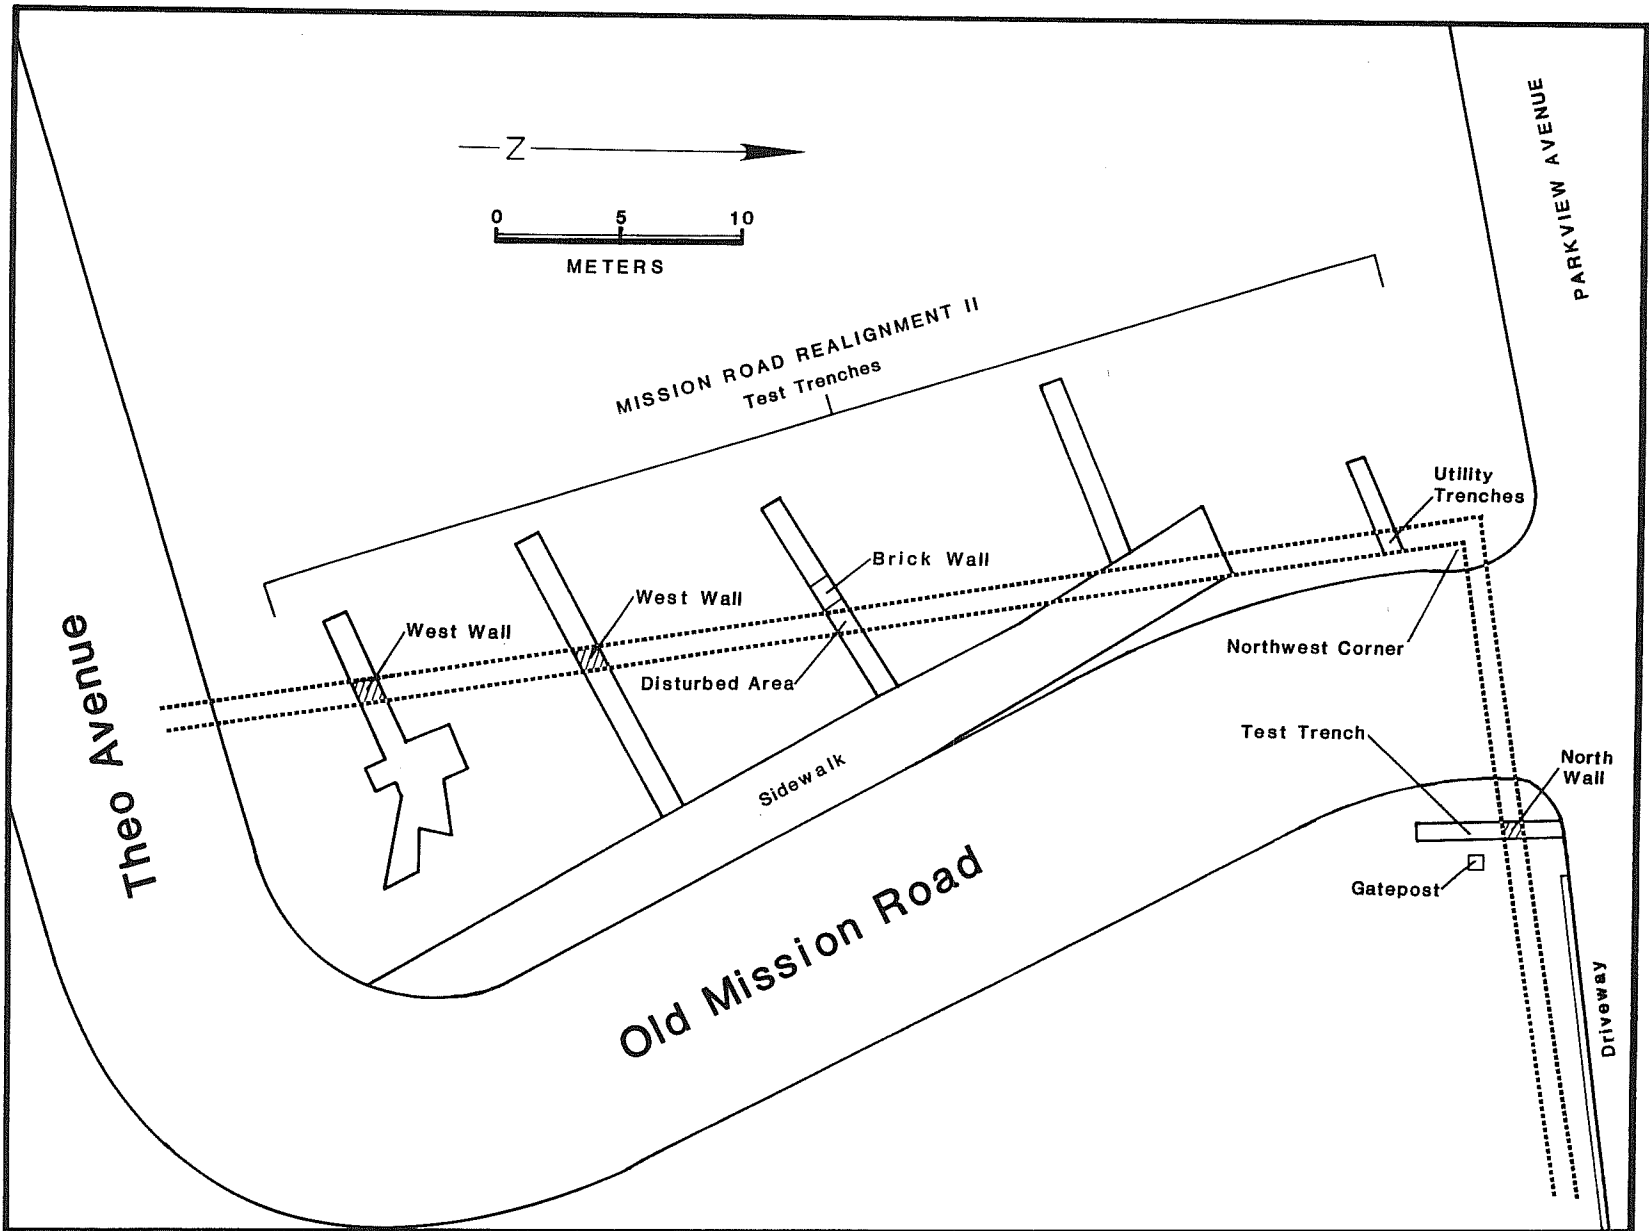
Figure 2. *Project Map*. Shown are previous and current test trenching that indicate the west and north wall alignments, and the projected northwest corner of the Mission Concepción quadrangle.

A backhoe trench 80 cm wide and approximately 5 m long was laid out 60 cm from the western face of the southernmost brick gatepost on the south side of the entrance drive to the St. John's Seminary buildings (Figure 2). The trench long axis was oriented to magnetic north. Approximately 1.25 m north of the gatepost, at ca. 75 cm below the surface, the top of the north wall of the compound was found. The wall was found to measure approximately 75 cm in thickness. The depth to the bottom of the wall was not determined, but it continued more than 1 m below the surface, where the trenching stopped.

The location of the northwest corner of the mission compound can be determined by projecting the lines of the west and north walls until they meet (Figure 2). This bit of information can now be added to the accumulated data about the outlines of the mission recovered by previous archaeological investigations. It can also be used in the future to relocate the northwest corner on the ground when the time comes to suitably indicate the mission walls on or above the ground surface.
