J. Chem. Eng. Chem. Res.
Vol. 1, No. 2, 2014, pp. 122-131
Received: June 5, 2014; Published: August 25, 2014

Corrosion Behaviour of Short Basalt Fiber Reinforced with Al7075 Metal Matrix Composites in Sodium Chloride Alkaline Medium

Abstract: The aim of the research work was to investigate the corrosion behaviour of basalt short fiber reinforced aluminum metal matrix composites (MMCs) in alkaline solution using weight loss method. The Al/basalt MMCs contains basalt short fiber from 2.5 to 10 % in steps of 2.5 wt. % and fabricated using liquid metallurgy technique. The corrosion characteristics of Al/basalt short fiber composite and the unreinforced alloy were experimentally assessed. The corrosion test was carried out at different temperatures in mixture of sodium-chloride alkaline solution at a concentration of 1N, 2N & 3N for different exposure time were subjected to corrosive media to evaluate their corrosion resistance. The results indicated that corrosion rate of metal matrix composites was lower than that of matrix material Al 7075 under the corrosive atmosphere for both unheat treated and heat treated conditions. Al/basalt short fiber composite become more corrosion prone

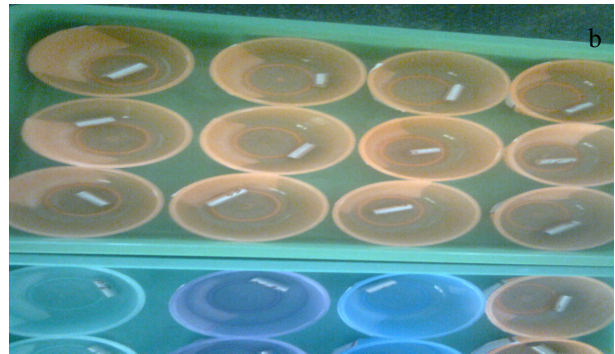
Fig. 1 Specimens dipped in NaCl Solution in 1N, 2N & 3N normality.

The corrosion tests were conducted as per the ASTM standards of G1 at room temperature (28 °C) using the conventional weight loss method. The corrodent used was 1N, 2N & 3N NaCl. The specimens were obtained from the bar castings. Small cylindrical disks of diameter 20 mm and 20 mm length were used for study. These specimens were polished with SiC emery paper of grade 400 to 600 grit in order to obtain a smooth and identical surface finish on all the specimens. The specimens were then washed with distilled water, followed by acetone, and then allowed to dry thoroughly. They were finally weighed to an accuracy of three decimal places. This same cleaning procedure was used before each weighing at each stage of the corrosion test. The initially weighed specimens were immersed in the corrosive environments as shown in Fig. 1 and taken out at 10 days intervals for testing up to a total of 90 days. One specimen was used for each test condition. Each time, the corrosion products formed on the corroded specimens were removed with a bristle brush. The cleaned specimens were dried and weighed. The

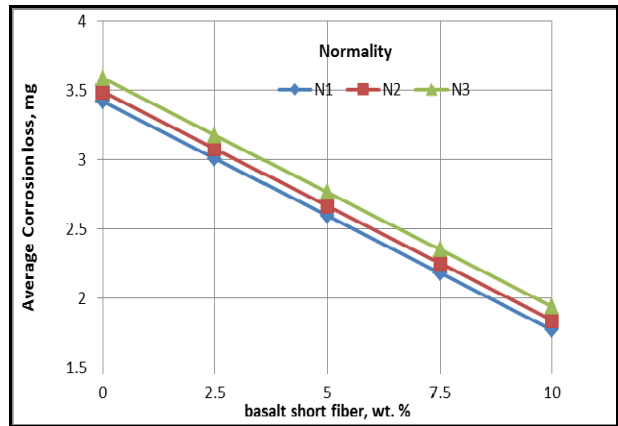
Fig. 3 Effect of basalt short fiber on corrosion weight loss of Al7075/basalt short fiber composites.

The plots of the corrosion loss (in mg) with a variation of basalt dispersoid in metal matrix composite in NaCl solution has been presented in Fig. 3. The measured mean values of corrosion loss (in mg) were plotted as a function of weight percentage of

basalt short fiber. From the study it can be observed that within the scope of this investigation as the basalt short fiber content was increased, there has been a decrease in the corrosion loss. The corrosion loss (in mg) with variation in weight percentage of basalt short fiber for different exposure times (in days) in 1N, 2N & 3N NaCl solution has been computed and tabulated in Table 4. From the Fig. 3, it can be clearly seen that, the percentage weight loss due to corrosion decreases monotonically with basalt short fiber content. In other words, more the basalt short fiber added more is the corrosion resistance of the composite. This decrease in the corrosion resistance of the basalt short fiber reinforced composite may be attributed due to the presence of interface between the basalt short fiber and the Al alloy matrix, which has generated during manufacturing. The presence of a more conductive phase at the interface provides an easier path for the electron exchange necessary for oxygen reduction and will drive the anodic reaction to higher level. The results obtained show that, for both reinforced composite as well as the unreinforced matrix alloy, the corrosion loss seems to decrease with duration of the corrosion test. Since the specimens were thoroughly cleaned and weighed at each time, it is safe to assume that each time this was done, the hydrogen bubbles

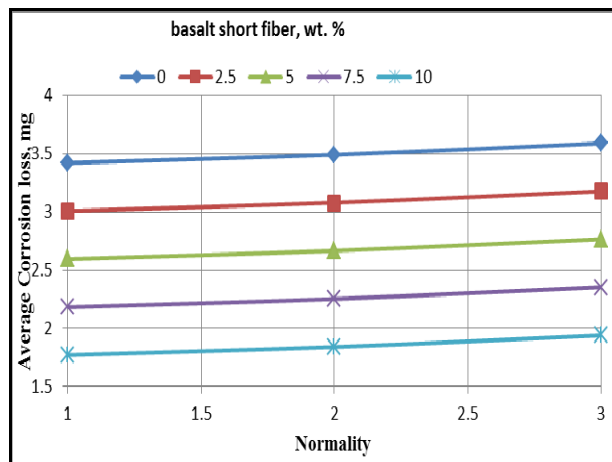
Fig. 4 Effect of normality on corrosion weight loss of Al/basalt short fiber composites.

The plots of corrosion loss (in mg) of as cast Al 7075 alloy and Al7075/ basalt short fiber reinforced composites as function of normality of NaCl solution have been presented in Fig. 4. The measured mean values of corrosion loss (in mg) were plotted as function of normality of NaCl solution. From the study it can be observed that within the scope of this investigation as the normality of NaCl solution was increased, there has been an increase in the corrosion loss. The variation of the corrosion loss (in mg) as function of normality of NaCl solution for both basalt short fiber reinforced basalt short fiber composite as well as the as cast Al7075 alloy has been computed and tabulated in Table 5. It can be seen that the shape of the corrosion curves as function of normality depends on the concentration of NaCl. The corrosion loss increases monotonically with increase in the concentration of NaCl solution for both the basalt short fiber- reinforced composite as well as cast Al7075 alloy. The basalt short fiber reinforced composite exhibited lesser corrosion loss than that of

as cast Al7075 alloy alloy. It is well known that the chemical reaction depends on the concentration of solution, area of the reaction surfaces, etc. The intensity of the corrosion attack increased with increase in concentration. On the same line some researchers [19-23] attributed this trend to the intensity of Cl⁻ concentration of the solution, which increases corrosion loss.
