Analysis of the Normal Transition Event of the LHD Helical Coils

Abstract—Normal transitions and a subsequent quench were experienced with the pool-cooled helical coils of the Large Helical Device (LHD) during its excitation test. Although the initiated normal zone once started to recover, a disruptive transverse propagation followed and triggered an emergency discharging program. The cryogenic stability of the composite-type superconductor has been studied by sample experiments as well as by numerical calculations. Due to the rather long magnetic diffusion time constant in the pure aluminum stabilizer, transient stability of the conductor seems to play an important role for driving finite propagation of a normal zone. The cause of the final quench is also discussed from the viewpoint of cooling deterioration due to a possible accumulation of helium bubbles.

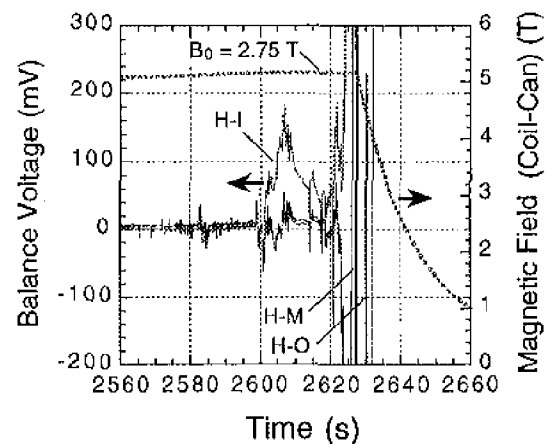
Fig. 1 shows the waveforms of the measured balance voltage signals for the three blocks of the helical coils during the quench event. A transport current of 11.45 kA was being supplied to each block before the emergency discharge. As is inferred from the positive rise of the H-I balance voltage (at $t \approx$

Fig. 1 Waveforms of the balance voltage signals measured for the three blocks of the helical coils, during a quench event at a toroidal field of 2.75 T. Magnetic field measured by a Hall probe on the coil-can is also shown.

2600 s) in Fig. 1, a normal zone was initiated in the H1-I block. According to the normal conducting resistivity of the superconductor obtained by previous sample tests, the initiated normal zone can be estimated to have developed over approximately 15 m and then it started to shrink (at $t \approx 2607$ s). It might be reasonable to consider that a normal zone was initiated at the innermost layer of H1-I block, where the magnetic field becomes the highest. According to the spike signals seen on the balance voltages, the initiation of normal zones seemed to be brought on by mechanical disturbances due to the large electromagnetic force acting on the windings.

Despite the gradual recovering process of the normal zone, sudden and simultaneous increases of the balance voltages occurred for all three blocks (at $t \approx 2621$ s), which finally triggered the quench detectors. Then the emergency discharging process went into action (at $t \approx 2627$ s) as it was programmed to do. Subsequently, the entire superconducting coil system, including the poloidal coils and bus-lines, were safely discharged with a time constant of 20 s, together with the proper action of the cryogenic system [4].

During the LHD excitation tests, normal transitions in the H-I blocks have been observed five times, including the most severe one shown in Fig. 1. In other cases, the initiated normal zones lasted only for a few seconds and recovered, and thus there has been no other quench. The important point is that even for the quench case, the normal zone initially showed a recovering process. These observations seem to be exactly consistent with our understanding of transient instability, which was confirmed with sample tests.

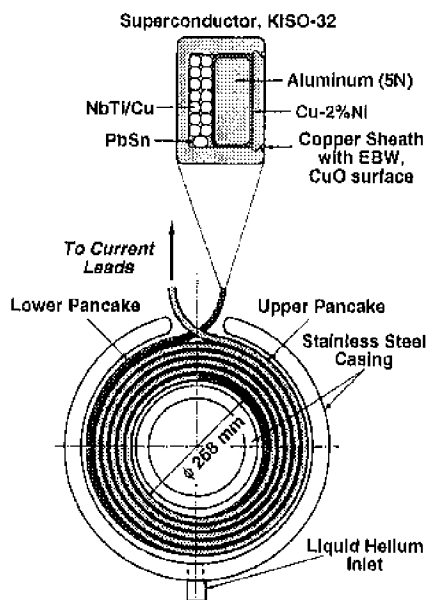
Fig. 2 Schematic drawing of a double pancake coil, HELIUT. The internal structure of the superconductor is also shown.

The cryogenic stability of this superconductor has been intensively studied by preparing a number of short samples [7] as well as R&D coils [8]. A short sample consists of two or four straight conductors, each 2 m long and soldered together in series. Fig. 2 illustrates one of the R&D coils, named HELIUT, which has double pancake windings (inner radius: 134 mm, outer radius: 227 mm), each 5 turns, and a total conductor length of 13 m. Both short samples and coil samples have been tested in a superconductor test facility with a 9 T split-coil, 100 kA current leads, and 75 kA DC power supplies. The sample conductors were directly cooled by 4.4 K liquid helium and stability tests were performed using tiny resistive heaters installed on the conductor surface to initiate a normal zone. The recovery currents and stability margins were measured by changing the bias magnetic field.

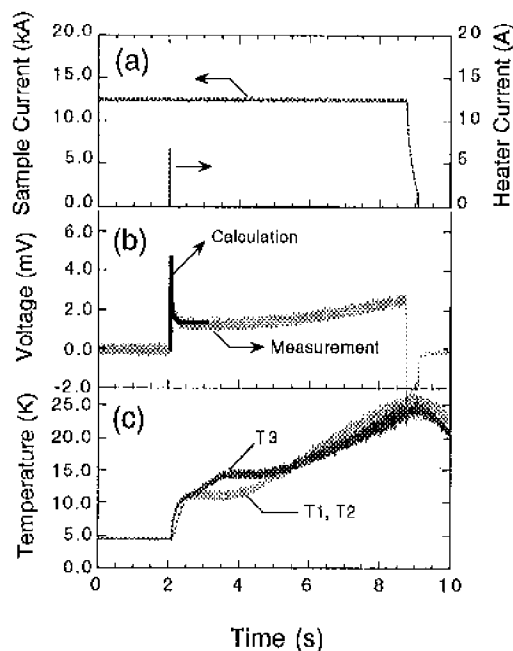
Fig. 3 Typical waveforms of the measured signals on the R&D coil HELIUT during a stability test. (a) Transport current and heater power, (b) a longitudinal voltage at the innermost layer with a 126 mm tap, and (c) conductor surface temperatures. In (b), the thick solid line is given by numerical simulation.

Fig. 3 shows a typical example of the waveforms of a longitudinal voltage signal as well as temperature signals measured for the R&D coil HELIUT. In this case, the maximum field on the innermost conductor was 6.8 T by adding the self-field generated by the sample coil current of 12.5 kA to the bias field of 6.4 T. As is seen in Fig. 3(b), after the initiation of a normal zone by the heater power, a longitudinal voltage develops with a short-time excess rise at the beginning of the propagation. This peak voltage seems to be brought on by the magnetic diffusion process in the pure aluminum core. A simple one-dimensional analysis gives a

time constant of 84 ms which is fairly close to the measured value of 97 ms determined from the voltage signal.

Another example for supporting the scenario of cooling deterioration is found in the test results of the double pancake R&D coil, HELIUT. Fig. 3(c) shows the temperature development of the innermost conductor of this coil during a stability test. Cernox sensors were attached on the conductor surface; T1 and T2 were located above the equatorial plane, whereas T3 were at below the equatorial plane. As is seen in Fig. 3(c), although T1 and T2 showed temporary decreases, T3 continuously increased, which might have led to the full quench of the coil at the end. This phenomenon might also be explained by the deterioration of cooling conditions, especially at the lower part of the coil where it should have an easier condition for accumulating helium bubbles between tight cooling channels in a stainless steel coil-can. On the contrary, another R&D coil without a coil-can showed significantly higher recovery currents [8].

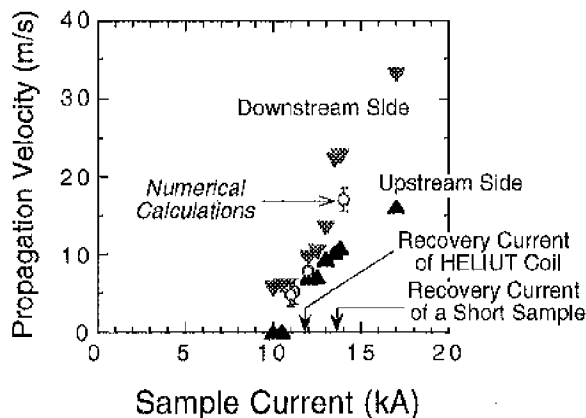
Fig. 4 shows the dependence of the measured propagation velocity of normal zones on the transport current. Data are taken from some of the short sample tests as well as the HELIUT coil with the magnetic field of 7 T. One important point found in Fig. 4 is that we observe finite propagation of a normal zone even with a transport current lower than the 'cold-end' recovery current. In this region, an initiated normal zone develops over a few meters length within a few seconds time and then it ceases to propagate further and shrinks back to the superconducting state.

Fig. 4 Propagation velocity of normal zones as a function of transport current, measured for short samples and a coil sample. The dashed line is given by numerical analysis.

between the two measured lines. The numerical calculation confirms that a finite propagation is possible even at a transport current of 9 kA.
