§26. R&D of Retro-Reflector for LHD with Anti-Reflection Reduction Mechanism

Yoshida, N., Tokunaga, T., Fujiwara, T. (Kyushu Univ.),
Akiyama, T., Tokitani, M., Kawahata, K.

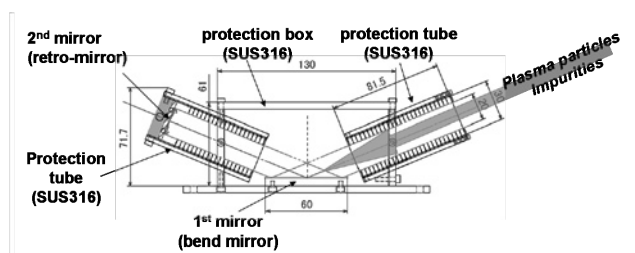
Test model for (a) is shown in Fig.1. Bend angle of the protection pipe is 45° and its length was designed as long as possible, about 5 times longer than its diameter in the present case, to reduce influx of plasma particles and impurities. After the end of the plasma exposure through Cycle 13, optical properties and microstructure of the reflectors were examined.

Fig. 1. Test model of bend type retro-reflector examined in the present work

It is worth to note that rather thick deposition was formed on the inner wall near the open edge of the protection tube. The deposition distributed on one side of inner wall and impurities did not reach beyond about 5cm (about 2.5 times of the diameter of the protection tube). The inner surface of the opposite side is very clean due to sputtering erosion. These results indicate that large amount of impurities are formed at the opening mouth of the protection tube due to the sputtering erosion under glow discharge cleaning, however sputtered impurities could not reach beyond 5cm. It was corroborated that protection of a long tube with an obtuse angle is very effective to suppress the reduction of reflectivity of retro-reflectors.

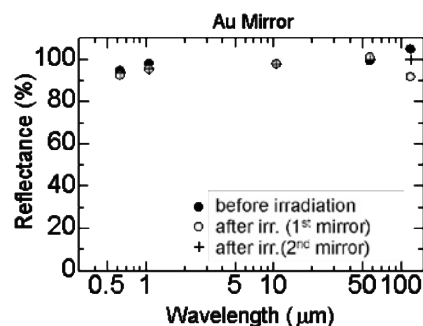
It was successfully demonstrated that the protection tube with an obtuse angle could sufficiently reduce PSI on the reflectors. As shown in Fig.2 reflectivity of the first mirror (Au) and the second mirror (Au) did not decrease significantly. TEM observation of the pre-thinned specimen placed on the flat mirror indicated that the deposition of impurities were negligibly small. Nano-scale dislocation loops were formed slightly in the first mirror facing to the plasma but no damage in the second mirror. These results indicate that influx of impurities and high energy particles which can transfer impurities to the retro-reflector is very low and therefore the surface properties of the mirrors placed in the protection tube did not changed even after one experimental cycle.

Fig. 2. Change of optical reflectivity of the 1st and 2nd mirrors

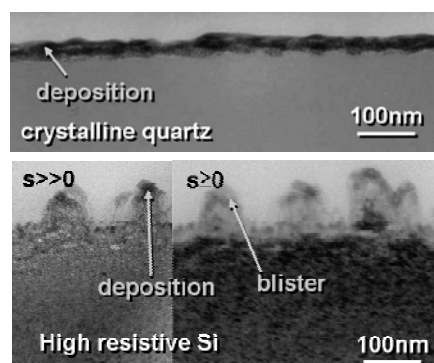
Fig. 3. Cross sectional TEM micrographs of crystalline quartz (CQ) and high resistive silicon (Si).

high resistive silicon (Si) were exposed to plasmas. After taking out from LHD, changes of optical transmittency for several kinds of laser were measured. By picking up cross-sectional micro-samples from the bombarded surface, change of microstructure was observed by TEM. The transmittency of Si and ZnSe decreased slightly. As shown in Fig.3, quite thick impurity deposition layers were found on the surface of SQ and CQ while not much on ZnSe and Si. Since the formers are insulator, it is expected that glow discharges could not sputter the deposited impurities. These results indicate that covering the retro-reflector by high resistance Si for laser in FIR and by ZnSe for visible-IR is a simple method to keep long the retro-reflectors at reasonable condition.
