§23. Stability of Advanced Tungsten - SiC/SiC Plate under Plasma Exposure in LHD

Kohyama, A., Asakura, Y., Kishimoto, H. (Muroran Institute of Technology)

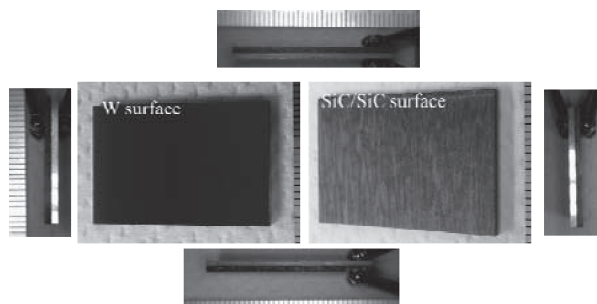
Figure 1. Test samples before Plasma Exposure

W-SiC/SiC dual plate was fabricated by hot pressing, where sample was W plate bonded on NITE-SiC/SiC plate. The plate for the plasma exposure test, with the dimension of $30 \times 20 \times 2 \text{ mm}^3$ was shown in Figure 1. The thickness of W and SiC/SiC was the same with 1.0 mm. The test samples fabricated were mounted on a carbon stand by molybdenum plate and bolt. The test port for plasma exposure was the port number 10.5L of LHD. The shot number was #121947.

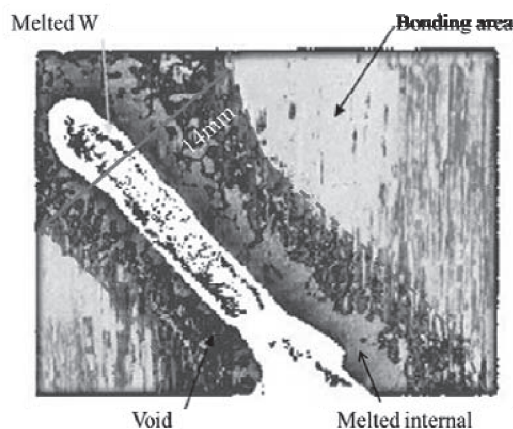
The result of ultrasonic test is shown in Figure 3. The blue area indicates damaged region of bonding interface and yellow area is with no significant damage along bonding interface by the plasma exposure. The blue area with the width of about 14mm is expanding from the plasma exposure area.

Figure 3. The Result of Ultrasonic Test
