## §103. Synergistic Effects of Neutron (ion) and Plasma on Material in QUEST

Watanabe, H., Yoshida, N. (RIAM Kyushu Univ.), Muroga, T., Kurishita, H. (Tohoku Uni.)

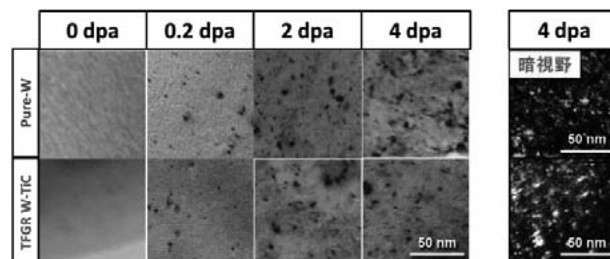
Fig.1 Microstructure of pure W and TFGR W-1.1TiC irradiated at room temperature.

In order to clarify the effect of radiation induced damage on D retention in W based materials with different microstructures, specimens of pure R-W (0.1mm thick sheet recrystallized at 2273K for 10 min,) and TFGR W-1.1TiC were employed. The pure W was electrolytically polished and TFGR W-1.1TiC was mechanically mirror polished followed by degassing at 1473 K for 5 min. The both specimens were irradiated with 2.4MeV-Cu<sup>2+</sup> at room temperature up to  $1 \times 10^{19}$  ions/m<sup>2</sup> for pure W and  $2 \times 10^{19}$  ions/m<sup>2</sup> for TFGR W-1.1TiC, which correspond to 2 and 4 dpa (displacement per atom), respectively. The position of the peak damaged zone is around 400-500 nm from the surface. After the ion irradiation, the specimens were irradiated with 2.0 keV-D<sup>2+</sup> at room temperature and higher temperature up to  $1 \times 10^{21}$  D<sup>2+</sup>/m<sup>2</sup> and subjected to TDS at temperatures from RT to 1023K in vacuum with an heating rate of 1 K/s. Fig. 1 and 2 show the microstructure of pure W and TFGR W-1.1TiC irradiated at room temperature. Fig. 1 and 2 show dislocation contrast images and void contrast images, respectively. By the irradiation, dislocation loops of interstitial type and a high density of nano-voids were observed in both materials. But, the microstructure of TFGR W-1.1TiC was almost same as the pure W. These results mean that the addition of 1.1TiC does not significant affects on the formation of dislocation loops and voids by the present irradiation conditions. Fig. 3 and 4 show the effects of displacement level (dpa) and irradiation temperature dependence of desorption rate of D<sub>2</sub> for pure W and TFGR W-1.1TiC, respectively. These results show that the sink density (dislocation loops and nano-voids) and resultant lattice defects due to 2.4MeV Cu<sup>2+</sup> irradiation have significant effects of the desorption of D<sub>2</sub> in both pure W and TFGR W-1.1TiC.

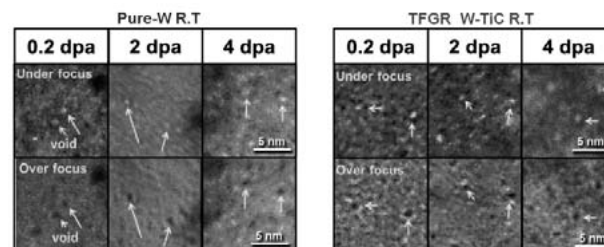
Fig.2 Void contrast image of pure W and TFGR W-1.1TiC irradiated at room temperature

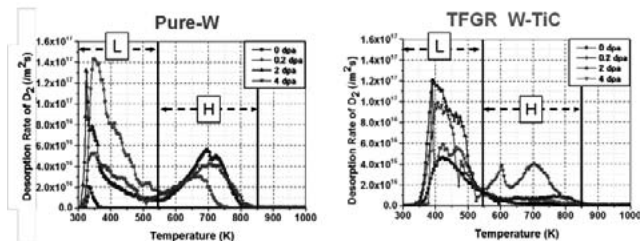
Fig.3 Effects of Cu ion irradiation on desorption of D<sub>2</sub> for pure W and TFGR W-1.1TiC irradiated at room temperature

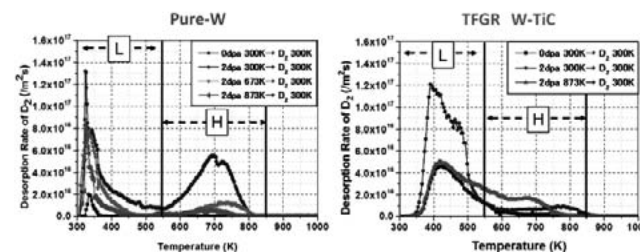
Fig. 4 Effects of higher temperature irradiation of on desorption of D<sub>2</sub> for pure W and TFGR W-1.1TiC
