§19. The Effects of Ion Irradiation on Heat Affected Interface between W and Low Activation Structural Materials

Watanabe, H., Yoshida, N. (RIAM Kyushu Univ.), Nagasaka, T., Muroga, T.

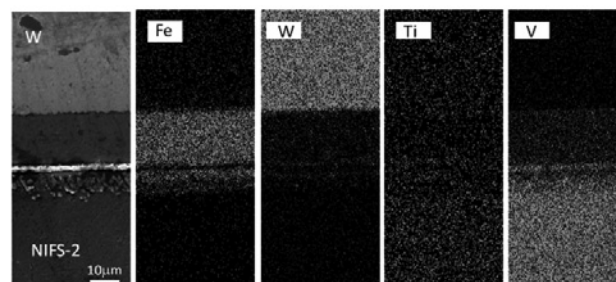
Fig.1. SEM images of interface between NIFS-HEAT-2 and brazed W.

1mm-thick sintered pure W was brazed with annealed NIFS-HEAT-2 substrate using 0.025 mm Fe-3B-5Si foil. The brazing condition was 1453K for 30 min in a vacuum of about 1.0×10^{-3} Pa. Fig. 1 shows SEM images of the interface between NIFS-HEAT-2 and brazed W. In the brazed sample, about 30 μ m of intermetallic layer was observed at the interface. For the transmission electron microscopy, the interface was prepared by Focus Ion Beam Technology (FIB). Fig. 2 shows the TEM images of interface between NIFS-HEAT-2 and brazed W. In the figure, (a) and (b) show microstructure near NIFS-HEAT-2 side and brazed W side, respectively. As shown in Fig. 2(a), in NIFS-HEAT-2 side, grown of grain perpendicular to the interface, which is commonly observed in welded sample was prominent. And blocky Ti precipitates, which are observed in the NIFS-HEAT-2, are not detected. It is known that irradiation hardening of V-4Cr-4Ti alloy was mainly controlled by a very high density of dislocation loops at lower temperature, but higher irradiation temperature, formation of radiation-induced Ti(CON) precipitates becomes dominant. These results mean that the oxygen atoms, which dissolved from the large Ti(CON) precipitates during W deposition strongly affects microstructural evolution of the materials. The understanding the effect of heat treatment (namely, post-coating heat treatment; PCHT) on W coated materials is important to reduce the radiation hardening of the materials.

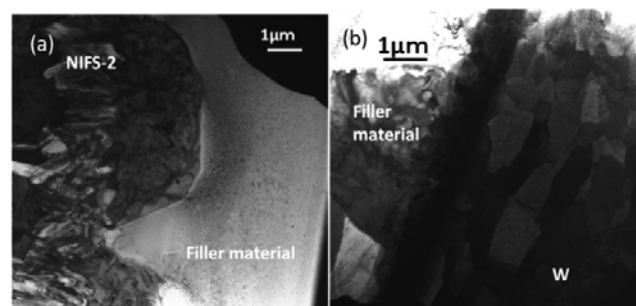
Fig.2. Microstructure of the interface between NIFS-HEAT-2 and brazed W (a) NIFS-HEAT-2 side (b) W-side

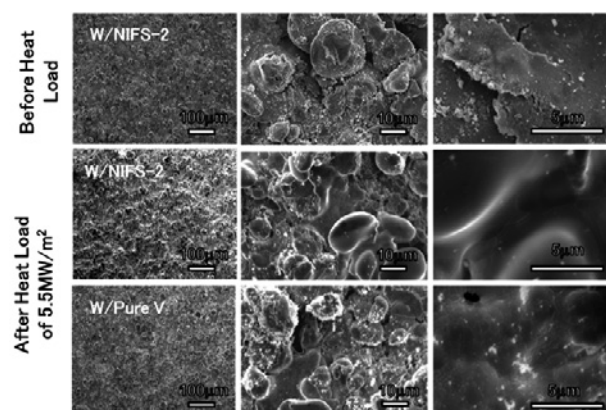
Fig.3. SEM images showing surface morphology of VPS-W on NIFS-HEAT-2. In the figure, VPS-W on pure V is also shown for comparison.

To know the effects of heat load, the samples were heat loaded in ACT. Fig. 3 shows surface morphology of VPS-W on NIFS-HEAT-2 before and after the heat load of about 5MW/m^2 (~ 50 cycles). In the figure, the results of VPS-W on pure V are also shown for comparison. Before the heat load, many spherical particles, which have not melted perfectly during the plasma spray process, exist on

the surface. After the heat load, the surface of VPS-W has very fine rough structure and prominent crack due to thermal heat load was not detected. Samples for ion irradiation are preparing from VPS-W and also brazed W.
