Ocean & Coastal Management

Factors influencing the initial establishment of salt marsh vegetation on engineered sea wall terraces in south east England

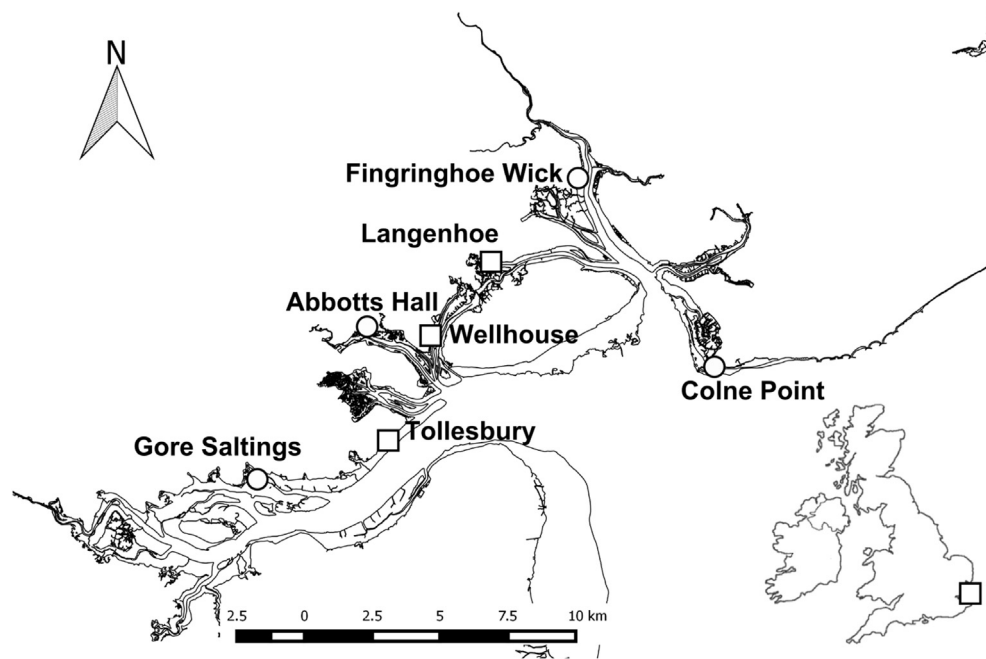
Fig. 1. Three sites in the southeast of England (squares) where experimental gabion terraces were constructed. Reference vegetation data was sourced from surveys conducted at four local salt marshes (circles). The relatively exposed location of Colne Point was used for a comparative reference for an index (F) of average wave fetch exposure (see Table 1 for grid references to individual terraces).

Twelve soft engineered terraces were installed by the EA at three sites within estuarine embayments along the Essex coastline. Langenhoe and Wellhouse (Mersea Island) both had five terraces, Tollesbury had two (Fig. 1, Table 1). Construction work commenced in January 2012 and the terraces were completed sequentially from June 2012, with the final terraces at the Wellhouse site being finished in August 2012 (Table 1). Individual gabion baskets filled with approximately 2 m³ of stone were placed in front of the toe-boards at the base of the sea wall. The terraces were created by backfilling clay into the space between the gabion baskets and the sea wall (Fig. 2). The clay for the terraces at Langenhoe and Wellhouse was imported. At Tollesbury the clay was locally sourced by digging linear lagoons, this method involved extracting clay from the grazing marsh and had the benefit of creating additional aquatic habitat. The 12 individual terraces varied in size (from 4 m to 42 m in length and 1.5 m–3.0 m in width) due to variation in the extent to which sections of blockwork and toe needed repair (Table 1). This provided an opportunity for the trial to include size (length) as a factor affecting terrace stability and recruitment.

sea (Fig. 1, 51.775431N, 1.0373443E) had an exposure index of $F = 26.06$.

Plant communities within the four reference salt marshes (Fig. 1) were sampled with quadrats identical to those employed on the terraces. Assembled from a pool of 17 species, the mean alpha diversity (i.e. species richness within a single sample unit) across the reference sites was six (minimum of three and maximum of 11 species). Percent vegetation cover at the reference sites ranged from 65 to >100% (accounting for vertical structure, the Domin system allows communities to receive scores of greater than 100%). The most frequently occurring and dominant species within the reference sample were *P. maritima* (36% cover), *A. portulacoides* (23% cover), *Salicornia* sp. (11% cover) and *Limonium vulgare* (10% cover).

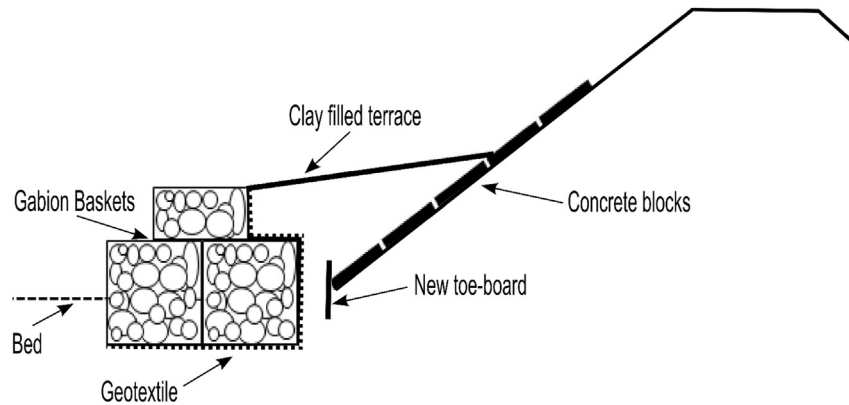
Fig. 2. Schematic cross section of new terraces, backfilled with clay behind stone filled gabions to protect the toe of the sea wall.

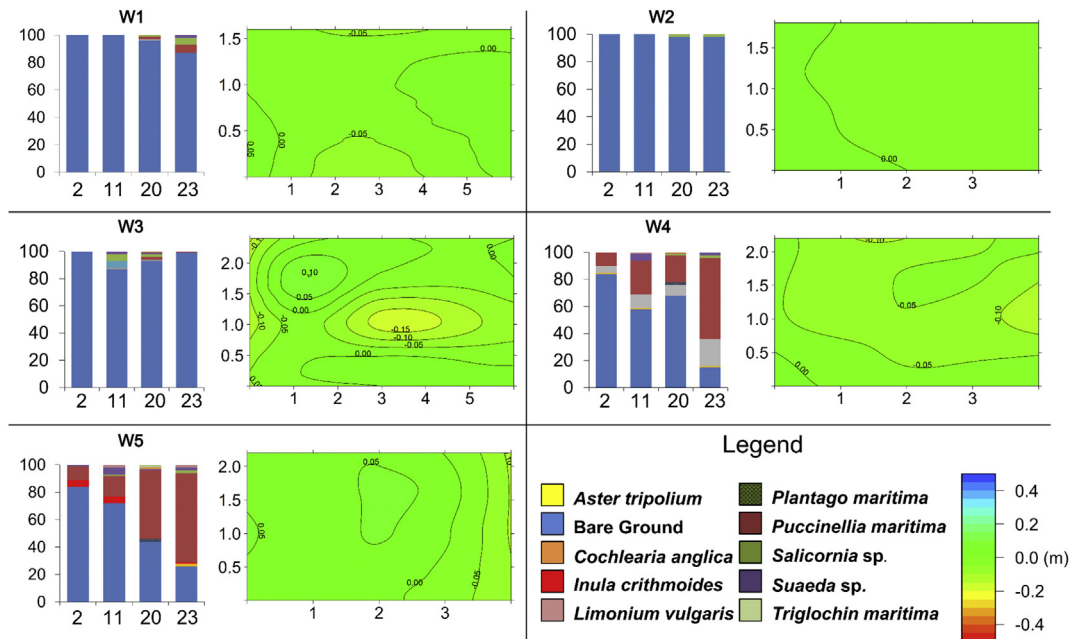
Fig. 3. Vegetation cover and composition and mean changes in surface topography of five terraces at Wellhouse (October 2012 to July 2014). Bars represent percent (%) plant cover at 2, 11, 20, and 23 months after terrace construction was completed. Contour plots illustrate the net effects of deposition and erosion between months 2 and 23, Terrace length (x axes) width (y axes) and height change (z axes) are shown in meters.

Over the three growing seasons, a pattern of sedimentation was seen at seven of the 12 terraces where net sediment deposition occurred towards the sea wall and was eroded towards the edges of the seaward edges of the terraces (Figs. 3 and 4; W2, W3, W4, L1, L3, L4 and L5). Three of the terraces at Wellhouse exhibited erosion just behind the gabion cages (W1, W3 and W4). Overall, at Wellhouse, the changes in sediment surface heights were non-significant, and all five of the terraces maintained constant sediment heights throughout the period studied.

All 12 terraces showed some degree of plant colonisation between at least one pair of observations (Figs. 3–5). The smallest recorded increase was at Tollesbury where terrace T1 remained without vegetation until April 2014 when it had 0.3% cover (Fig. 5). The highest relative vegetation cover was on W4 (85%, July 2014), and W5 with 74% cover in July 2014 and 56% in April 2014 (Fig. 3).

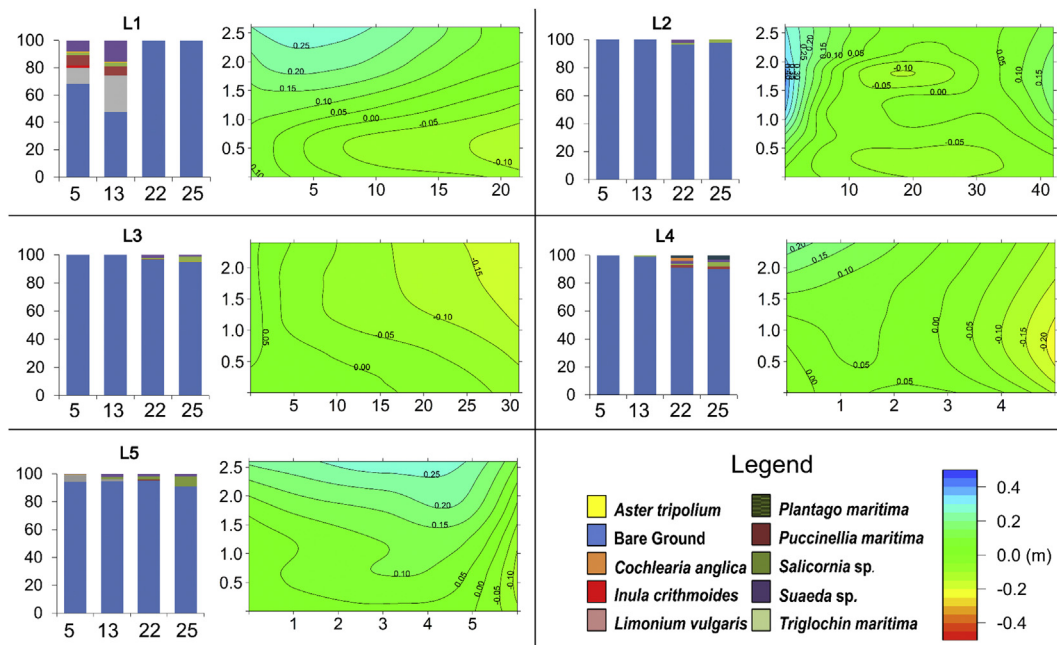
Fig. 4. Vegetation cover and composition and mean changes in surface topography of five terraces at Langenhoe (November 2012 to July 2014). Bars represent percent (%) plant cover at 5, 13, 22 and 25 months after terrace construction was completed. Contour plots illustrate the net effects of deposition and erosion between months 5 and 25, Terrace length (x axes) width (y axes) and height change (z axes) are shown in meters.

Over the 22 month study period (October 2012–July 2014), Langenhoe terraces L5 and L2 increased in surface height by +8 cm and +12 cm respectively. There was net accretion on Langenhoe terraces L1, L2, L4 and L5 during the period July 2014 to April 2014 (including the tidal surge of December 2013) (Table 2), with only Terrace L3 losing sediment ($U = 2.25$, $p = 0.03$, Table 2). Terrace L2 had a particularly pronounced ($U = -11.02$, $p < 0.01$) +13 cm gain in surface height during this period, which was concentrated towards either end of the terrace (Fig. 4). Terrace L2 had its highest levels of erosion in the centre of the terrace with some deposition on the side furthest from the estuary-mouth and against the sea wall.

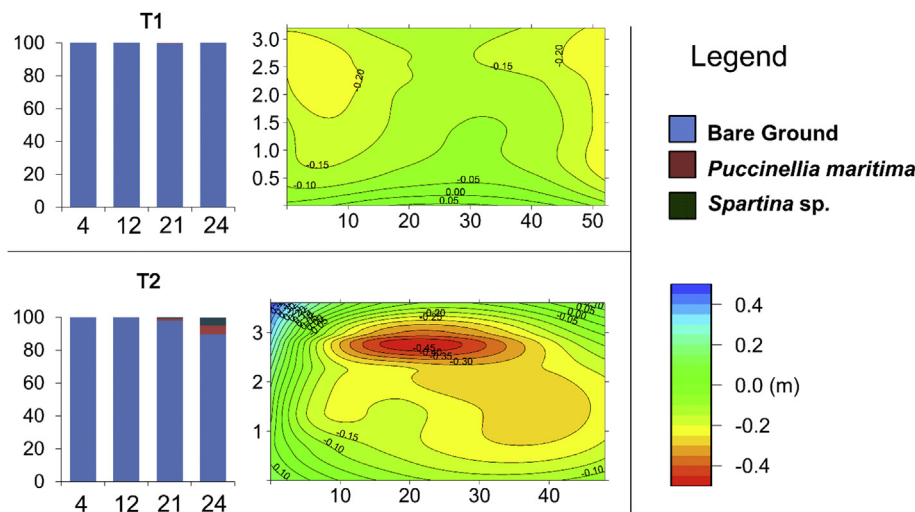
Fig. 5. Vegetation cover and composition and mean changes in surface topography of two terraces at Tollesbury (November 2012 to July 2014). Bars represent percent (%) plant cover at 4, 12, 21 and 24 months after terrace construction was completed. Contour plots illustrate the net effects of deposition and erosion between months 4 and 24, Terrace length (x axes) width (y axes) and height change (z axes) are shown in meters.

From October 2012 to July 2014, both Tollesbury terraces decreased in surface height. Erosion at T1 was lateral, i.e. sediment was scoured from behind the gabions towards the centre of the terrace (Fig. 5). The surface topography of both Tollesbury terraces significantly changed during the period including the 2013 surge event. Terrace T2 gained in height (+6 cm) whilst terrace T1 lost 10 cm of sediment to erosion (Table 2; $U = 5.66$, $p < 0.01$). At T1 most of the deposition occurred in the middle of the terrace, where an L-shaped bend in the sea wall was present, while increased erosion occurred towards the edges of the terrace. T2 showed the highest level of erosion in the centre of the terrace with decreased erosion towards the edges, and high levels of deposition towards

the edge least exposed and sea wall side (Fig. 5).

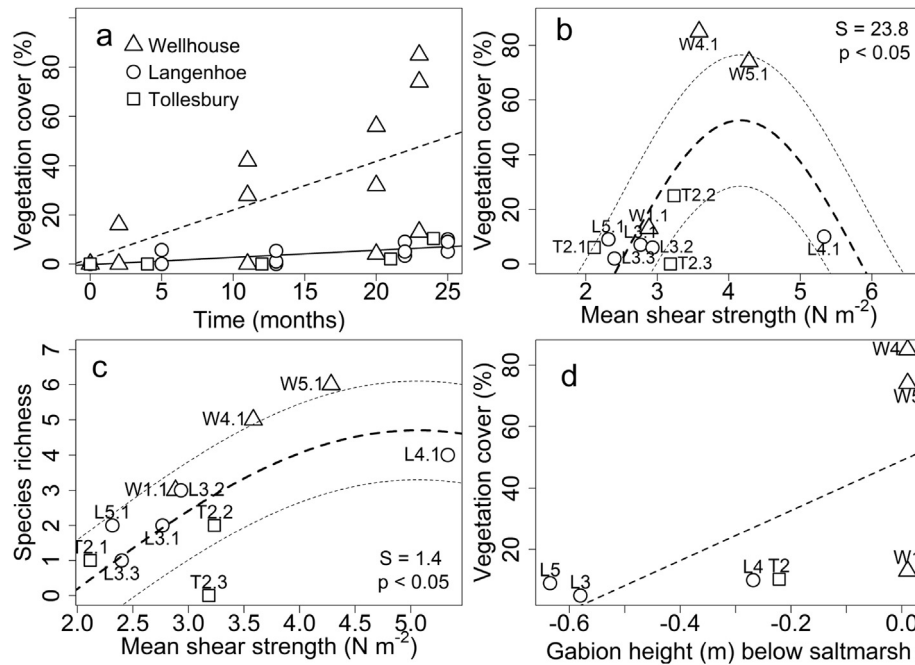
Fig. 6. (a) changes in vegetation cover at seven terraces W1, W4, W5, L3, L4, L5 and T2 over time from construction in 2012. Broken line = line of best fit for Wellhouse, solid line = line of best fit for Langenhoe and Tollesbury. (b) Non-linear relationship between sediment shear strength and vegetation cover, (c) plant species richness of seven successfully colonised terraces in July 2014. Fitted curve (dashed line) and standard deviation (dotted lines). (d) Relationship between vegetation recruitment (% cover) and terrace height in relation to existing adjacent saltmarsh ($r^2 = 0.4$ $p = 0.1$).

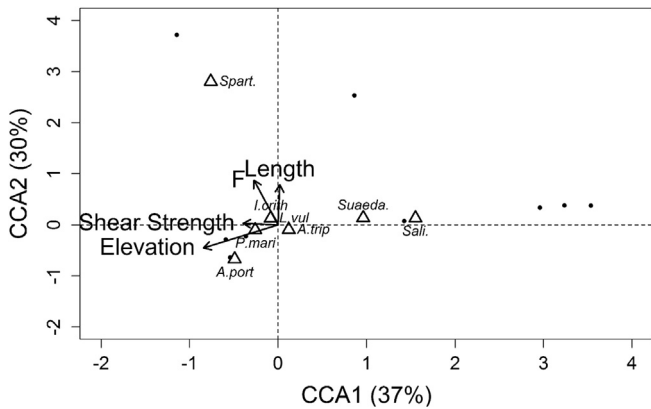
Fig. 7. Distribution of eight species of plant at ten colonised experimental terraces, 23–25 months after construction in relation to environmental factors. Ordination diagram of Canonical Correspondence Analysis (CCA), for axes CCA1 and CCA2 the percentage cumulative proportion of constrained eigenvalues are shown in parentheses. Triangles indicate plant species, dots indicate terrace sites and environmental variables are illustrated by arrows. The plant species are; A. trip = *Aster tripolium*, A. port = *Atriplex portulacoides*, L. crith = *Inula crithmoides*, L. vul = *Limonium vulgare*, P. mari = *Puccinellia maritima*, Sali = *Salicornia* sp., Suaeda = *Suaeda* sp and Spart. = *Spartina* sp. Environmental variables are; Length = terrace length, F = an index for wind and wave exposure, sediment shear strength ($N\ m^{-2}$) and Elevation = the height each terrace was constructed relative to the surface of local remnant salt marsh.

Ordination (CCA) explained 72% of the variation in the distribution of plant species (Fig. 7). Elevation relative to existing salt marsh exerted the greater influence (37%). Weighted averages generated by CCA positioned plant species along a gradient of

elevation; with the pioneer species *Salicornia* sp. centred at the lower range of the gradient and *A. portulacoides* at the upper. Exposure (F) accounted for 30% of the variation. With the exception of *Spartina* sp., the extent to which plant species were distributed along the exposure axis was less pronounced than for elevation. *Spartina* sp. distribution was centred common to the main centroid with regards to elevation but was strongly influenced by exposure. The remaining five percent of explained variation was due to terrace length and shear strength. Twenty eight percent of the variation was unexplained by the constraining variables.
