Title: Post Occupancy Evaluation of social housing designed and built to Code for Sustainable Homes Levels 3, 4 and 5

Author: Stephen Pretlove Sidonie Kade

To appear in: *ENB*

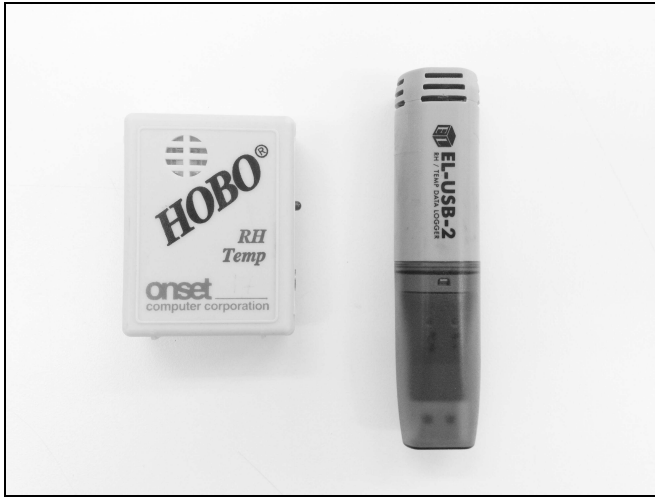
Figure 1: HOBO H8 and LASCAR EL-USB-2 dataloggers

The dwellings were monitored during the period 15<sup>th</sup> March 2013 to 14<sup>th</sup> March 2014 and during this period dataloggers were used to collect hourly readings of temperature and relative humidity in four locations in each dwelling: the living room, kitchen, bedroom and outside. Data was collected using a combination of HOBO H8 and LASCAR EL-USB-2 dataloggers, which are shown in Figure 1. HOBO H8 dataloggers have an accuracy of  $\pm 0.7^{\circ}\text{C}$  at  $21.0^{\circ}\text{C}$  and  $\pm 5.0\%$  RH. LASCAR EL-USB-2 dataloggers have an accuracy of  $\pm 0.5^{\circ}\text{C}$  at  $21.0^{\circ}\text{C}$  and  $\pm 3.0\%$  RH. In addition to this, during regular visits to each dwelling for the collection of data, gas, electricity and water consumption readings were taken, where possible, together with data from renewable energy generating systems installed at each location. Social surveys were also carried out at the start of the project, where the occupants were interviewed in order to assess how they use their homes. The basic specifications of the seven dwellings in this study are shown in Table 1.

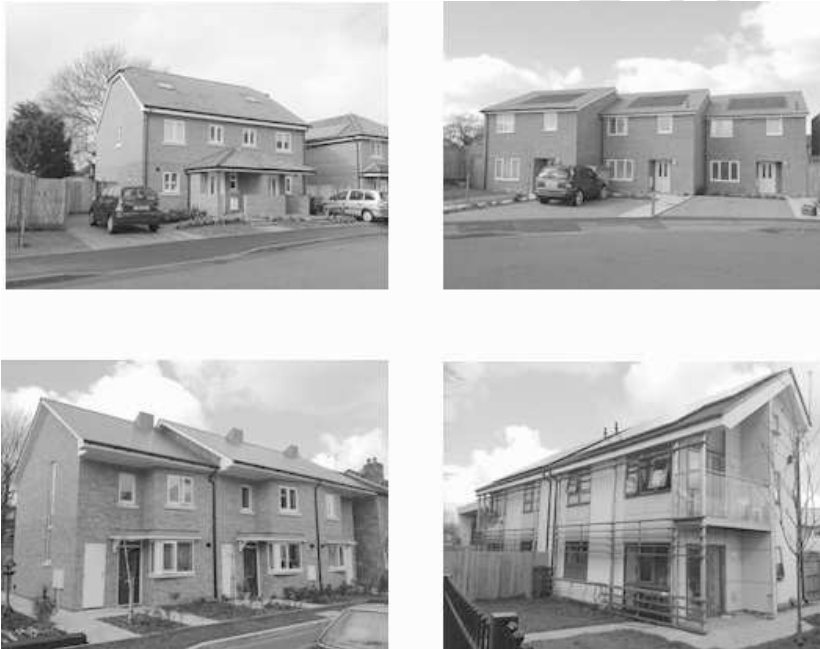
Figure 2: The dwellings, clockwise from top left, 39OB (Code level 3); 138NG / 139NG (Code level 4); 94SR/ 96SR (Code level 5); 249MR / 249aMR (Code level 5)

To ensure anonymity, the dwellings are given simple reference numbers and these are used throughout this paper. The table shows the basic dwelling unit configuration in terms of number of bedrooms and occupants, the floor area and the CfSH level. It also describes the fabric and building servicing strategy for each dwelling giving details of the technology installed into each home. Figure 2 shows the four dwelling types tested in this study.

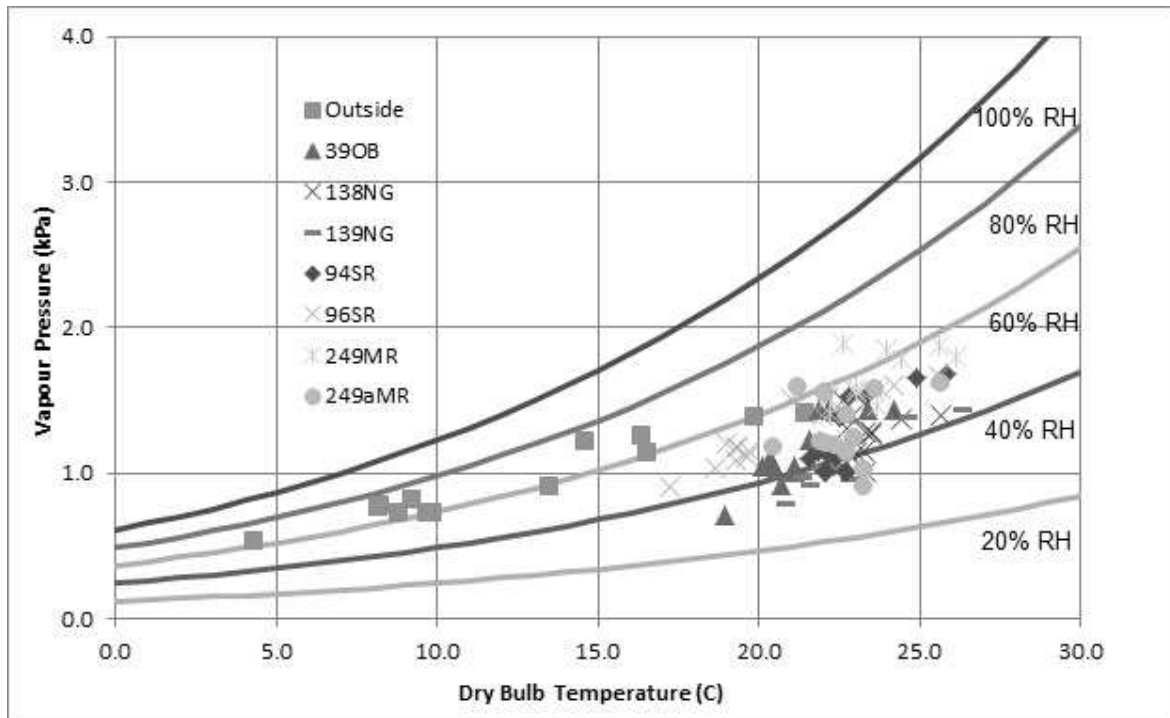
Figure 3: average monthly monitored conditions for all dwellings, internally and externally

Figure 3 shows the average monthly monitored conditions for all dwellings, internally and externally, superimposed onto a psychrometric chart.

The data shows a relatively wide range of average external temperatures measured during the period, between approximately 4°C and 22°C. A significantly reduced range of temperatures were measured inside the dwellings, most of the data within the range of 20°C and 25°C. It is evident that the dwellings were heated to different levels of comfort, dwelling 96SR having seven months when the average internal temperatures were less than 20°C, and dwelling 249MR where the average monthly temperatures never fell below 22°C and for two months the average temperatures were above 25°C. Similar variations have been reported in published literature [8] which questions the assumption of a comfort temperature of 21°C in domestic dwellings in the UK. Comprehensive monitoring studies have shown that there are a significant number of UK dwellings where the occupants set demand temperatures much higher than this [16].

In general, the monthly average levels of external relative humidity are consistent, ranging between 60% and 80%, and corresponding internal relative humidity levels are less than this, as would be expected as the temperature rises, typically between 40% and 60%. The monthly averages of internal relative humidity indicate that levels were not sufficiently high in any of the dwellings for there to be a significant moisture related risk to the health of the occupants, for example from mould growth, which occurs when the airspace relative humidity exceeds 70% for extended periods [17].

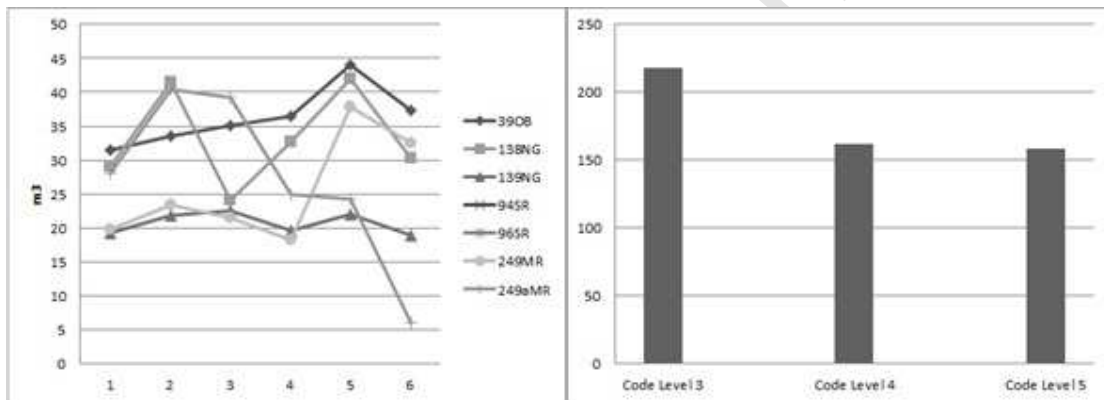
Figure 10: Water consumption for five dwellings with a bar chart showing the average water consumption by Code level

Figure 10 shows the water consumption data graphically for the five dwellings where water meter readings were possible, together with a bar chart showing the average water consumption by Code level.

It is usually assumed that each person in a dwelling consumes 150 litres of water per day. This equates to approximately 55 m<sup>3</sup> of water consumed per person in a year. Given that in dwelling reference 39OB there are four occupants, and limited water saving features, the actual consumption figure of 218 m<sup>3</sup> measured over the year is about what would be expected. Measured water consumption in Dwellings reference 138NG and 139NG (Code level 4) are below the level expected given the levels of occupancy. The Code Level 5 dwellings, 94SR, 96SR, 249MR and 249aMR all incorporate EcoPlay grey water systems which should reduce the water consumption figures, but as mentioned earlier, we were unable to collect meter readings from dwelling references 94SR and 96SR, and, given the reduced number of data samples, it is difficult to establish any clear connection between the grey water recycling systems and water consumption figures. This will, in part, also be due to the faults reported with the EcoPlay systems during the year.

The results indicate, once again, that whilst there is variability in the consumption of water across all seven dwellings, and during the year, there is a downward trend in consumption of water with increasing levels of the Code.
