Impact Properties of Hemp Fibre Reinforced Cementitious Composites

Xiangming ZHOU^{1, a *}, Reza MADANIPOUR^{1, b}, Seyed GHAFFAR^{1, c}

¹Department of Mechanical, Aerospace and Civil Engineering, Brunel University London, Uxbridge, Middlesex UB8 3PH, United Kingdom

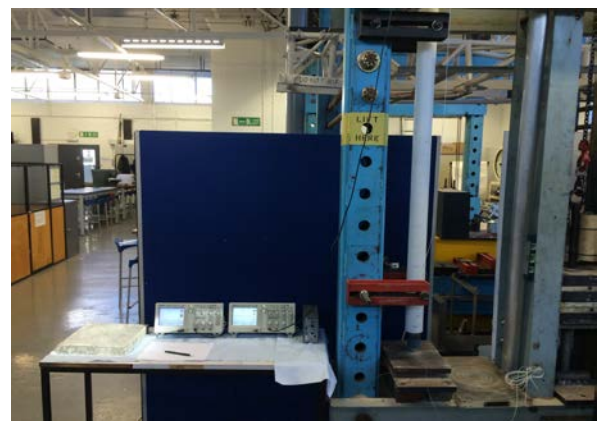
Repeated drop weight method was employed to investigate impact resistance of HFRCs on panels. The repeated drop weight impact test set-up is shown in Fig 1. The testing system consisted of a stainless steel rod as the drop weight of 6 kg from the height of 0.8 m with a cylindrical body diameter of 4 cm which was connected to a tensile wire that can be manually controlled, and kept vertically by a steel wire fixed to the pulley installed on frame. Steel rod front head had a spherical shape and the impact surface area had been reduced from the diameter of 4 cm into 2 cm, which modified it to act more as a point load at the moment of impacting. A central impact was achieved by means of a plastic

Figure 1 Impact resistance test set up including oscilloscope

tube guide. The guide tube had an inner diameter greater than that of the ball in which the projectile was allowed to slide freely up and down with no friction between them. Additionally, the inside surface of the plastic tube was lubricated in order to prevent any friction between the tube guide and the steel rod.

HFRC panels were placed on a steel base plate, which was fixed to the vertical steel frame. Two oscilloscopes were used to monitor the chosen physical parameters. One oscilloscope was connected to an accelerometer, which was mounted underneath the centre of the steel base plate. Voltage signals were picked up by the accelerometer and presented on oscilloscope so that it could be used to calculate the energy absorbed by HFRC panels at each blow. In addition, the projectile was equipped with an accelerometer, which was connected to the other oscilloscope in order to measure the impact load. Applied impact load was determined by multiplying the deceleration and mass of the projectile. In this study, for the impact resistance tests carried out, all HFRC panels were subjected to impact at their centre point of 300×300 mm².

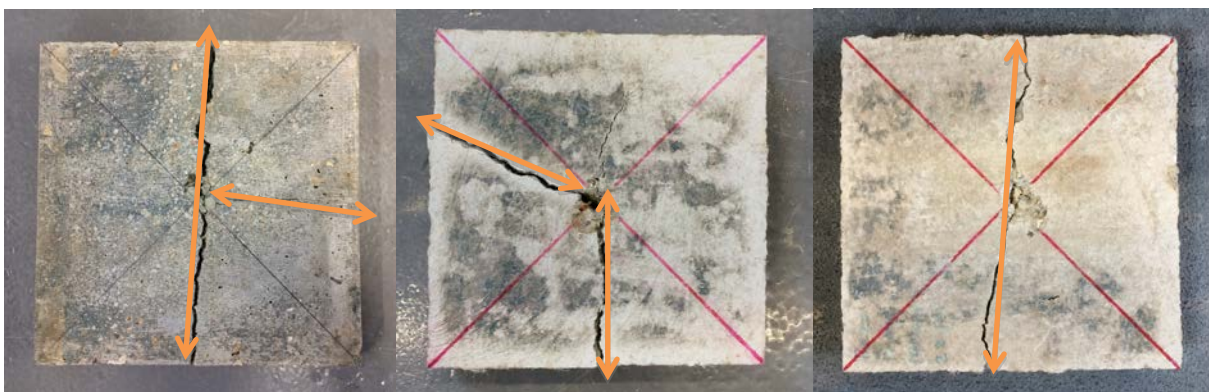
Cracking behaviour. It has been evident that failure pattern and cracking behaviour of HFRC panels is similar under both fibre lengths of 10 and 20 mm, and is related to their respective age. Fig. 2 illustrates cracking behavior of HFRC with fibre length of 20 mm at ages of 7, 14 and 28 days. It can be seen that cracks for the specimen at the age of 7 days propagated in three directions from the centre of a panel to the middle of its sides with narrow crack width. At the age of 14 days wider cracks were formed which divided one corner of the panel by propagating from centre of the panel to middle of side edges showing more damage. At the age of 28 days most specimens were halved from centreline of the square panel with crack wider than that at 7 and 14 days. Additionally, in case of HFRC panels at 7 days, fibre pullout was observed at ultimate failure especially for those reinforced by 20 mm long fibres. At ages of 14 and 28 days, more fibres fractured than being pulled out at ultimate failure. These failure behaviours with ageing can be explained by two reasons. Initially, higher level of moisture due to the slower hydration process makes early age specimens more ductile, while specimens at age of 28 days are very brittle. Second reason is that alkali environment of HFRC led to deterioration of hemp fibres causing them to lose their functionality as reinforcement. At early ages, due to slower hydration process, alkalinity in HFRC was not strong, resulting in less deterioration of fibre structures while with ageing of specimens higher rate of alkali reactions with hemp fibre lignin will occur. Furthermore, generally crack width increased with increase in curing age. For instance, crack width at 28 days were almost twice as crack width at 7 days. It has also been noticed that specimens reinforced with longer fibres regardless of their age provided better post cracking behaviour as they tended to reduce further increase in overall crack width by bridging them. Despite the fact that both types of specimens did have similar maximum crack width where the first crack was initiated, specimens with longer fibres provided better widening resistance for cracks grown later and tended to have narrower crack width in overall.

Figure 2 Failure pattern of HFRC panels with curing ages of 7, 14 and 28 days, respectively, from left to right
