The Fourth International Conference on Through-life Engineering Services

## Review of Non-destructive Testing (NDT) Techniques and their applicability to thick walled composites

School of Aerospace, Transport and Manufacturing, Cranfield University, Bedfordshire, United Kingdom

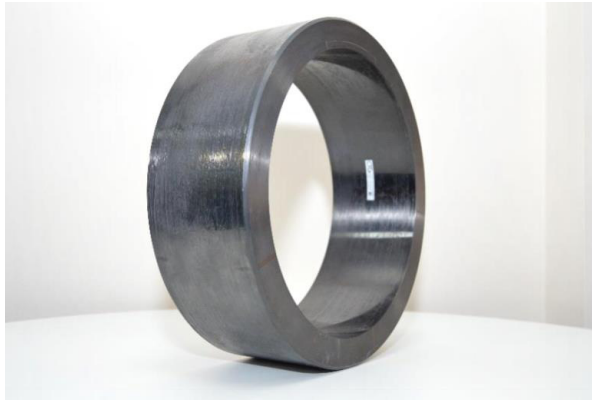
Fig. 1. Composite component under consideration

The component under consideration is an integral part of the flywheel. It is cylindrical in shape and is made out of CFRP intermediate modulus and approximately 30 mm thick (see figure 1).

The cylinder is manufactured by filament winding with an outer diameter of about 350 mm and a height of 119 mm.

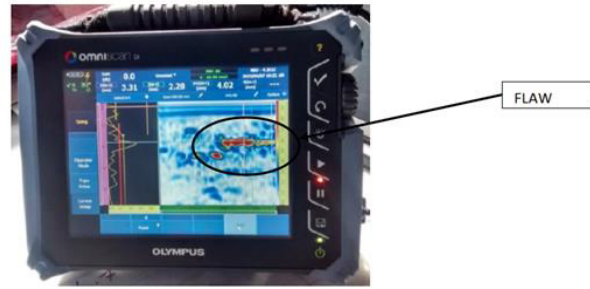
Fig. 5. Result of experiment and analysis of sample showing flaw characteristics.

The experiment with 5MHz frequency probe detected back wall echo of material. At the same time with a 2MHz frequency probe echo signal received with larger amplitude. However, the known flaw's present in material was not noticed. There was another flaw, which was detected in C-Scan and flaw characterization shows a crack of length (figure 5).

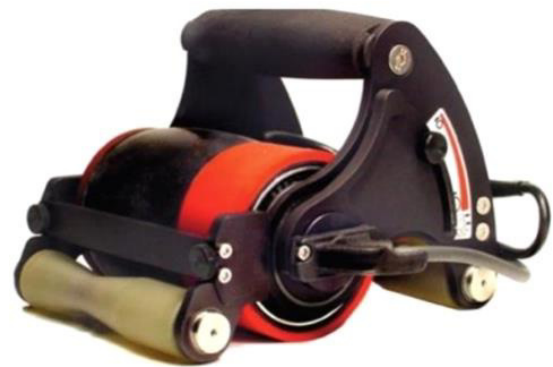
Fig. 6. Sonatest RadiusWheel Probe. [14]

The front wall echo was visible on the scanner screen. There was too much attenuation due to surface feature of the sample. The back wall echo was not detected on the screen. There could be several reasons for the lack of penetration. This could be failure of proper contact between RadiusWheel probe and flywheel due to geometry of part. The use of water as a coupling agent might have proved to be ineffective due to low viscosity and hence less adherence in between two surfaces. These factors could have led to large attenuation that were shown as near surface flaws.

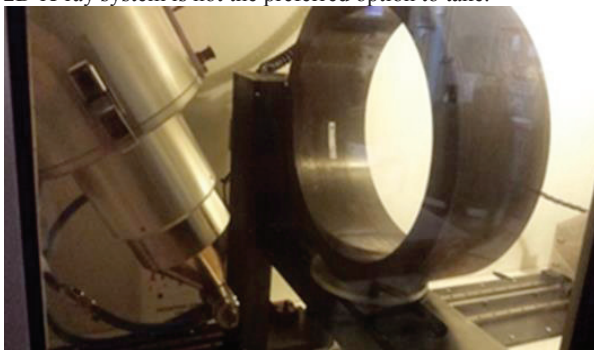
Fig. 7. Experimental set-up of a 2D X-ray system.

Initial tests with radiographic X-Ray equipment generating two-dimensional images have been made, figure 7 shows the experimental set-up.

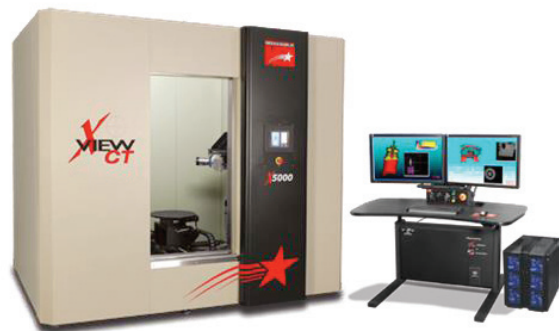
Fig. 9. North Star Imaging X5000 CT scanning system with workstation. [16]

will be presented below. Most of the companies recommended to use cabinet systems for an industrial production environment (like the one shown in figure 9). All products are state-of-the-art machines and are already used in the manufacturing industry. The price for CT scanning machines ranges from £200k to £600k, depending on precise requirements and resolution.

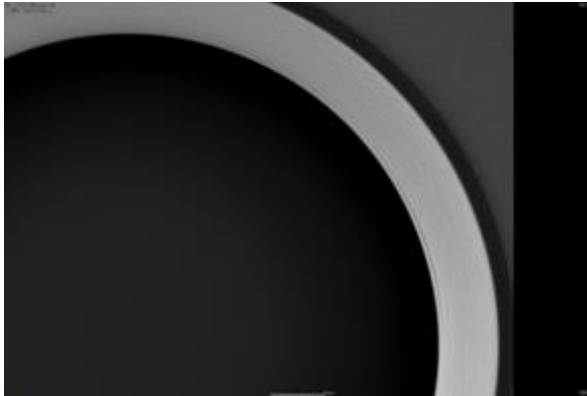
Fig. 10. Slice through the volumetric model acquired by CT scanning; the delamination on the inner side can clearly be detected

Several cabinet systems from various suppliers have been tested. Figure 10 shows results acquired with a NSI X5000 machine. A delamination on the inner side of the flywheel can clearly be seen on the right side of the picture. The data has been captured within 15 minutes with a resolution of approximately 200  $\mu\text{m}$ .

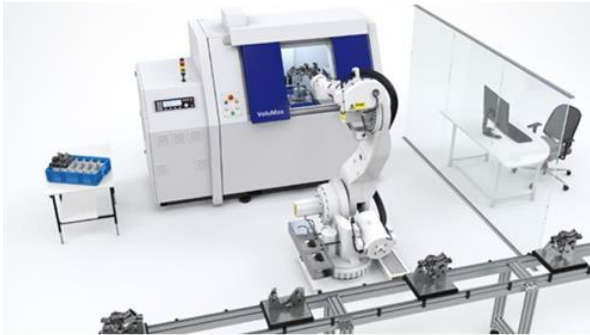
Fig. 13. Fully automated in-line CT system. [19]

All the machines can be operated using a robotic handling system (figure 13). Opening/closing the door, starting the machine etc. can also be automated and adapted to the final production line.
