# INSPIRATION AND EXPERIENCES FROM THE JOINT ANALYSIS OF SHINING EXAMPLES OF COMPREHENSIVE ENERGY RENOVATION BUILDING PROJECTS WITHIN IEA EBC ANNEX 56

*The International Energy Agency established in 2011 an Implementing Agreement within the Energy in Buildings and Communities Program to undertake research and provide an international focus on Cost Effective Energy and Carbon Emissions Optimization in Building Renovation (EBC Annex 56). The project aimed at developing a new methodology to enable cost effective renovation of existing buildings while optimizing energy consumption and carbon emissions reduction. Gathering of case studies was one of the activities undertaken to reach the overall project objectives. Among the case studies, a selection of “Shining Examples” was made to encourage decision makers to promote efficient and cost effective renovations. This paper presents the results of the analyses made on these Shining Examples.*

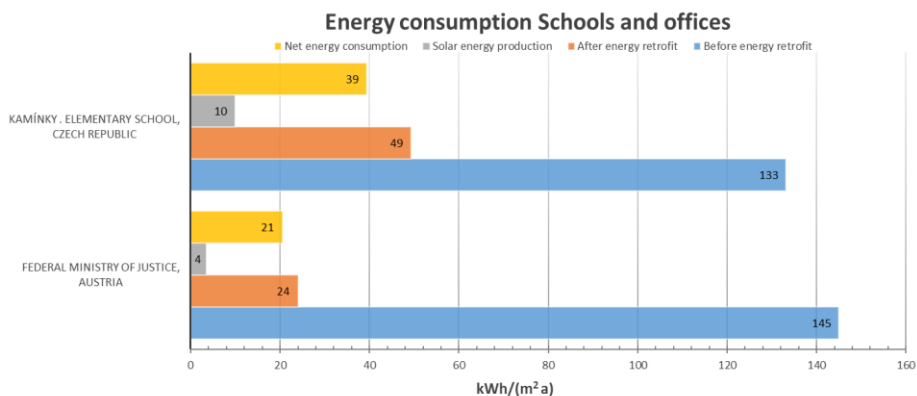
Only two public buildings were studied, an elementary school located in Kaminky, Czech Republic and The Federal Ministry of Justice of Bruck/Mur in Austria. Both buildings present a fairly high energy reduction by the incorporation of RUE by 63% and 83% for the school and the official building respectively, as it can be seen from Figure 1.

Fig. 1. Overview of the Energy consumption before and after energy retrofit for the two public building cases

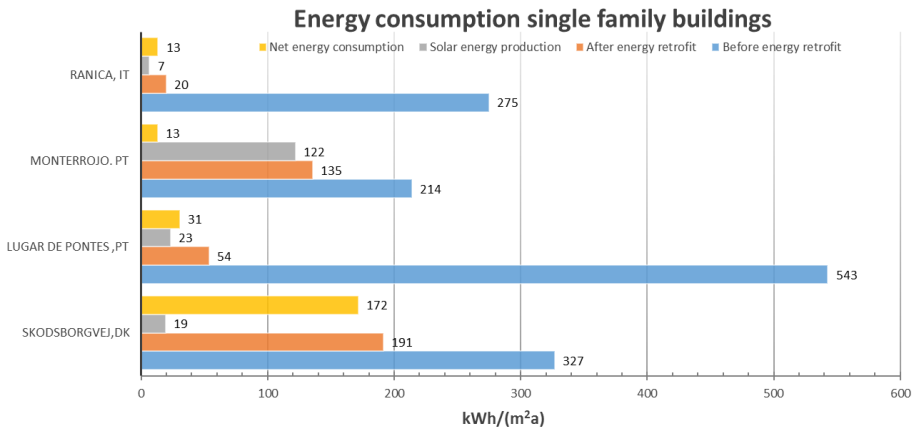
Four single-family buildings were analysed, two of them from Portugal, one from Italy and one from Denmark (see Figure 2). By the foreseen use of RUE and RE technologies Montarroio, PT becomes a “Nearly Zero Energy Building”. Solar thermal

and biomass energy supply 95% of the heating and DHW demand after the energy renovation.

Via Trento from Italy and Lugar de Pontes from Portugal present a considerable heating consumption reduction of 93% and 90%, respectively, after the RUE renovation. In addition, solar thermal collectors have been incorporated to the building reducing the heating consumption by additional 33% and 43%.

The single family house from Denmark shows a heating energy reduction of 42% after renovation and in addition 10% more is reduced by the incorporation of solar thermal collectors.

Fig. 2. Overview of the Energy consumption before and after energy retrofit for the four single-family buildings

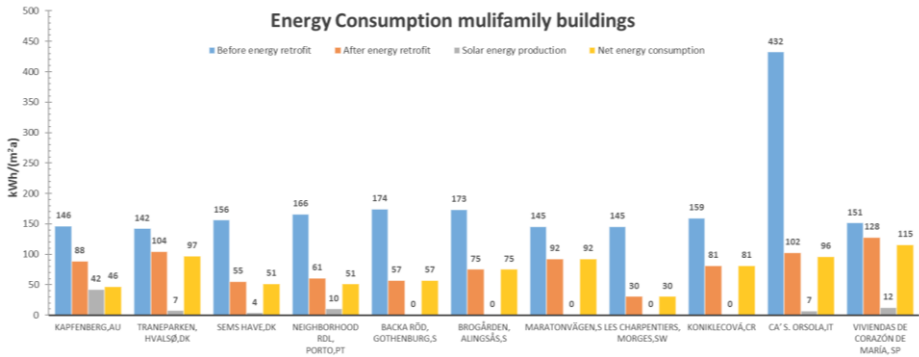
The Shining Examples are predominantly multifamily buildings. The 11 projects are shown in Figure 3. The most remarkable heating energy consumption reduction is seen in Switzerland: 83% is reached by the integration of a passive solar façade and a new gas cogeneration system.

Fig. 3. Overview of the Energy consumption before and after energy retrofit of multifamily buildings

Among the Shining Examples located in the South of Europe, Ca'S. Orsola in Italy presents a heating energy reduction from RUE by 77%. It should be noted, though, that the building was in very poor shape and the energy consumption before renovation has been calculated based on this condition. After the renovation the heating demand is provided by geothermal and solar thermal systems. In addition, the building has been equipped with a small PV electrical contribution of 2 kWh/m<sup>2</sup>. The building from Spain stands out by its low energy RUE and RES reduction, since only 50% of the DHW consumption is supplied by a solar thermal system.

The highest percentage of solar energy contribution, both solar thermal and PV electrical, is found in Kapfenberg, Austria, reducing by 48% the total energy consumption after energy renovation by RUE.

The Shining Examples in Sweden and the Czech Republic do not have any RES-system, but the total energy consumption has decreased by over 50% by RUE-systems.
