Architecture as a Portrait of Circumstance: The Restoration Career of George Edwin Brumbaugh

Cynthia Anne Rose
University of Pennsylvania

A THESIS

The Graduate Program in Historic Preservation

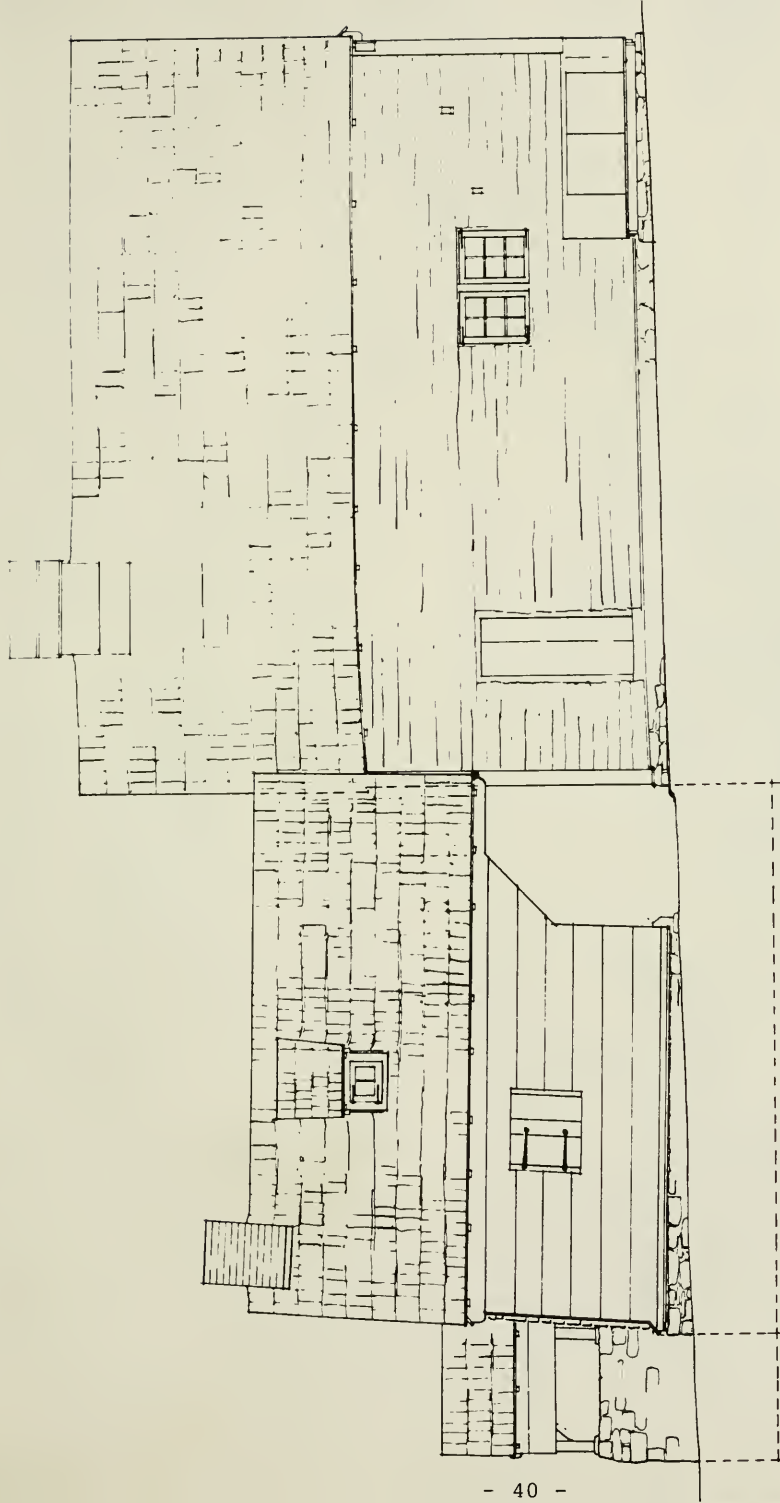
Ephrata - Beissel Cabin and Original Bake-House
East Elevation

EAST ELEVATION

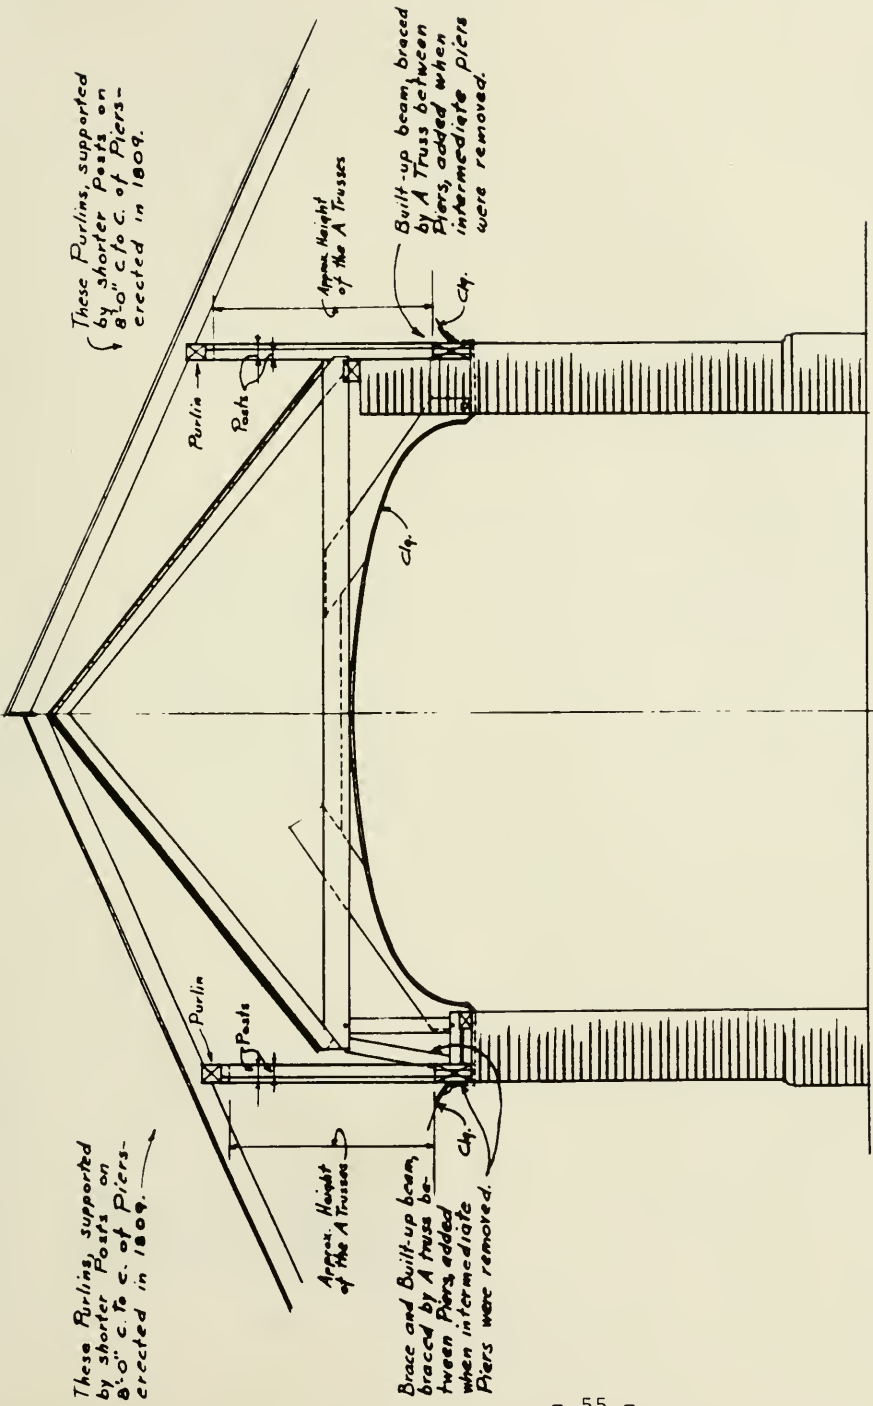
These Purlins, supported by shorter Posts on 8'-0" c. to c. of Piers - erected in 1809.

Brumbaugh was particularly concerned with the configuration and restoration of the shamble piers. His drawings illustrated the types of construction and proposed repairs of the piers. Also included

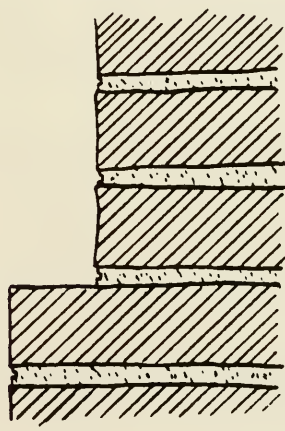
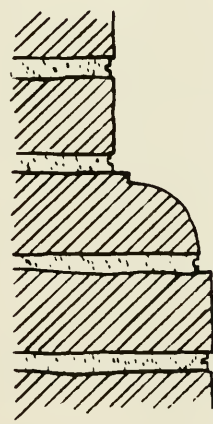
SURVIVING MARKET PIERS
Scale: $\frac{3}{8}'' = 1'-0''$

END
PIER A
ORIGINAL SHAMBLES
Erected 1745

RECENT
RECONSTRUCTIONS

1804
EXTENSIONS
