Characterization and Consolidation of Pennsylvania Blue Marble, with a Case Study of the Second Bank of the United States, Philadelphia, PA

A THESIS

Historic Preservation

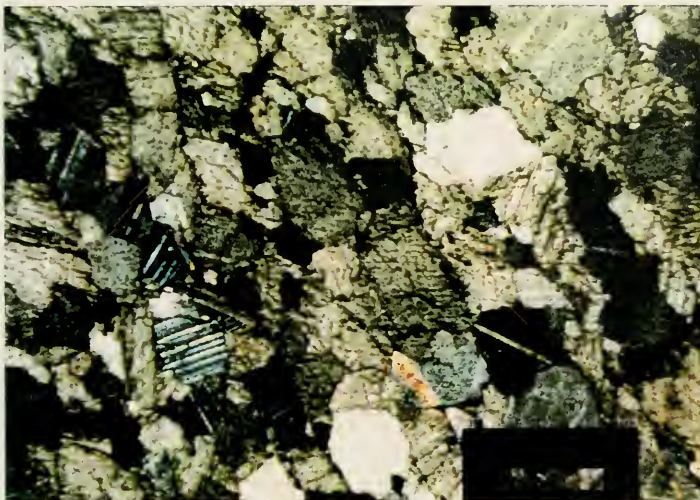
Figure 1. Thin Section of Sample I, crossed polars, 25X. Note twinning and tight interlocking of calcite grains.

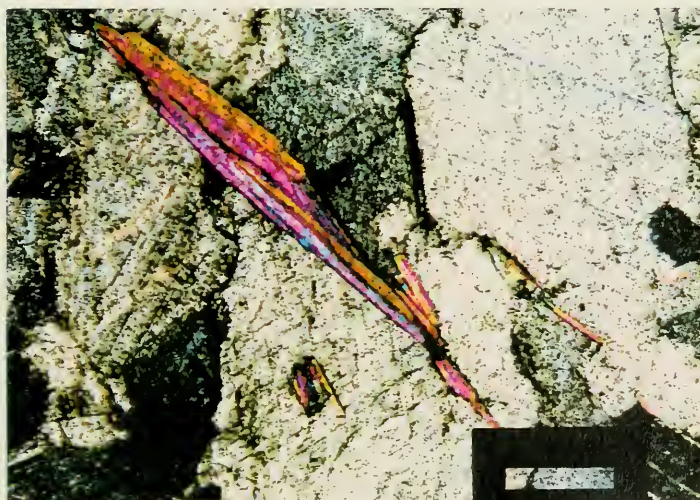
Figure 2. Thin Section of Sample I, crossed polars, 100X. Micaceous inclusion, interlocking calcite grains.

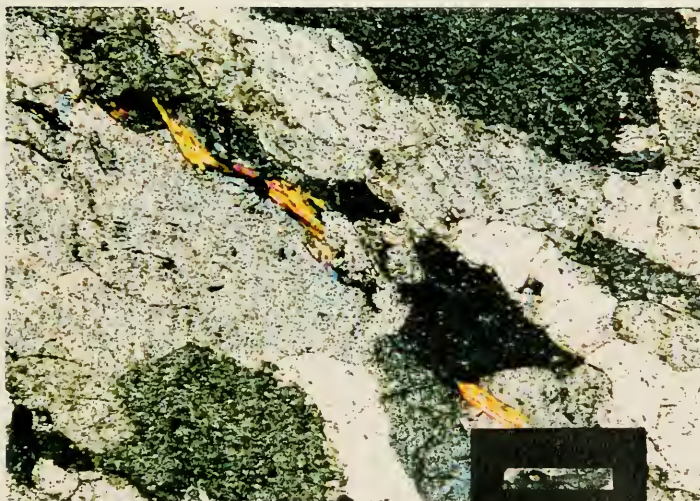
Figure 4. Thin Section of Sample II. Crossed Polars. 100X. Note mica inclusions and orthoclase.

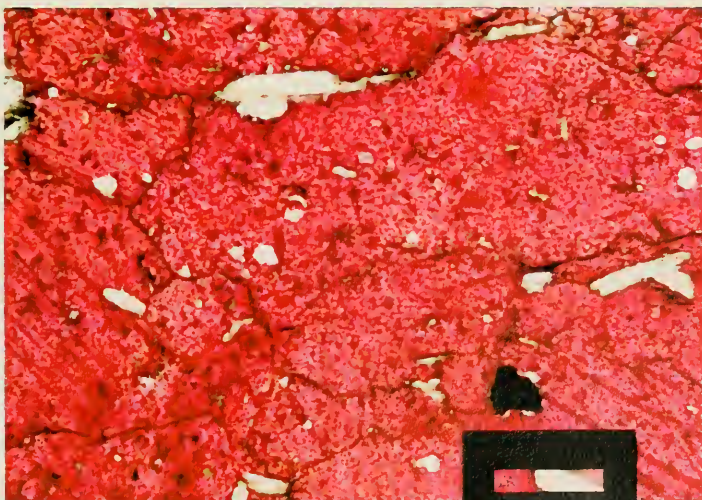
Figure 6. Thin Section of Sample III, crossed polars, 100X, stained for calcite. Note graphite inclusion, replacement within calcite matrix.

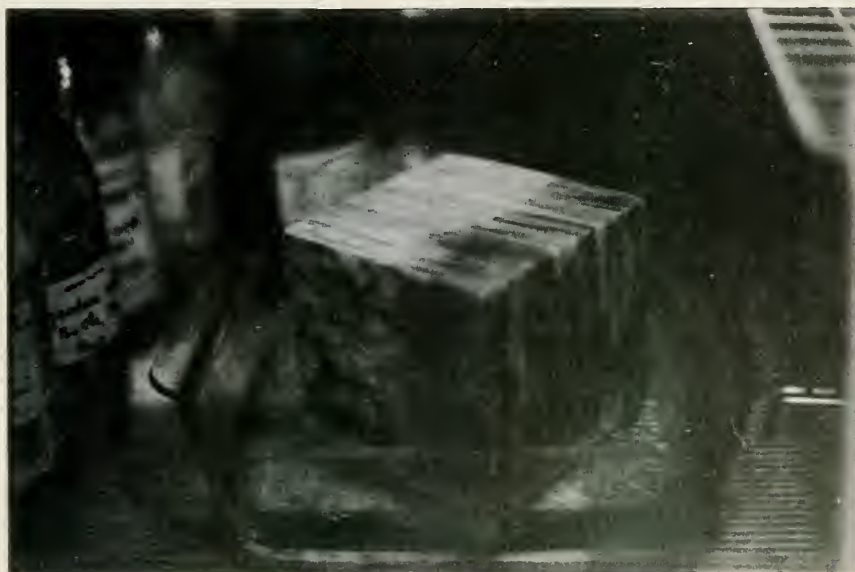
Figure 8. Scrap sample during consolidation procedure, turned on its side to show capillary rise.

Those samples to be tested for penetration depth were consolidated using one of the recommended field procedures, namely of a brush application procedure detailed by manufacturers and conservators as a simulation of field application. Samples to be treated with ethyl silicate has the consolidant applied in cycles of three applications to saturation, with five minutes between each application, and 20 minutes between cycles. Two cycles were performed on the Pennsylvania Blue laboratory samples, and three on the Second Bank Pennsylvania Blue samples. Samples to be treated with B-72/MTMOS were consolidated by brush application to the beading point, showing that no further consolidant was being absorbed.

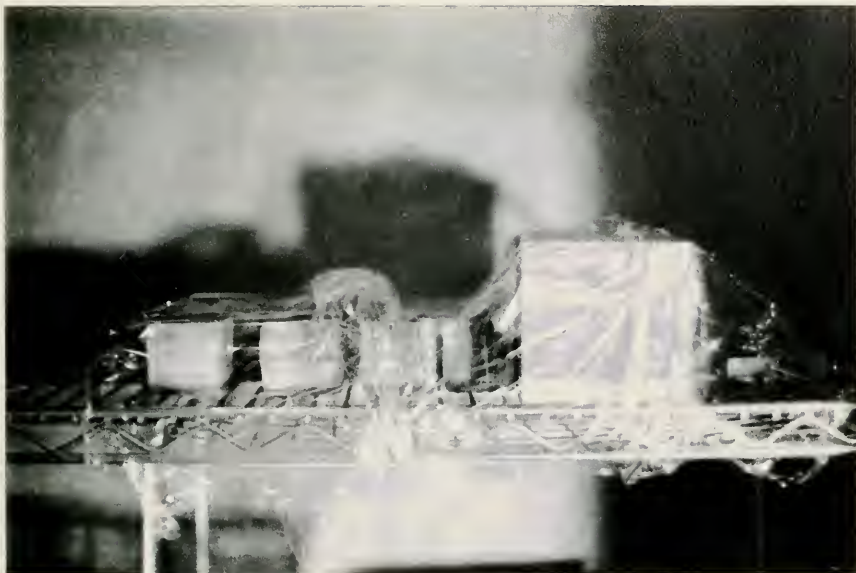
Figure 9. Samples treated with B-72/MTMOS, tented with plastic after consolidation.

Samples treated with B-72/MTMOS were tented with plastic wrap after the first half hour of drying to retard the volatility of the solvent (Figure 9). The samples were allowed to dry in a fume hood for 36 hours (Figure 10). Following the initial drying period, the consolidated samples were removed from the fume hood and allowed to dry at room temperature and relative humidity for two weeks.

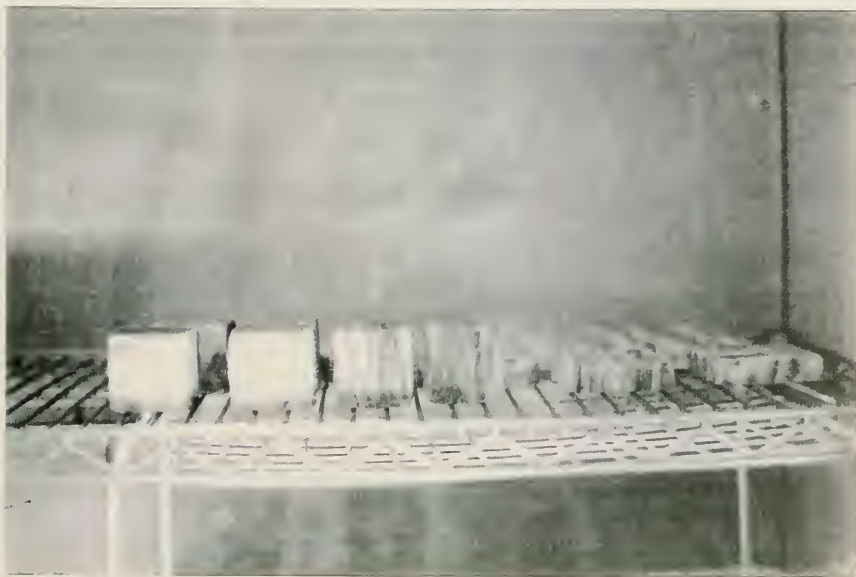
Figure 10. Consolidated samples drying in fume hood.

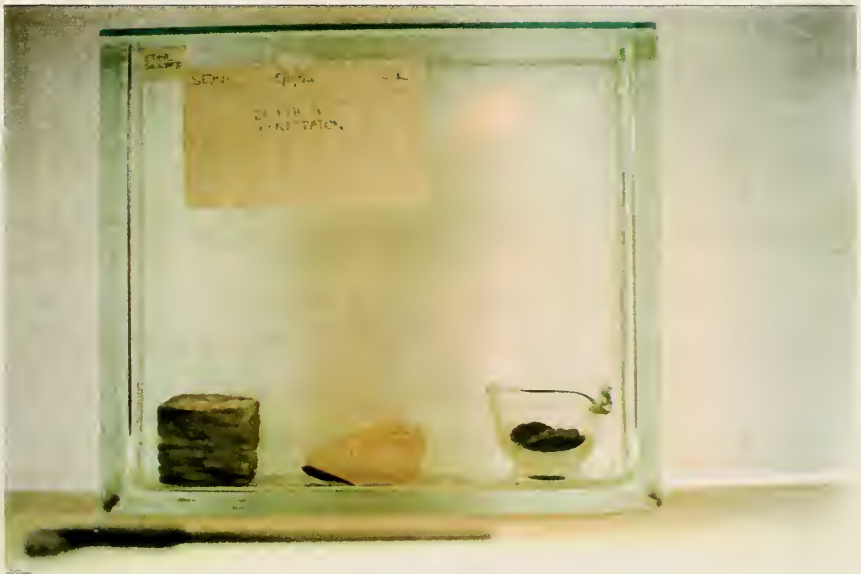
Figure 11. Samples during testing of consolidant penetration depth.

Both samples of artificially weathered Pennsylvania Blue showed full surface coverage plus a penetration depth of 1 mm. Second Bank samples, however, showed a far greater penetration depth: B-72/ MTMOS absorbed to a depth five times that of the B-72/MTMOS treated laboratory sample, and ethyl silicate absorbed to a depth of 25 times. This shows that while relatively intact Pennsylvania Blue absorbs very little consolidant, weathered Pennsylvania Blue is receptive to the treatment. Ethyl silicate, in particular, appears to penetrate far into the stone.

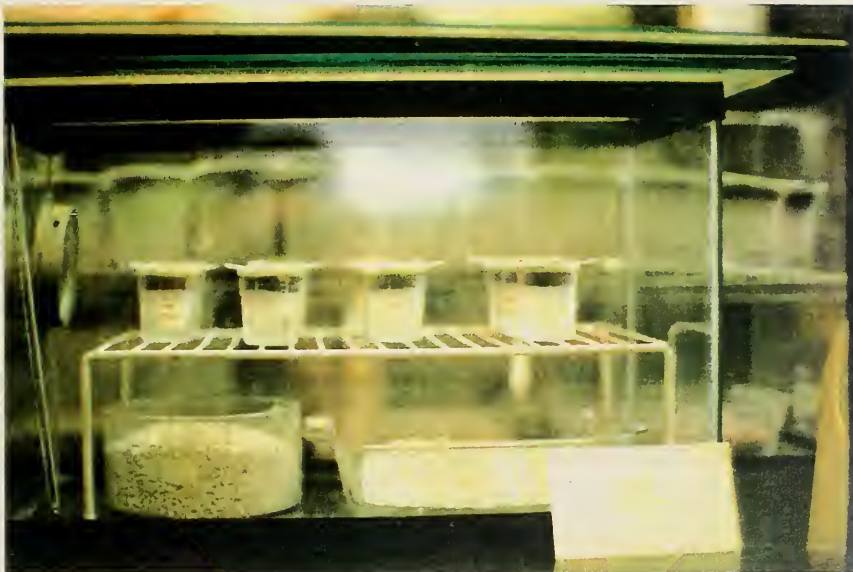
Figure 16. Samples during water vapor transmission rate testing.
