Seismic response of timber frames with cane and mortar walls

C. Málaga-Chuquitaype, S. Kaminski, A. Y. Elghazouli, A. Lawrence

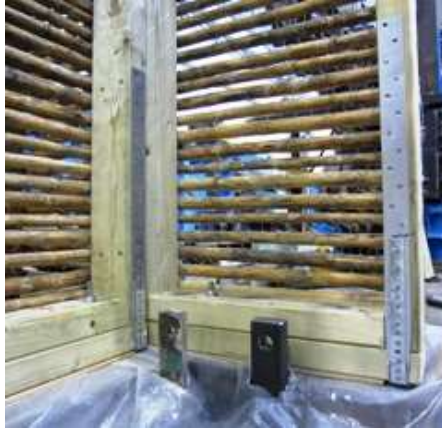
Figure 4. Detail of steel straps at the specimen ends

Grade 16 softwood studs of 2"x4" were employed for the timber frames in all specimens. All specimens incorporated a layer of horizontally placed *caña brava* canes (*gynerium sagittatum*) of 10-30mm diameter nailed to the exterior of the timber frames. The 3 m long canes were pre-treated by immersion in boron and shipped directly from Costa Rica. A lightweight galvanized wire mesh with hexagonal 25mm holes was nailed to the timber frame (i) before placing the cane (i.e. fitted towards the interior) in Specimens P2, P3 and P5; or (ii) after nailing the cane (i.e. fitted towards the exterior) in Specimen P1. In the case of Specimen P4, the wire mesh was eliminated. Finally, approximately 20 mm thick mortar layers were placed at each side of the wire mesh forming a 60 mm thick mortar panel. A simple sharp sand and Portland Cement mixture was used for the mortar, and the corresponding mean values of compressive strength as obtained from standard cube (100x100x100 mm) samples at the day of testing are reported in Table 1. Additionally, 600x100 Simpson Strong-Tie Light Engineered Straps (SSTLES) were used for the stud-to-sole plate tie-downs at the extremes as illustrated in Figure 4, with a nominal tensile working load of 4kN (Simpson Strong-Tie, 2013).

Figure 4. Detail of the steel straps at the specimen ends

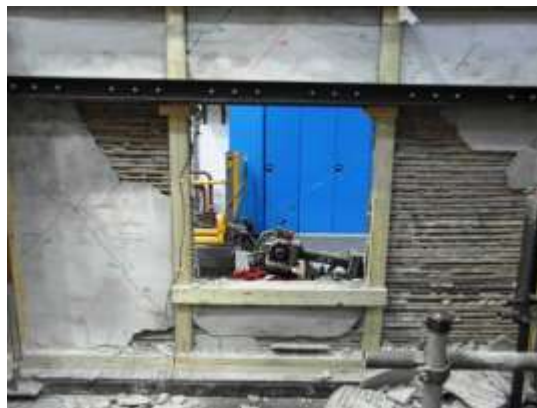
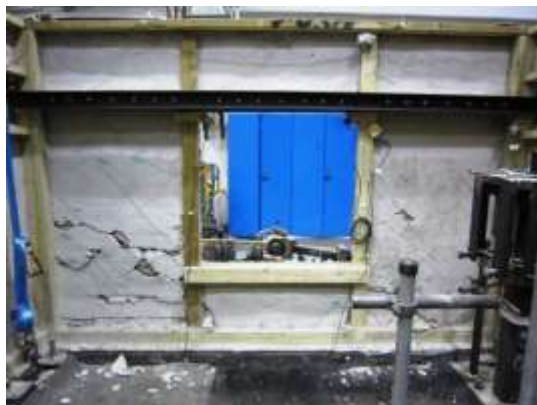
The effects of the location of the wire mesh within the thickness of the panel can be evaluated with reference to the response of Specimens P1 and P2 where the mesh was placed towards the exterior face in the former and towards the interior face in the latter while all other parameters remained unaltered. It can be seen from the results presented in Figure 6 and Table 2 that the initial stiffness of the wall is relatively insensitive to the location of the mesh. However, after the initiation of cracking in the cement mortar, at a lateral resistance of around 20 kN in both specimens, the wall with the mesh fixed towards the exterior face (Specimen P1) exhibits a slightly stiffer response that leads to a maximum lateral capacity of 46 kN in comparison with the 42 kN achieved in Specimen 2 (where the mesh is placed towards the interior). These effects are related to the relative stiffness contribution of the outer and inner layers of mortar within the wall (see Detail A in Figure 3(a)). The discontinuity of the interior layer of mortar imposed by the vertical timber studs breaks up the single panel into a number of smaller panels, the sum of which is less stiff and weaker than a single continuous panel. Consequently, by maintaining the integrity of the exterior mortar and delaying the spalling of rendering in the outer face, Specimen P1 is able to reach a nearly 10% increase in its maximum capacity in comparison with Specimen P2. However, it should be noted that preventing spalling of mortar towards the interior of the dwelling ought to be favoured since this may constitute a significant life-threatening hazard for the inhabitants. The effectiveness of the wire mesh in preventing mortar spalling and reducing the above mentioned hazard is evident from Figure 7 which presents the final state of the interior face of Specimens P1 and P2 after testing.

Figure 7. Damage state of the interior face at the end of test – Specimen P1 (a), Specimen P2 (b)

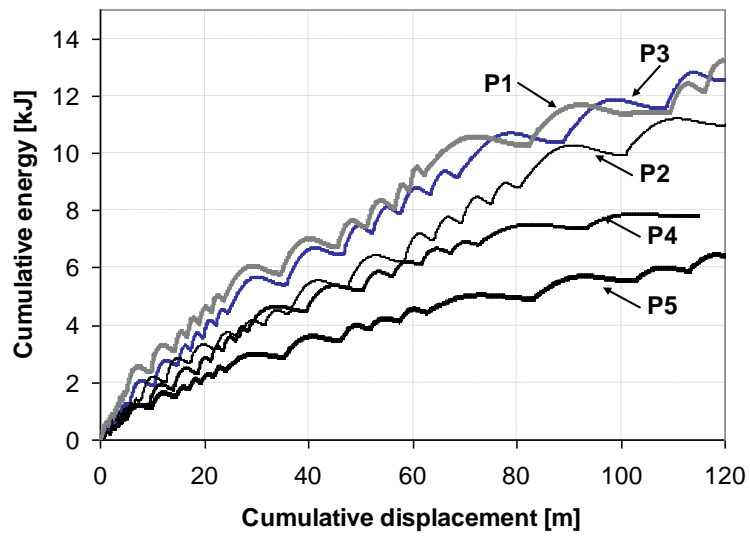
In general, the timber frame and composite cane mortar panels examined in this study exhibited good levels of ductility and energy dissipation. An assessment of the energy dissipation in all specimens is presented in Figure 8. The curves depict the cumulative dissipated energy versus cumulative displacement, whilst the rates of energy dissipated per unit rotation (between 40 and 60 mm of cumulative displacement) are given in Table 2. As expected, there is a direct relationship between the capacity of the Specimen and its energy dissipation capabilities. Accordingly, Panels P1 and P3 exhibited comparatively high levels of energy dissipation with dissipation rates in the order of 1.6 and 2.5 times those observed for Specimens P4 and P5, respectively.

Figure 8. Cumulative energy dissipation
