## X-ray CT analysis after blast of composite sandwich panels

Emily Rolfe<sup>a\*</sup>, Mark Kelly<sup>a</sup>, Hari Arora<sup>b</sup>, Paul A. Hooper<sup>a</sup>, John P. Dear<sup>a</sup>

Four composite sandwich panels with either single density or graded density foam cores and different face-sheet materials were subjected to full-scale underwater blast testing. The panels were subjected to 1 kg PE4 charge at a stand-off distance of 1 m. The panel with graded density core and carbon fiber face-sheets had the lowest deflection. Post-blast damage assessment was carried out using X-ray CT scanning. The damage assessment revealed that there is a trade-off between reduced panel deflection and panel damage. This research has been performed as part of a program sponsored by the Office of Naval Research (ONR).

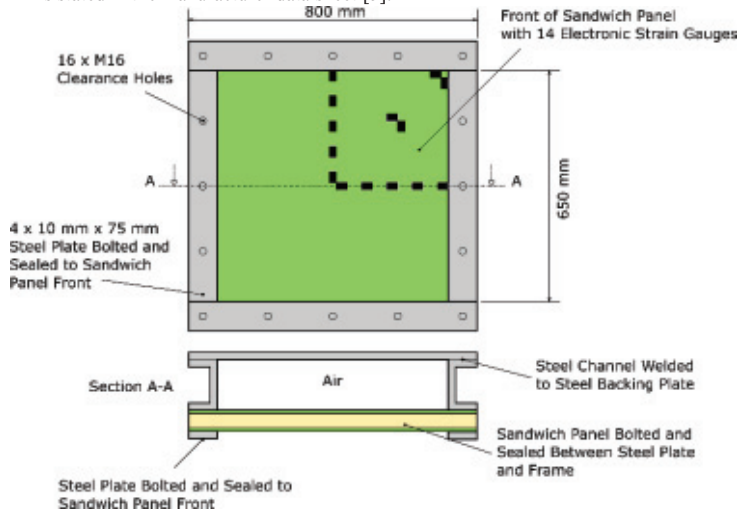
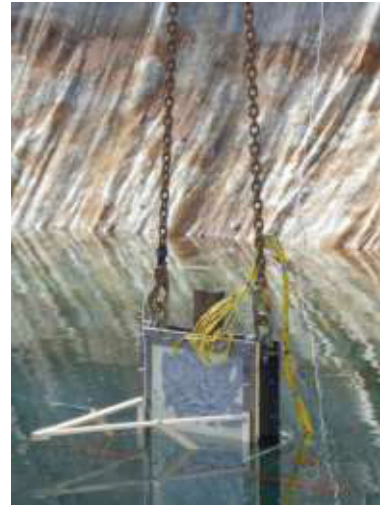
Fig. 1. (a) diagram of panel setup for underwater blast test; (b) photograph of panel being lowered into the water from crane without charge on pine frame.

The 0.8 m x 0.8 m panels were bolted in a welded steel channel box which had an enclosed volume of air behind the panel leaving an unsupported area of 0.65 m x 0.65 m. The charge was a 1 kg plastic explosive 4 (PE4) that was held 1 m from the center of the panel using a pine frame, this charge has an equivalent TNT weight of 1.28 kg. This load was chosen as it would cause full compressive failure of the foam cores and failure of the face-sheets. A reflected pressure gauge was adhered to the top of the steel box and a side-on pressure gauge was held at the same height and distance from the charge as the center point of the panel using a steel rod. The response of the panel was measured using electronic foil strain gauges; 14 were adhered to the front face-sheet and 16 to the rear face-sheet. These were situated along the horizontal, vertical and leading diagonal axes. Since the sandwich panels were square, only one quarter of each panel had strain gauges attached. The whole assembly was suspended from a crane and the center point was lowered into the test pond to a depth of 3.5 m. The setup of the blast test is shown in Fig. 1.

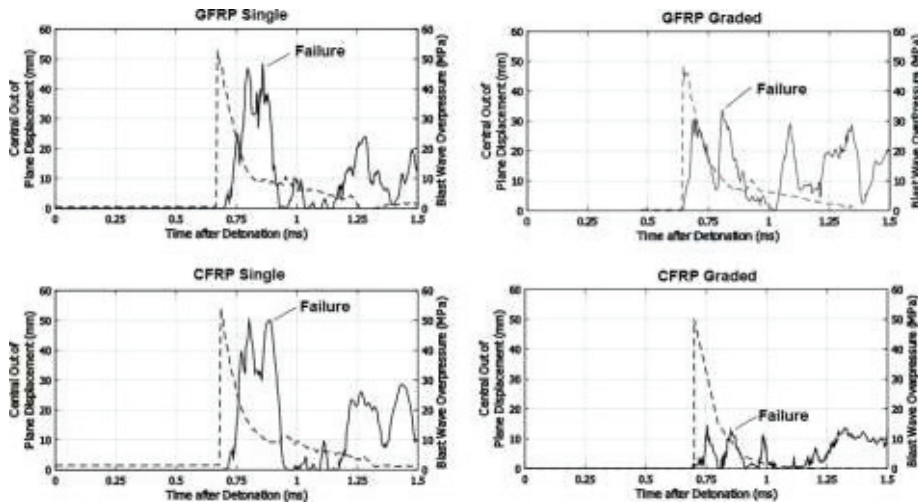
Fig. 2. Solid line: centre point out-of-plane displacement against time; dashed line: blast pressure profile.

The out-of-plane displacement of the panels could be calculated from the strain gauge results at their discrete locations then linearly interpolated to generate a displacement profile and to calculate the central out-of-plane displacement. The panel centerline strain was calculated by assuming no crushing occurs in the foam cores, which is not strictly true, and this centerline strain was used to calculate panel displacement. Despite the simplification, the values can be used to compare the relative displacement of the four panels tested and this displacement against time is shown in Fig. 2. The displacement is relative to the edge of the sandwich panel and, therefore, takes into account the deflection of the steel box. The blast pressure plot for the CFRP graded panel is calculated because a trace was not obtained during testing.

The results clearly show the reduction in panel displacement when a graded core is implemented. The GFRP panel with graded core deflected to 34 mm compared to the single core GFRP deflection of 48 mm. The reduction is even more significant for the panel with CFRP face-sheets. The out-of-plane displacement for the single and graded core CFRP panels was 50 mm and 13 mm respectively.

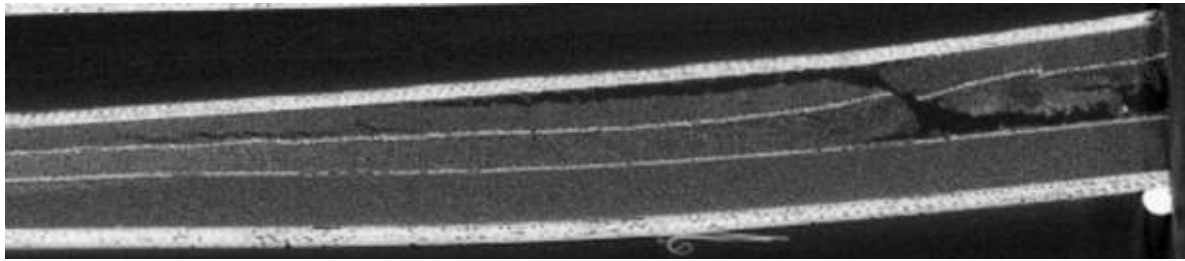
Fig. 3. X-ray CT scan showing region of debonding between front face-sheet and core on graded CFRP panel.

The majority of the damage to the sandwich panels was in the form of debonding between the front face-sheet and core and between the front core layers. In the graded core panels, the interfaces between the core layers arrested debonds and prevented them from propagating through the entire thickness of the panel. Fig. 3 and Fig. 4 shows regions where this is occurring in the CFRP and GFRP panel respectively.

The single core CFRP panel suffers from almost complete debonding between the front face-sheet and core, the panel is no longer able to transfer shear stresses between the face-sheets. The graded density core CFRP panel suffers from 10.3% less damage and experiences less core crushing. The single and graded core GFRP panels suffer from a similar amount of damage and core crushing. A summary of the damage is detailed in Table 2.
