Human–Wildlife Interactions 4(2):293–303, Fall 2010

Improved methods for deterring cliff swallow nesting on highway structures

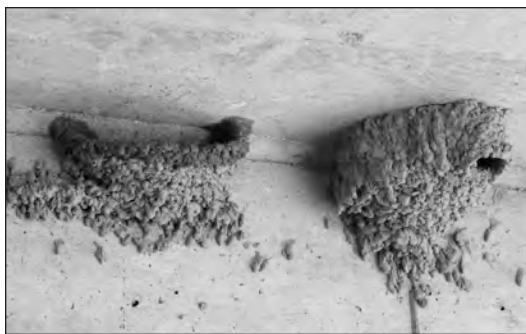
Figure 1. Partial (left) and completed cliff swallow nests on the underside of a bridge.

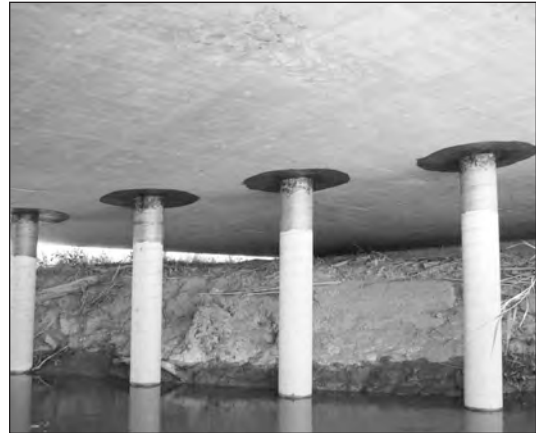
Figure 4. Highway structure with silicone paint surface modification.

We applied silicone paint at locations similar to the PTFE placement, extending it 61 cm down piles and 46 cm out on the overhead surface (Figure 4). We also covered up the surface around drop caps up to 46 cm out from the juncture. We stirred the paint for 2 minutes, then applied it to the surfaces using 1.9-cm nap paint rollers and paint brushes for the corners. The paint cured within several hours of application.

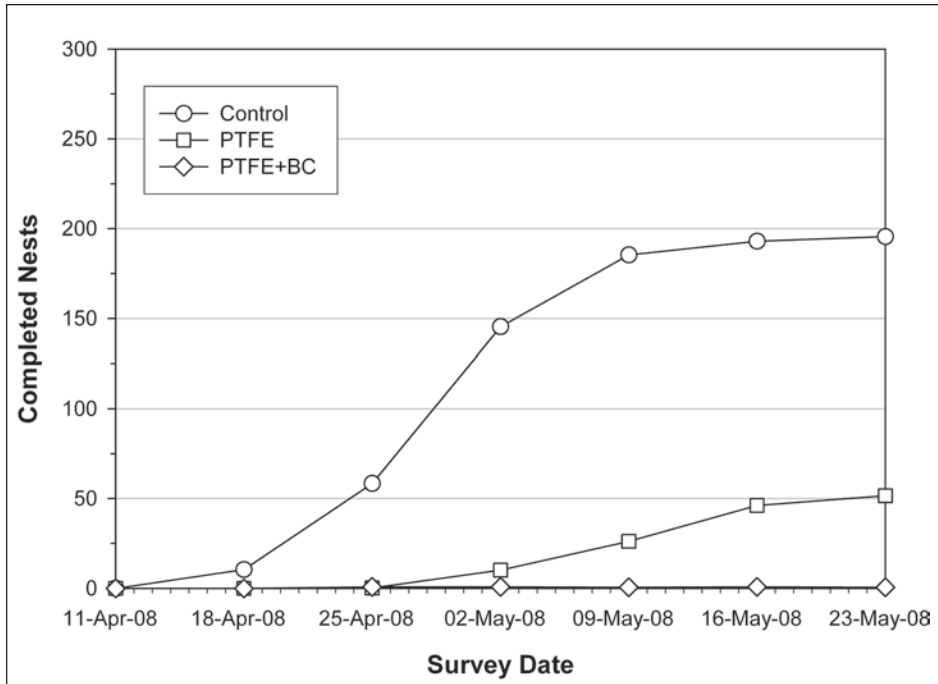
Figure 9. Average number of completed nests over 7 weeks in 2008.

at either PTFE or PTFE-BC sites were found on bare concrete. To be consistent with the 2007 analysis, we decided to do the statistical analysis on nest counts collected during the seventh survey and also because the PTFE sheeting was detaching from the bridge surfaces and could not be replaced quickly enough to maintain the integrity of the treatments. Furthermore, nest building at control sites had virtually ceased by the seventh week. Average completed nests over time for each treatment in 2008 are shown in Figure 9. At the seventh survey, the mean number of completed nests was 1 for PTFE+BC, 52 for PTFE, and 196 for the control. Statistical tests indicated that the treatment means were not equal ($P = 0.002$) and the PTFE+BC and control treatment means differed ($\alpha = 0.05$).

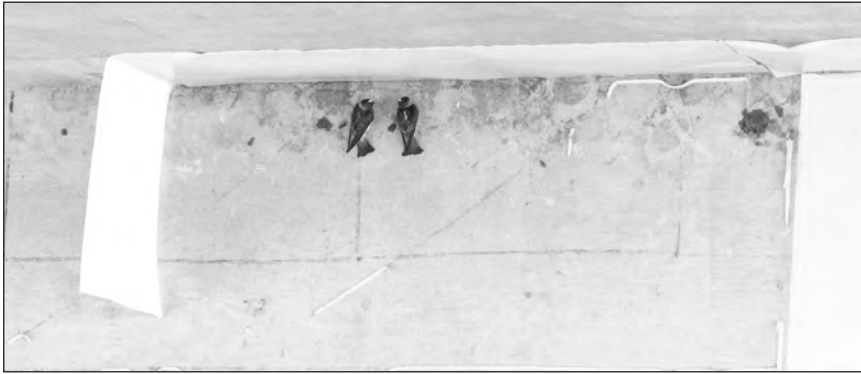
Figure 10. PTFE sheets detaching from the concrete bridge surface and cliff swallows building nests.

that both the PTFE and PTFE+BC treatments would have been more effective if it were not for problems with PTFE sheet adhesion to the bridge surface (Figure 10). Many of the detached sheets were installed overhead, such that the weight of the sheet pulled directly away from the bridge surface. We replaced missing PTFE sheets as quickly as possible during the first 7 weeks of the study, but at some sites we were unable to replace the sheets before the birds had built nests at that location. We included these nests in our counts, but they do not reflect the intrinsic ability of PTFE to deter nesting, assuming it is securely attached to the surface. Butyl adhesion failed at the concrete surface and at the PTFE surface in about equal proportions. This suggests that butyl sealant is not adequate for reliable surface modification treatments as conducted in this study. Thinner or smaller sheets of PTFE, or additional strips of butyl adhesive might prevent detachment from the bridge surface, but we feel that a better attachment method is needed, such as mechanical fasteners or semi-permanent epoxy adhesive.
