Post Weld and Epoxy Anchorage Variations for W-Beam Guardrail Attached to Low-Fill Culverts

MwRSF Research Report No. TRP-03-278-13

August 12, 2013

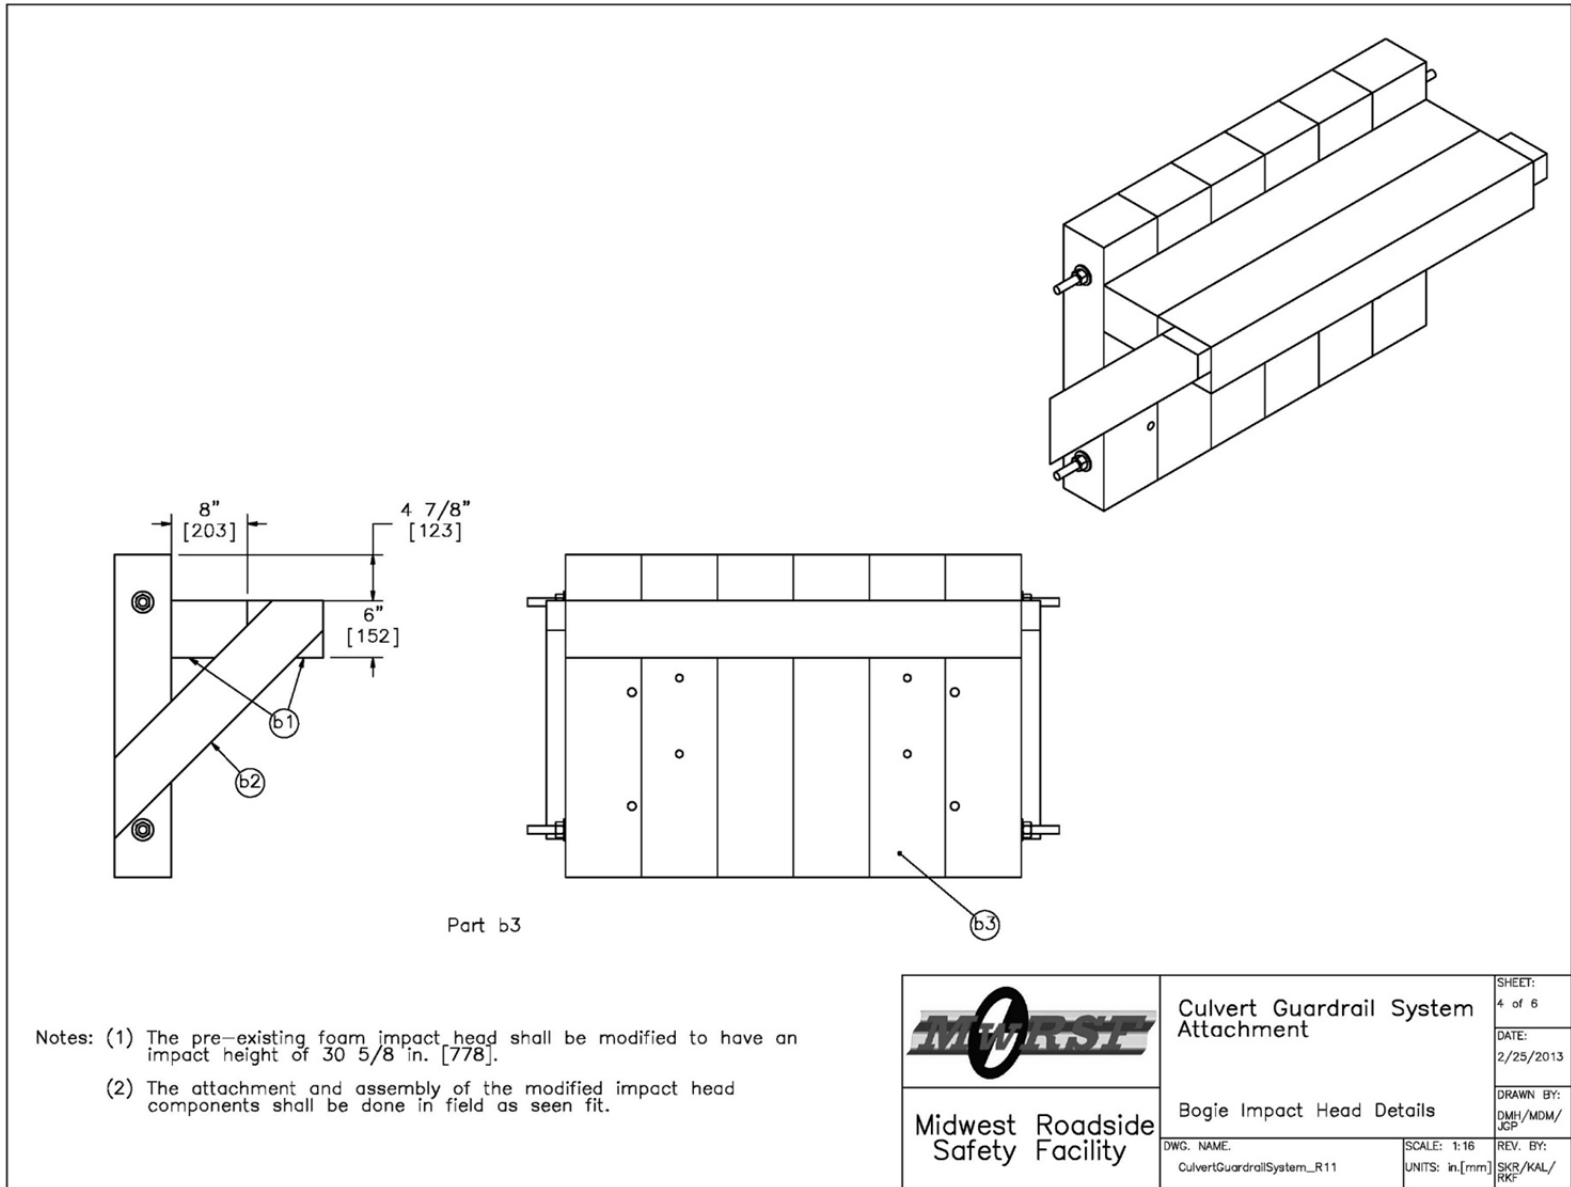
Figure 7. Bogie Impact Head Details, Test Nos. CGSA-1 through CGSA-4

A rigid-frame bogie was used to impact the posts. A customized, detachable wooden impact head, shown previously in Figures 7 and 8, was used in the testing. The bogie head consisted of six vertical and two horizontal 6 in. x 8 in. (152 mm x 203 mm) wood posts. This impact head matched the one used previously during the original component testing of the post-to-culvert attachment. The impact head was bolted to the bogie vehicle, thus creating a rigid frame with an impact height of 30⁵/₈ in. (778 mm), as shown in Figure 11. The weight of the bogie with the addition of the mountable impact head was 4,996 lb (2,266 kg), 4,999 lb (2,268 kg), 5,010 lb (2,273 kg), and 4,995 lb (2,266 kg) for test nos. CGSA-1, CGSA-2, CGSA-3, and CGSA-4, respectively.

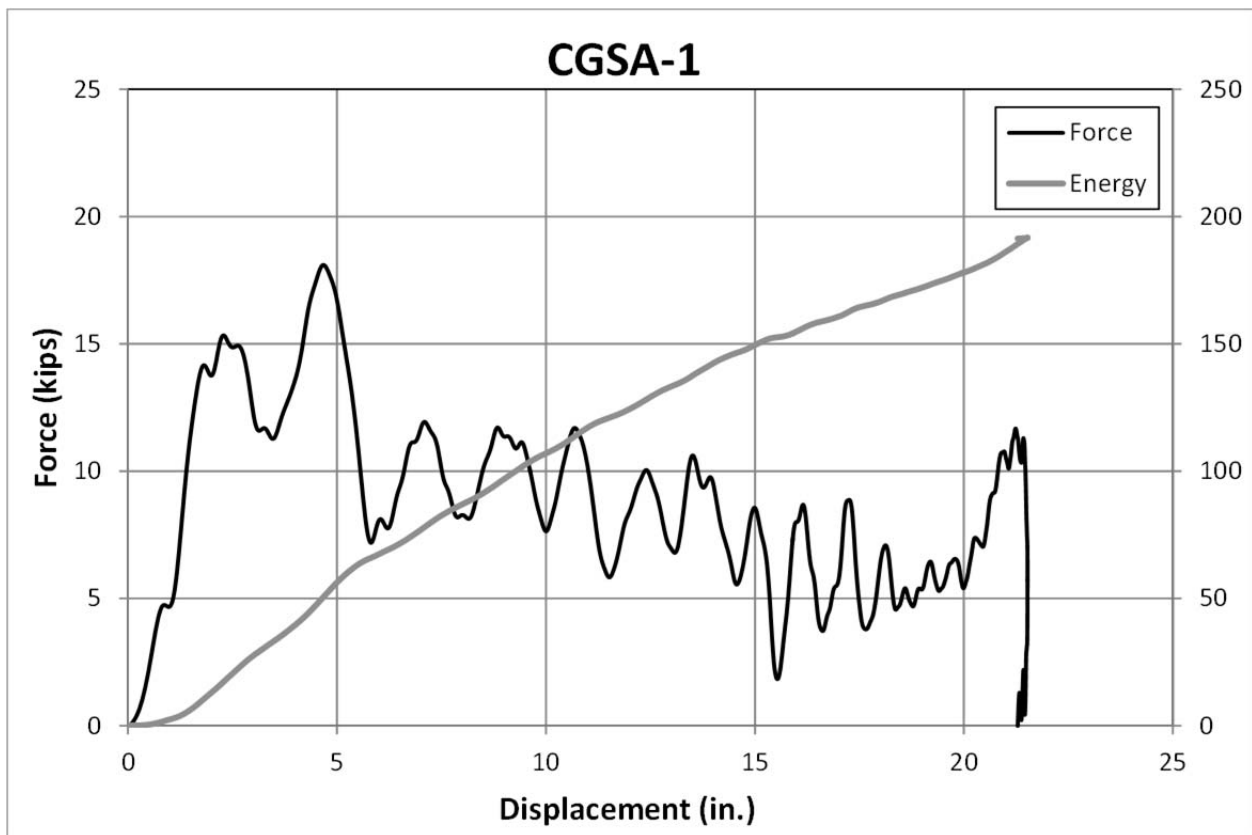
Figure 12. Force vs. Deflection and Energy vs. Deflection, Test No. CGSA-1

Force vs. deflection and energy vs. deflection curves were created from the DTS accelerometer data, as shown in Figure 12. Early in the impact event, a maximum resistance of 18.1 kips (80.5 kN) was recorded at 4.7 in. (119 mm) of deflection. Video analysis confirmed this peak force corresponded to the time just prior to the plate beginning to tear, or 0.034 seconds after impact. After the onset of tearing, the resistance force decreased and remained relatively constant. At the maximum deflection of 21.7 in. (551 mm), the post assembly had absorbed 191.7 k-in. (21.7 kJ) of energy. Time-sequential and post-impact photographs are shown in Figures 13 through 15.

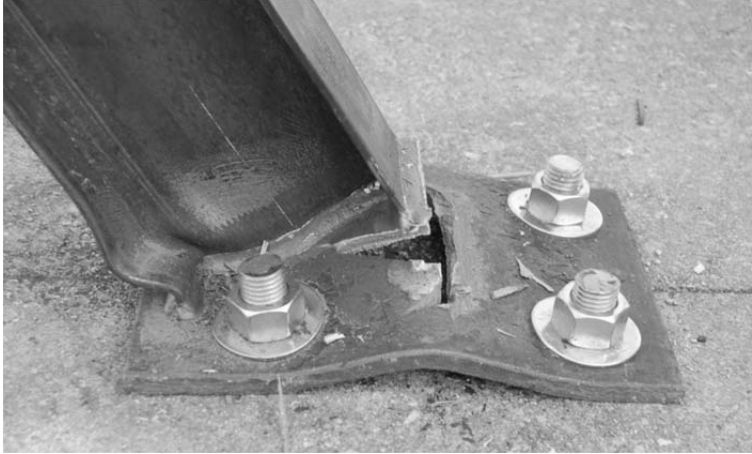
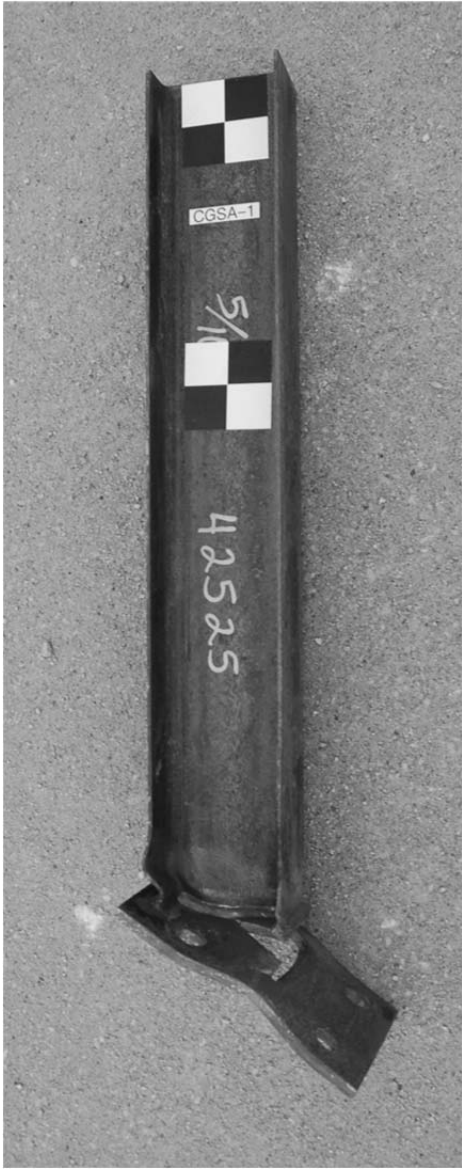
Figure 15. Post-Impact Photographs, Test No. CGSA-1

For test no. CGSA-1, the post was connected to the base plate using a $\frac{5}{16}$ -in. (8-mm) fillet weld all around the base of the post. To anchor the post assembly, four 1-in. (25-mm) diameter threaded rods were epoxied into the tarmac with an embedment depth of 12 in. (305 mm). During test no. CGSA-1, the bogie impacted the post at a speed of 9.8 mph (15.8 km/h). As a result, the post rotated backward, and the bogie was eventually brought to a stop at a displacement of 21.7 in. (546 mm) as determined from the DTS data. Post-test inspection revealed that both the back flange and the web of the post had buckled and the base plate was bent upward. Although the weld held, the plate was torn adjacent to the weld on the front flange, and the tearing extended around the flange and 1 in. (25 mm) toward the back of the plate on both sides.

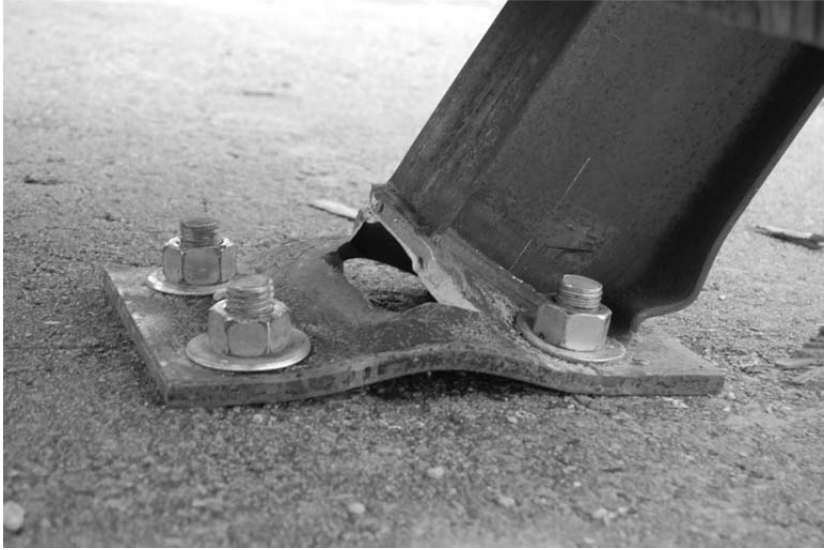
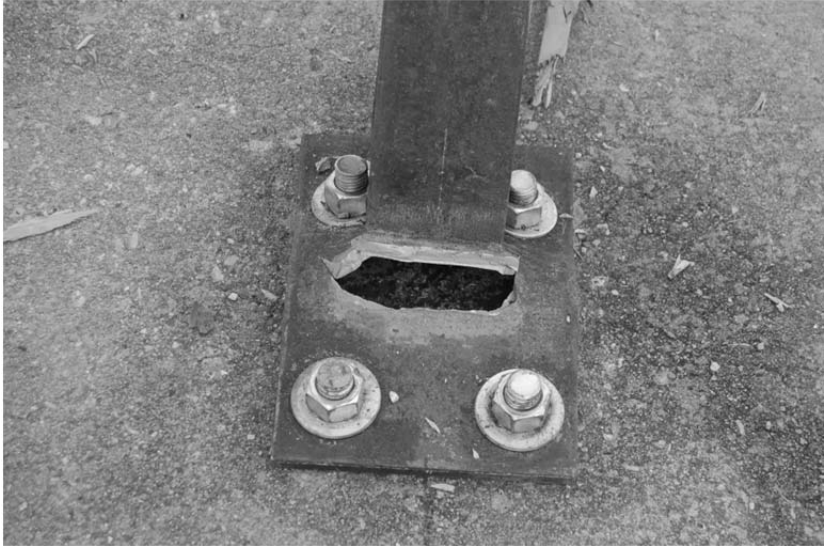
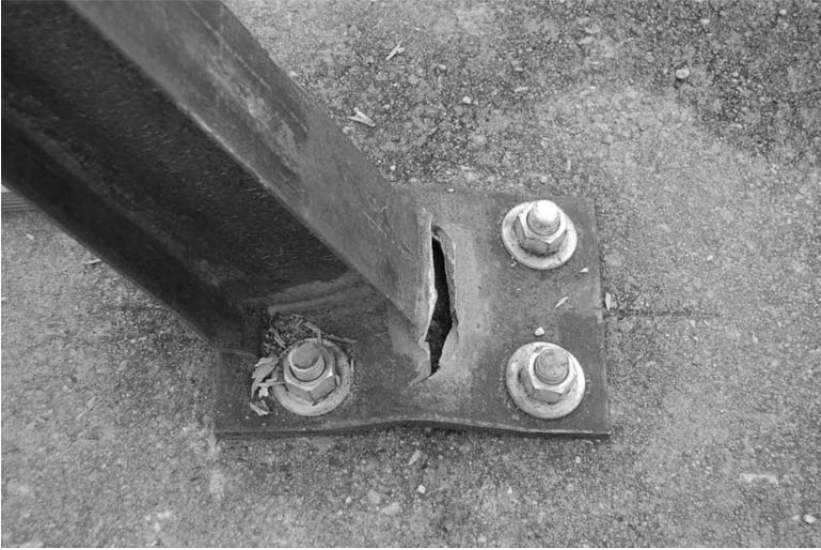
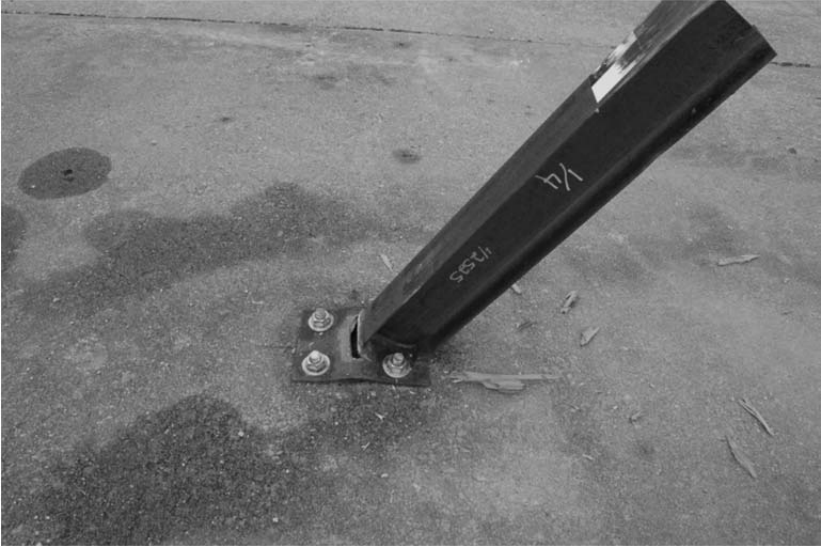
Figure 19. Post-Impact Photographs, Test No. CGSA-2

For test no. CGSA-2, the post was connected to the base plate using a ¼-in. (6-mm) fillet weld all around the base of the post. To anchor the post assembly, four 1-in. (25-mm) diameter threaded rods were epoxied into the tarmac with an embedment depth of 12 in. (305 mm). During test no. CGSA-2, the bogie impacted the post at a speed of 9.6 mph (15.4 km/h). As a result, the post rotated backward, and the bogie eventually overrode the top of the post at a displacement of 23.2 in. (589 mm) as determined from the DTS data. Post-test examination revealed failure modes similar to test no. CGSA-1. The back flange of the post had buckled, and the plate was torn adjacent to the front flange weld and continued approximately ¾ in. (19 mm) backward on each side.

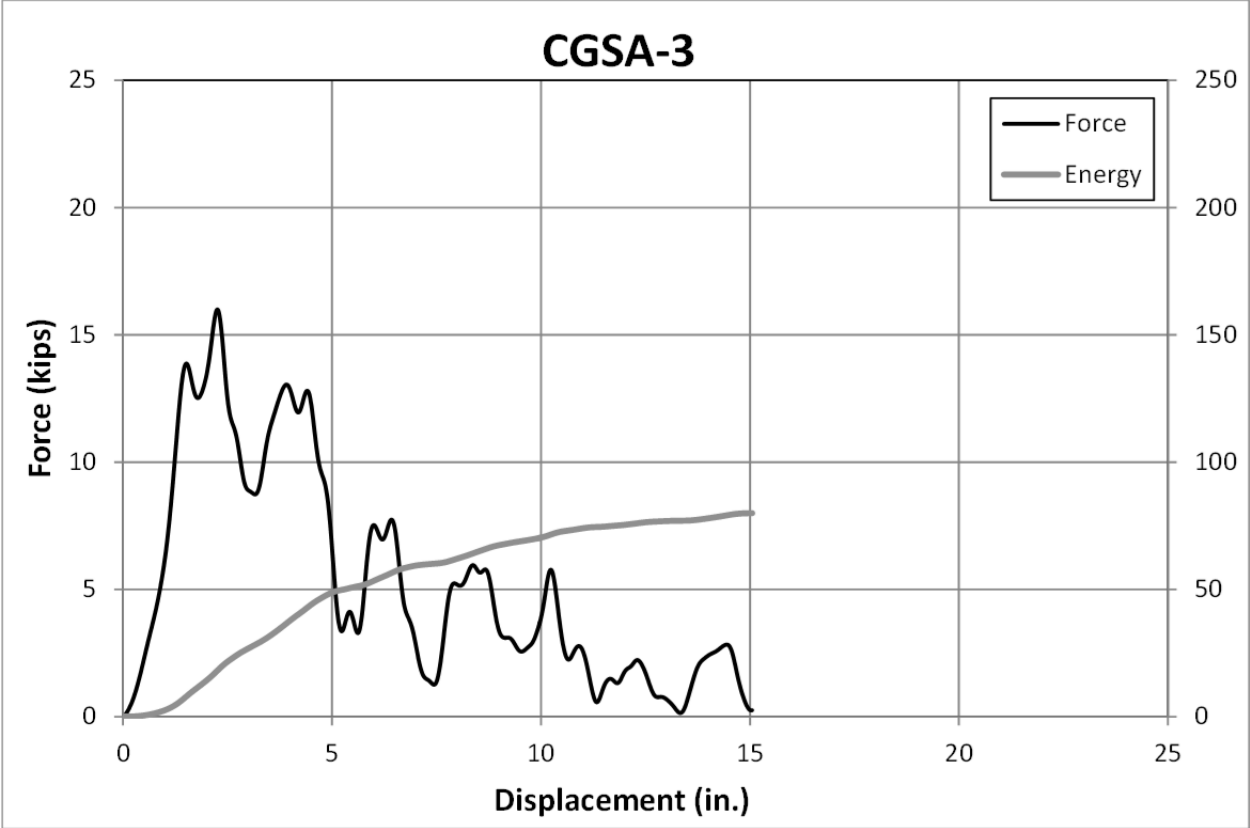
Figure 20. Force vs. Deflection and Energy vs. Deflection, Test No. CGSA-3

Force vs. deflection and energy vs. deflection curves were created from the DTS accelerometer data, as shown in Figure 20. Note, the curves only show the interaction forces and energies related to the primary impact. The plotted data was extracted prior to the secondary impact between the bottom of the bogie head and the base of the post. Early in the test, peak forces of 16.0 kips and 13.0 kips (71.2 kN and 57.8 kN) were recorded. Once the anchorage failed at approximately 5 in. (127 mm) of deflection, the resistance force decreased quickly and was nearly zero when the base of bogie impacted the post at 15.1 in. (384 mm) of deflection. Prior to this secondary impact, the assembly had absorbed 80.4 k-in. (9.1 kJ) of energy. Time-sequential and post-impact photographs are shown in Figures 21 through 23.

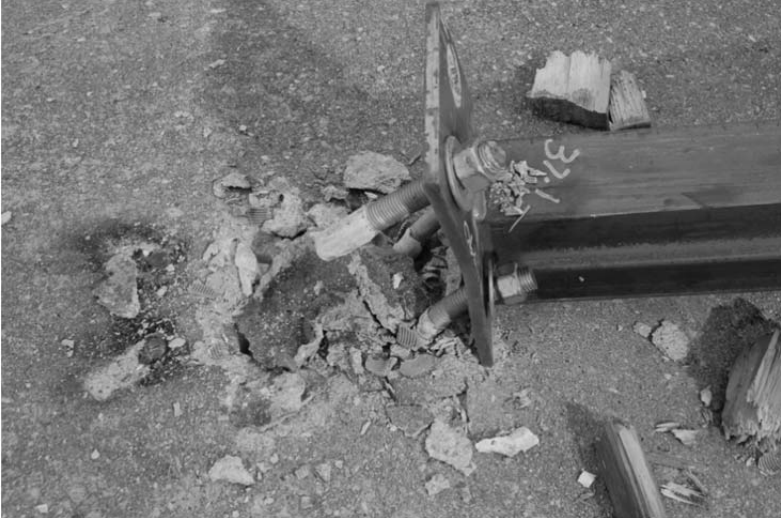
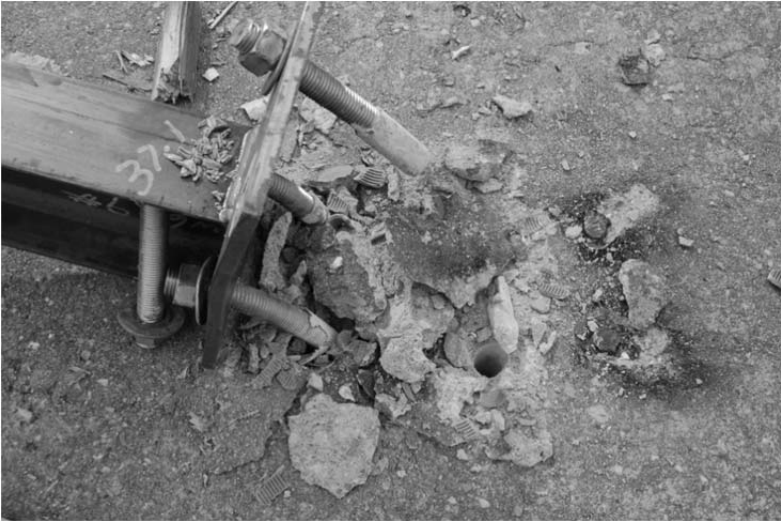
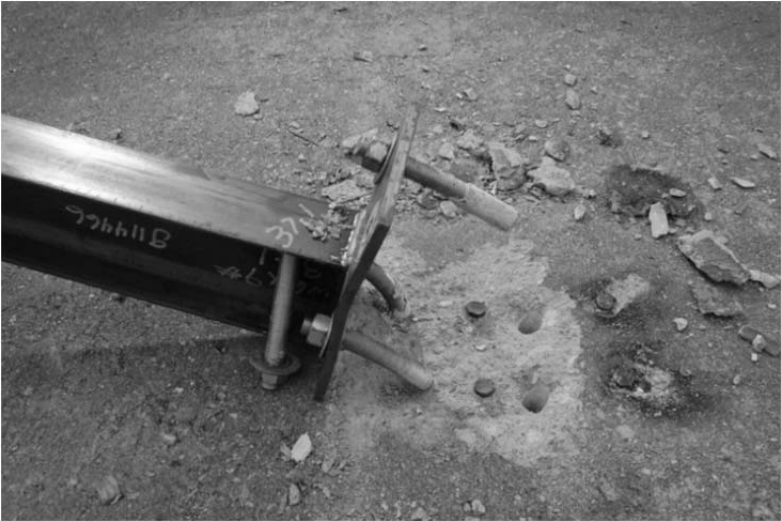
Figure 23. Post-Impact Photographs, Test No. CGSA-3

For test no. CGSA-3, the post was connected to the base plate using a $\frac{5}{16}$ -in. (8-mm) fillet weld all around the base of the post. To anchor the post assembly, four 1-in. (25-mm) diameter threaded rods were epoxied into the tarmac with an embedment depth of 6 in. (152 mm). During test no. CGSA-3, the bogie impacted the post at a speed of 9.7 mph (15.6 km/h). As a result, the post rotated backward, and the bogie eventually overrode the top of the post. At 0.020 sec after impact, concrete cracks began to form around the front anchor rods, and by 0.026 seconds, the anchor rods were pulled out of the concrete. The post assembly then rotated about the back of the plate causing the back anchors to bend. At approximately 0.150 seconds, the base of the bogie head impacted the post and caused the back anchor rods to pull out.

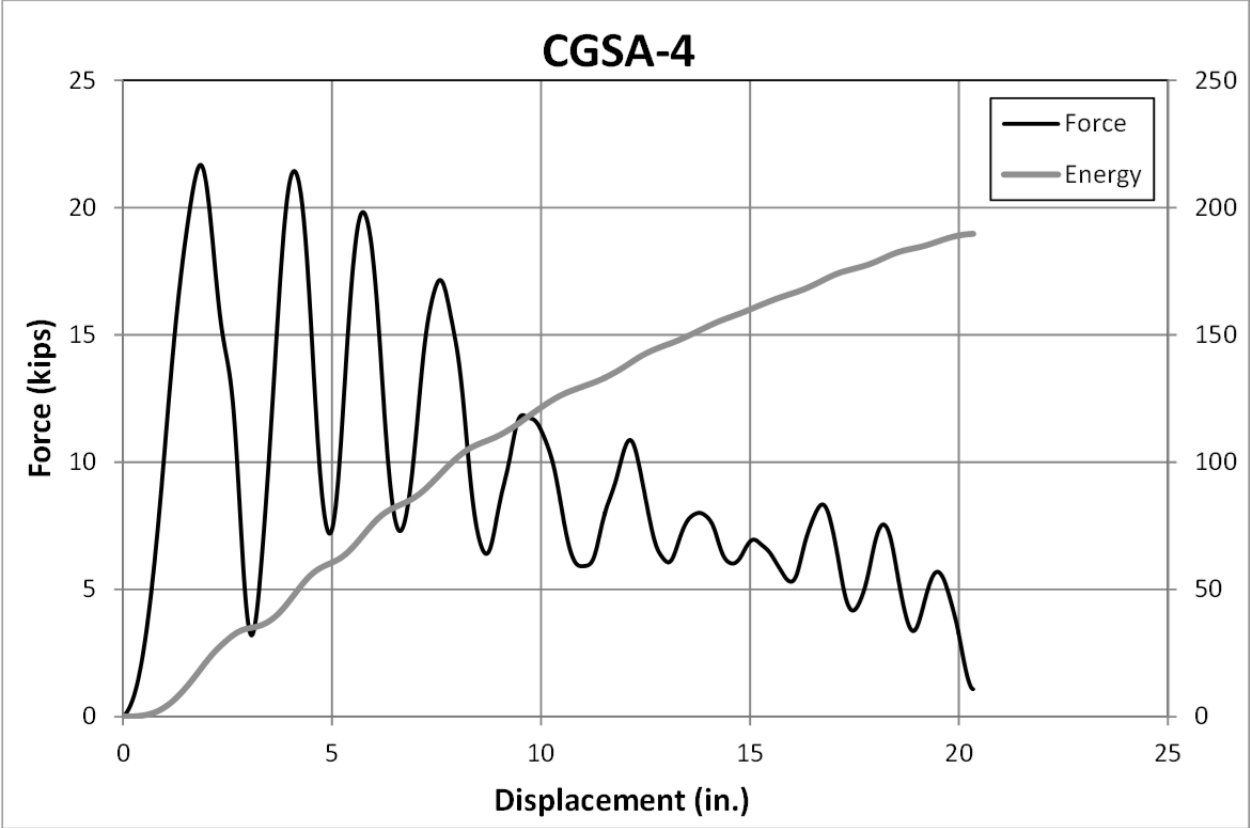
Figure 24. Force vs. Deflection and Energy vs. Deflection, Test No. CGSA-4

Force vs. deflection and energy vs. deflection curves were created from the DTS-SLICE accelerometer data, as shown in Figure 24. Early in the test, multiple force spikes of around 20 kips (89 kN) were recorded within the first 6 in. (152 mm) of deflection. The resistance force then steadily declined until the bogie overrode the post at a deflection of 20.3 in. (516 mm). The post assembly absorbed a total of 189.7 k-in. (21.4 kJ) of energy. Time-sequential and post-impact photographs are shown in Figures 25 through 27.

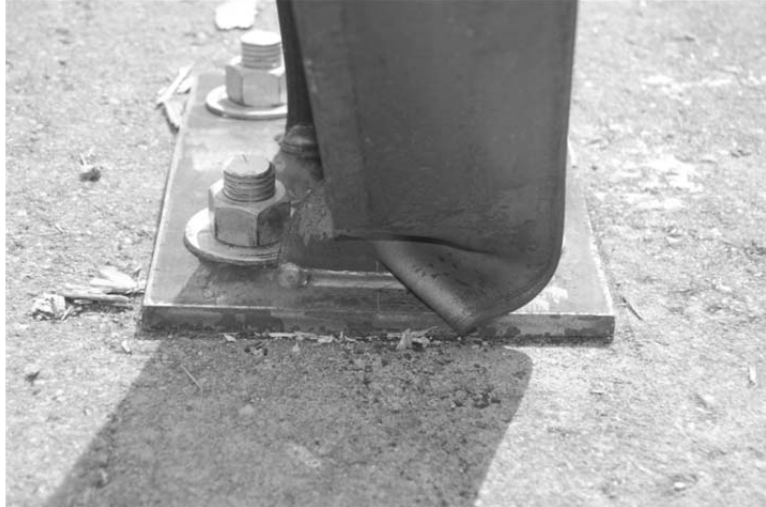
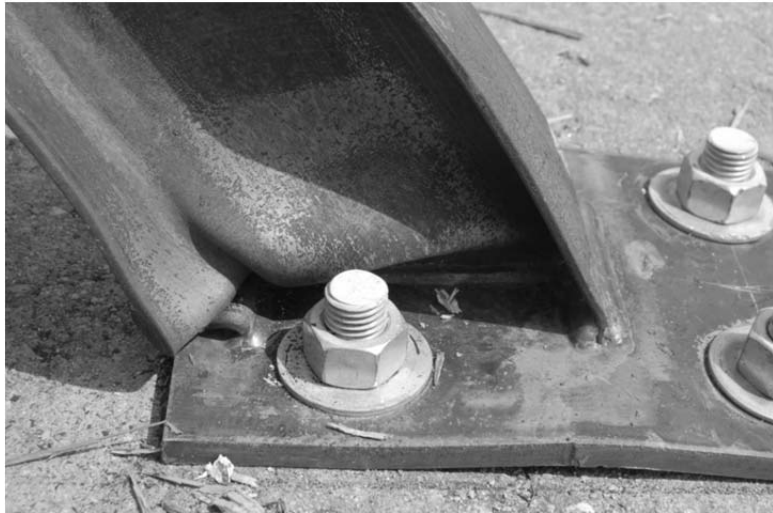
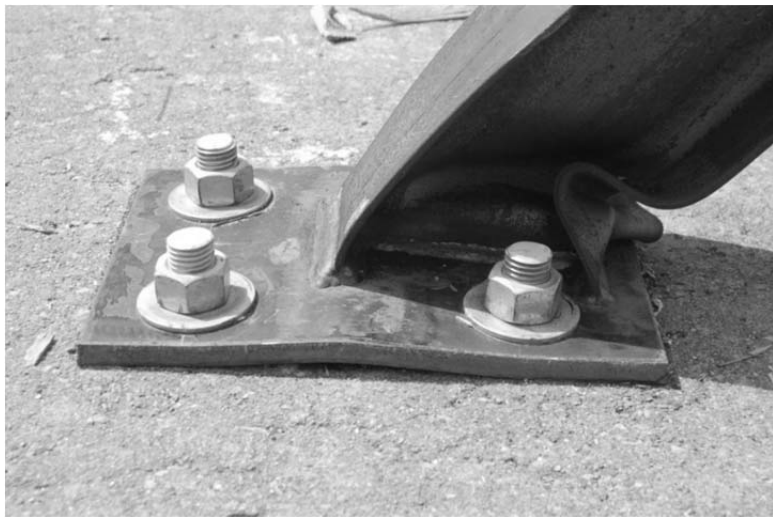
Figure 27. Post-Impact Photographs, Test No. CGSA-4

For test no. CGSA-4, the post was connected to the base plate using a 3-pass, $\frac{5}{16}$ -in. (8-mm) fillet weld on the front flange and a single-pass $\frac{1}{4}$ -in. (6-mm) fillet weld on the web and back flange. To anchor the post assembly, four 1-in. (25-mm) diameter threaded rods were epoxied into the tarmac with an embedment depth of 8 in. (203 mm). During test no. CGSA-4, the bogie impacted the post at a speed of 11.6 mph (18.7 km/h). As a result, the post bent backward, and the bogie eventually overrode the top of the post at a displacement of 20.3 in. (516 mm) as determined from the DTS-SLICE data. Post-test examination revealed buckling of the back flange and web of the post along with bending of the base plate. No evidence of plate tearing or weld failure was present.

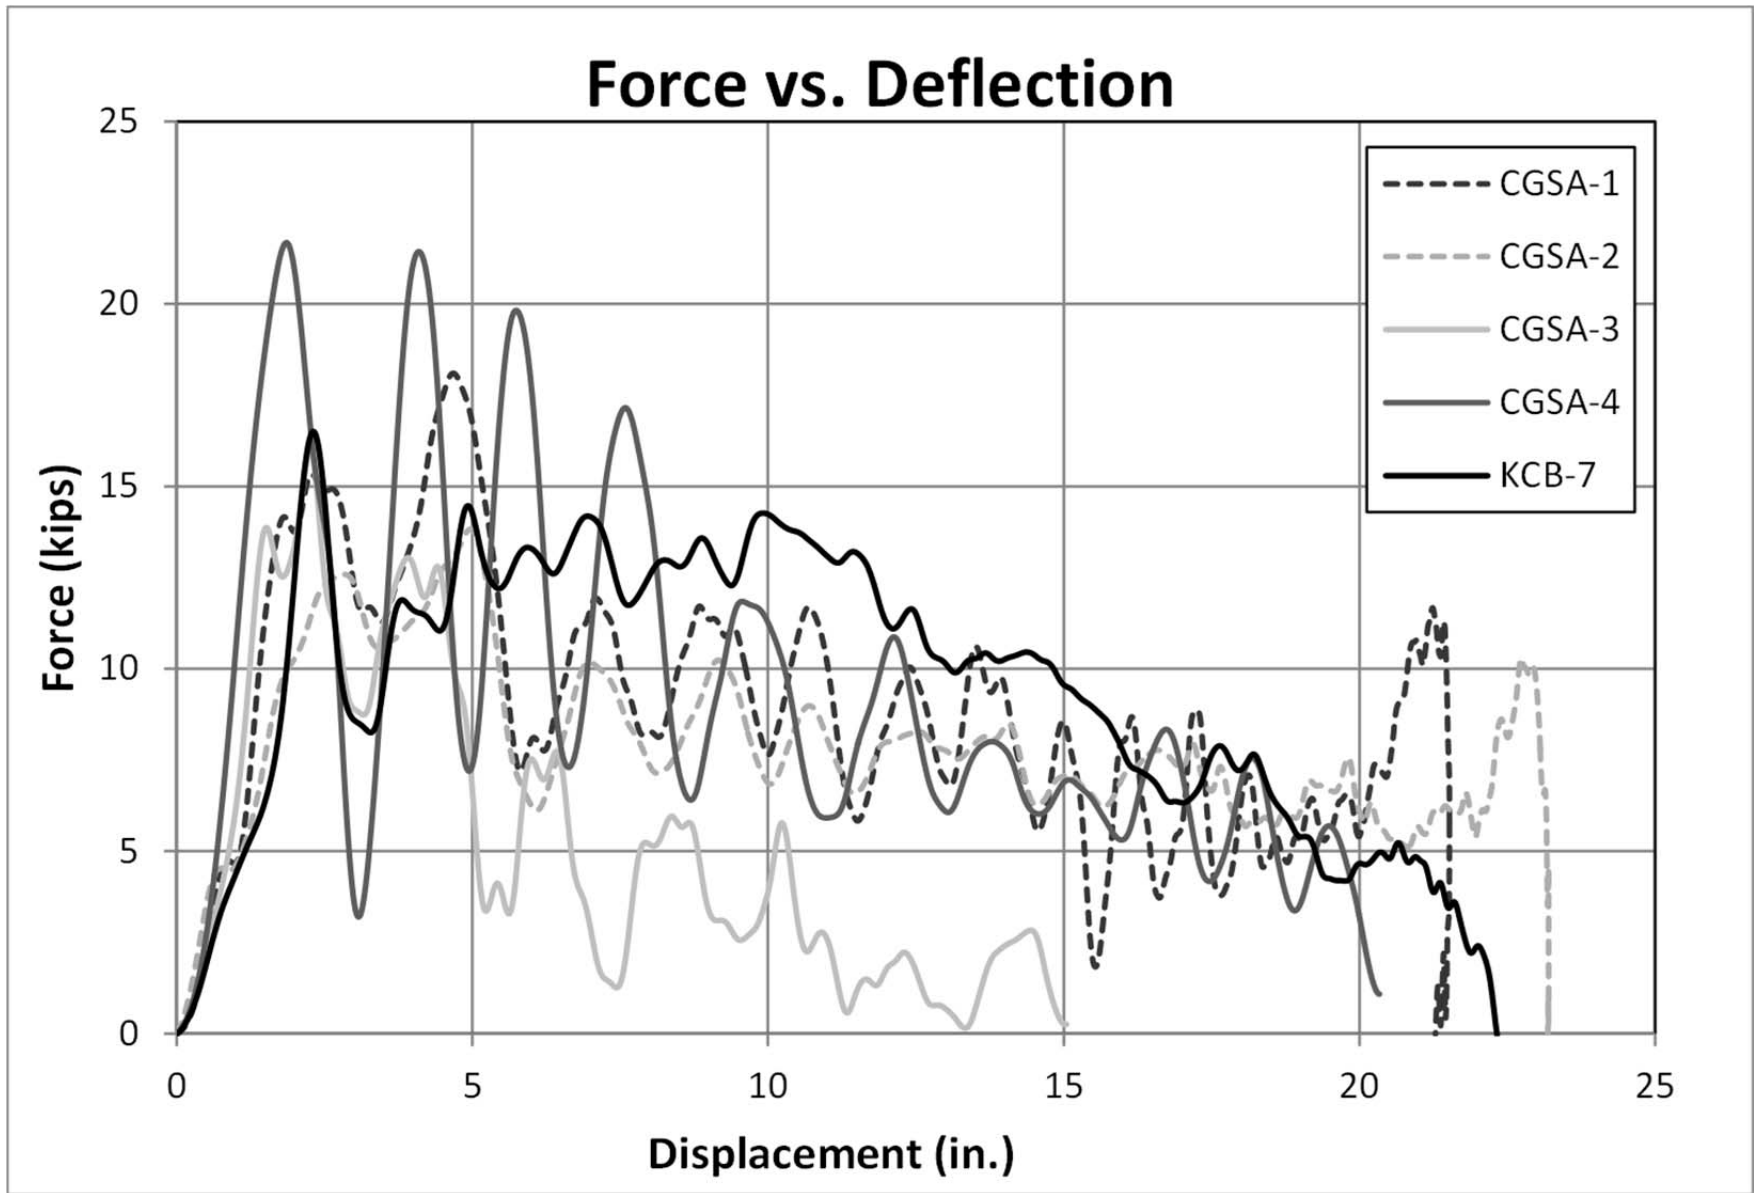
Figure 28. Comparison of Force vs. Deflection Curves

The force vs. displacement and energy vs. displacement curves from the four bogie tests conducted for this study and the curves from the bogie test conducted in the original study, test no. KCB-7 [1], are shown in Figures 28 and 29, respectively. The 50-ksi (345-MPa) steel of test no. CGSA-4 resulted in higher peak forces of the first 8 in. (203 mm) of deflection. However, after 20 in. (508 mm) of deflection, there was only a 6 percent difference in the total energy absorbed between test nos. CGSA-4 and KCB-7. Thus, both post assemblies would be expected to perform similarly when used in a full-system installation. The use of either steel grade should be acceptable for use in the W-beam guardrail system attached to low-fill culverts.

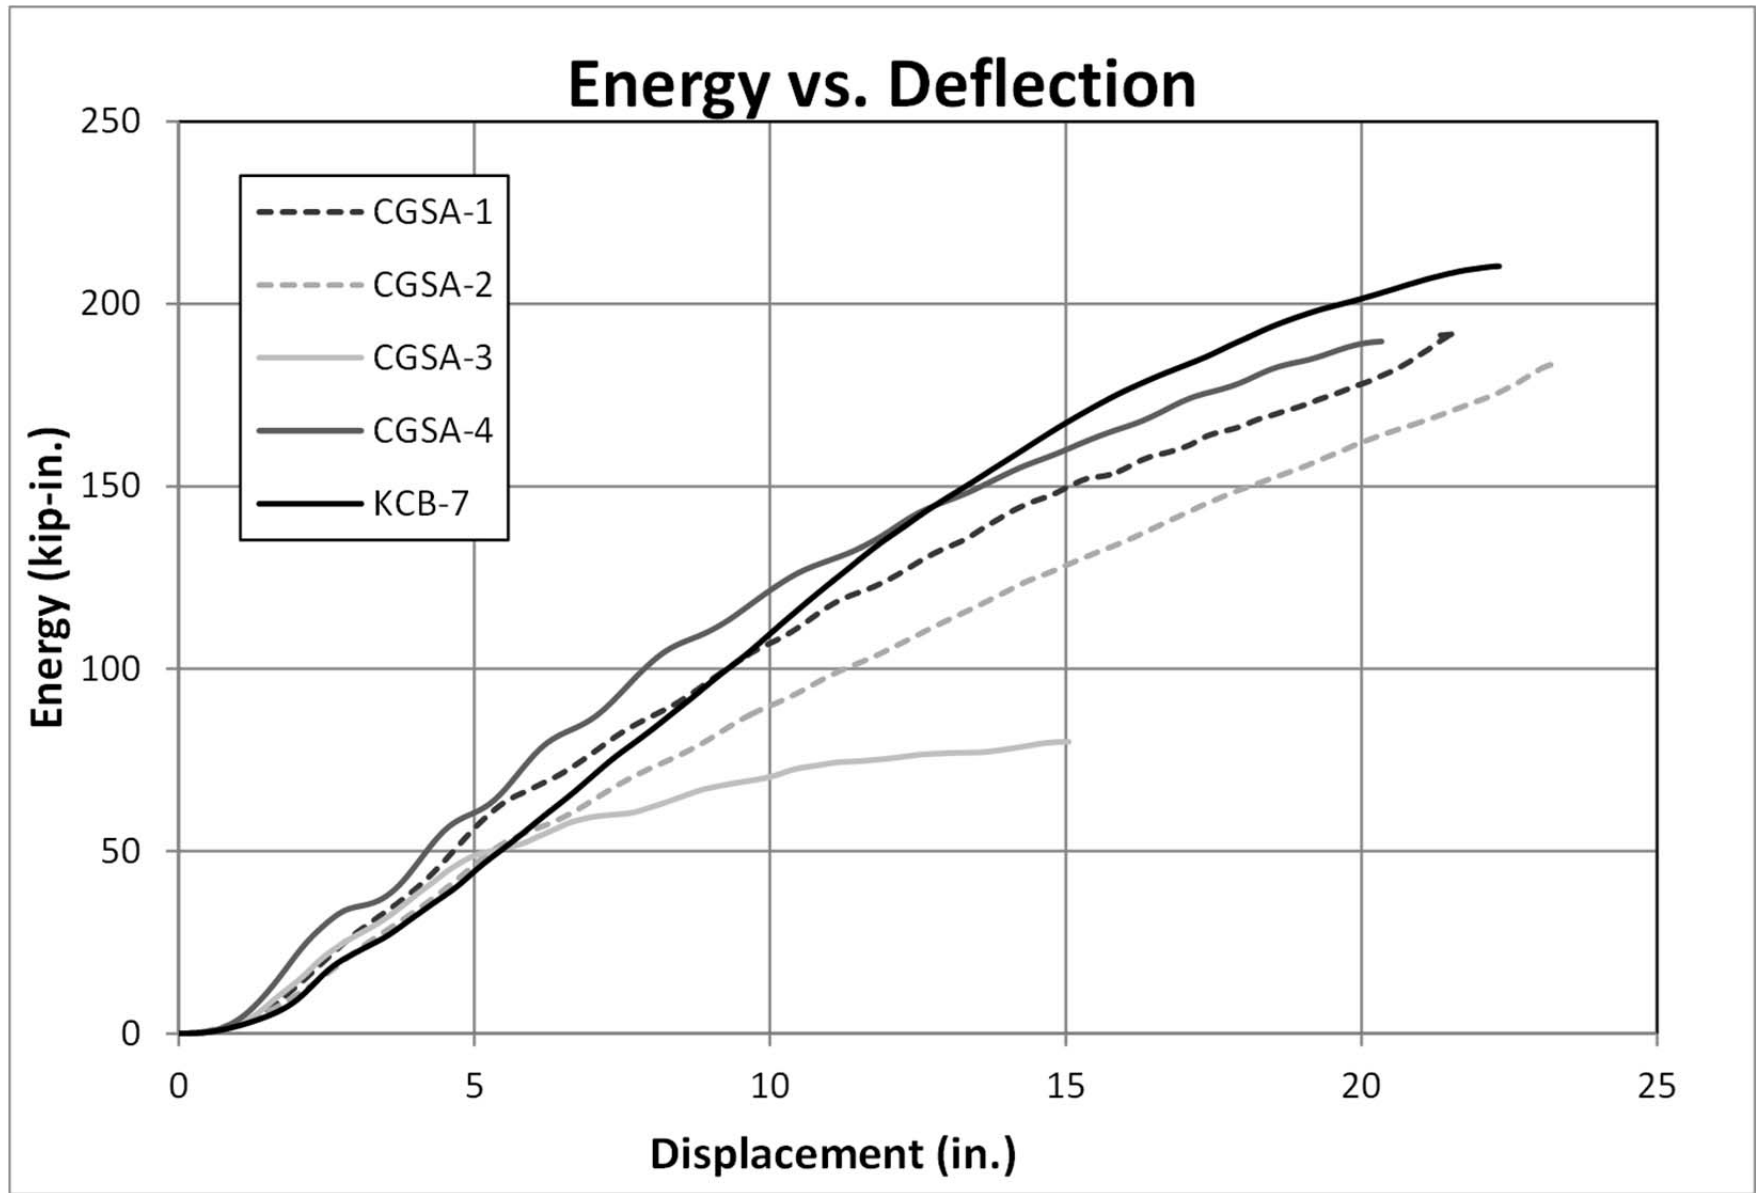
Figure 29. Comparison of Energy vs. Deflection Curves
