# Development of a Stand-Alone Concrete bridge Pier Protection System

*Midwest States' Regional Pooled Fund Research Program  
Fiscal Year 2003-2004 (Year 14)  
Research Project Number SPR-3 (017)  
NDOR Sponsoring Agency Code RFPF-04-05*

# **DEVELOPMENT OF A STAND-ALONE CONCRETE BRIDGE PIER PROTECTION SYSTEM**

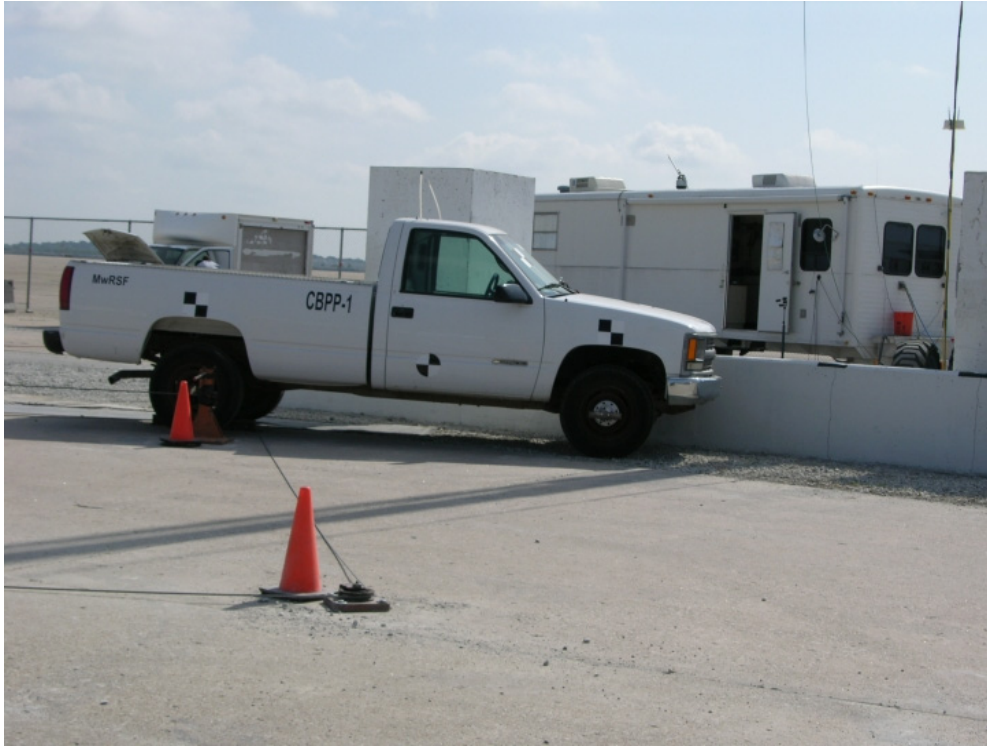
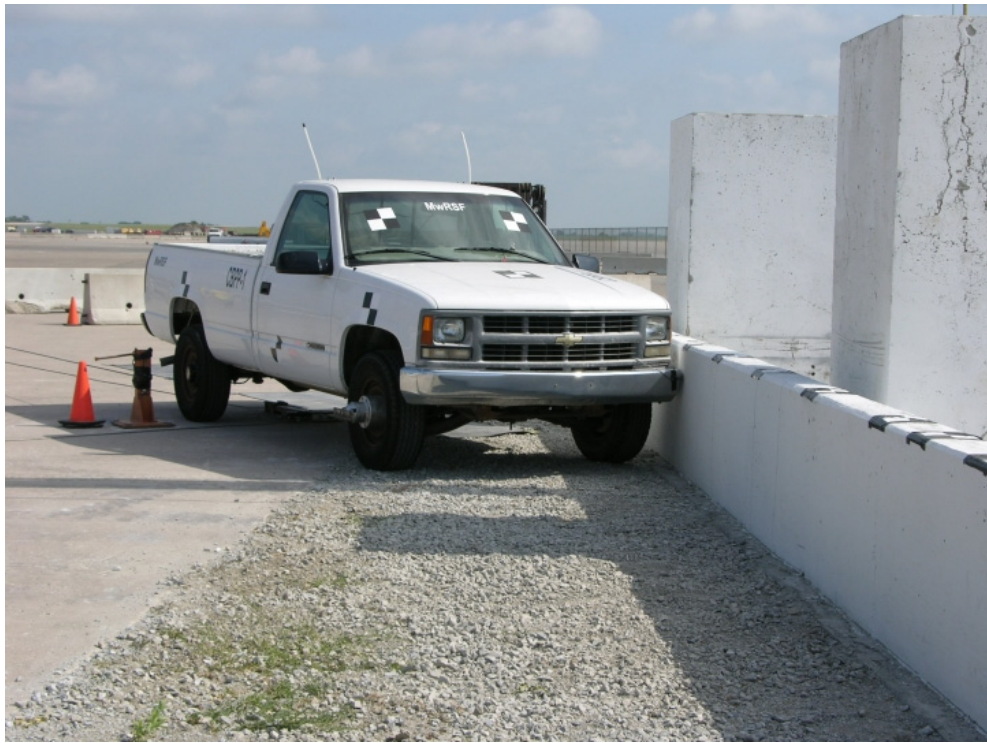
**Figure 7. Test Vehicle, Test No. CBPP-1**

For test CBPP-1, a 1999 Chevrolet C2500 3/4-ton pickup truck was used as the test vehicle. The test inertial and gross static weights were both 2,015 kg (4,442 lbs). The test vehicle is shown in Figure 7, and vehicle dimensions are shown in Figure 8.

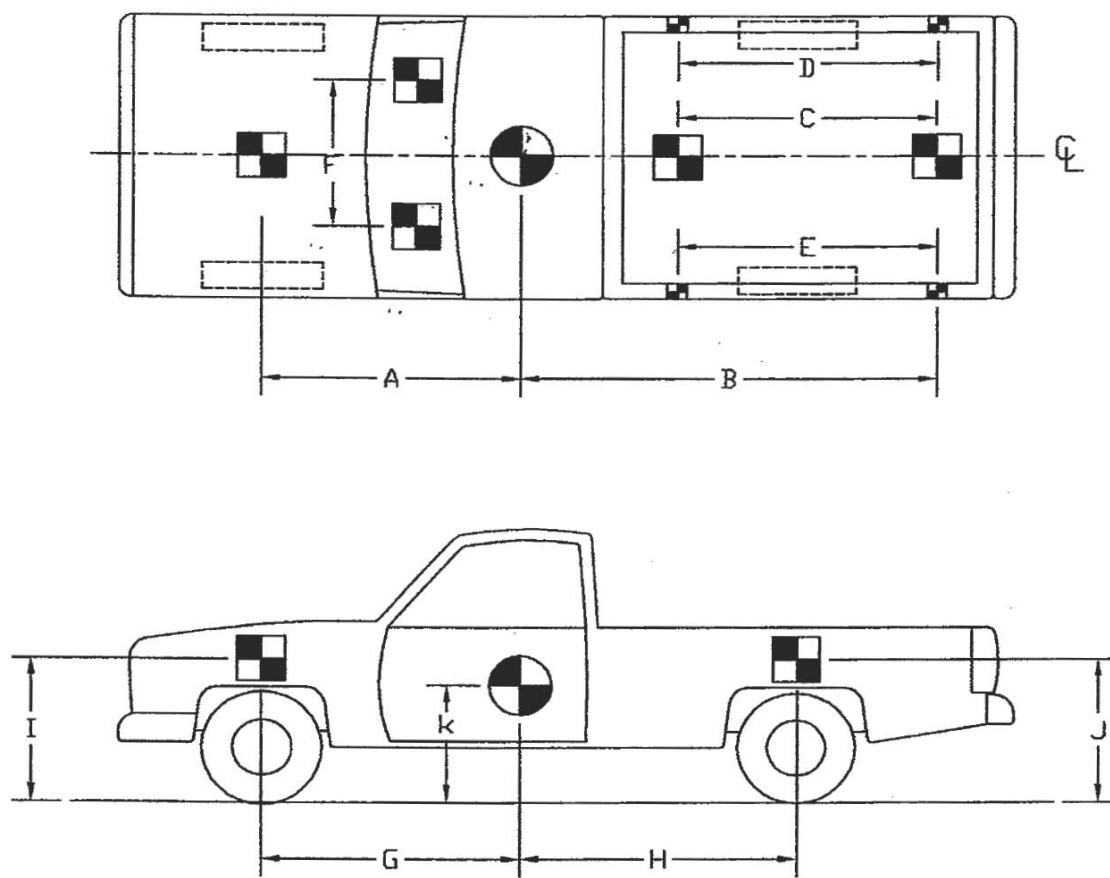
TEST #: CBPP-1  
 TARGET GEOMETRY-- mm (in.)

A	<u>1600</u>	(63.0)	E	<u>2153</u>	(84.75)	I	<u>1003</u>	(39.5)
B	<u>2496</u>	(98.25)	F	<u>1003</u>	(39.5)	J	<u>1048</u>	(41.25)
C	<u>1410</u>	(55.5)	G	<u>1439</u>	(56.66)	K	<u>667</u>	(26.25)
D	<u>2153</u>	(84.75)	H	<u>1946</u>	(76.6)

Square black and white-checkered targets were placed on the vehicle to aid in the analysis of the high-speed VITcam videos, as shown in Figure 9. Round, checkered targets were placed on the center of gravity, on the left-side door, on the right-side door, and on the roof of the vehicle. The remaining targets were located for references so that they could be viewed from the high-speed cameras for video analysis.

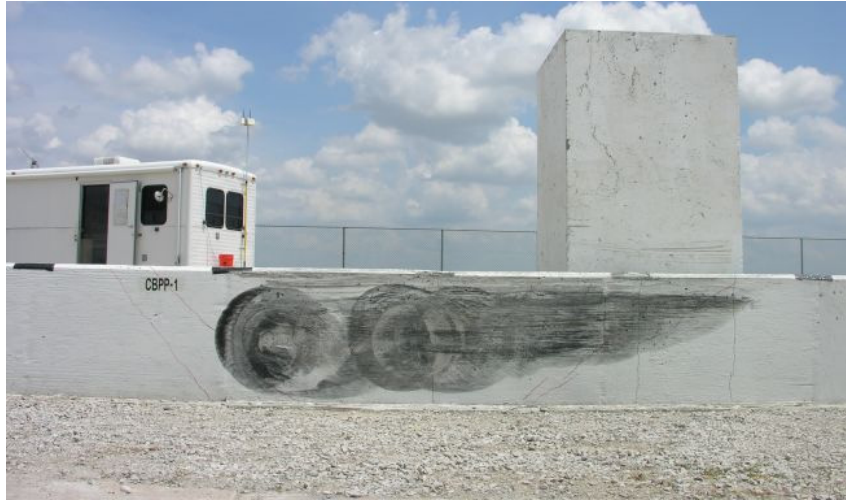
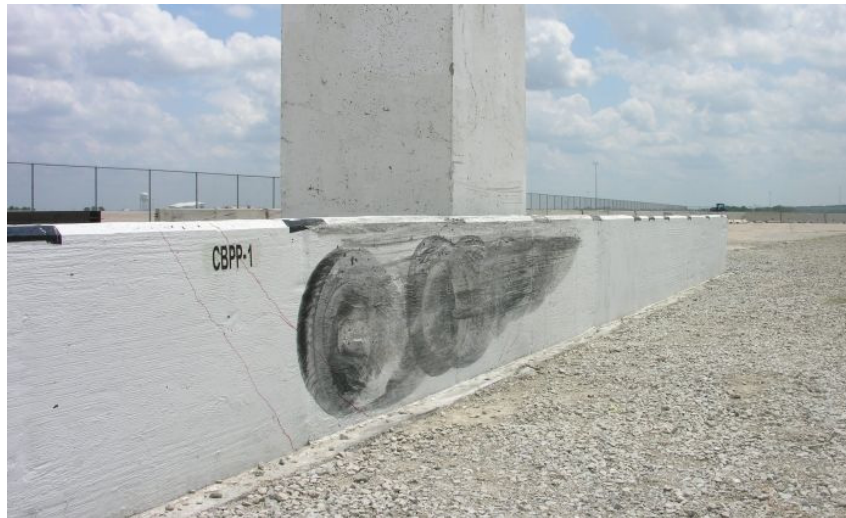
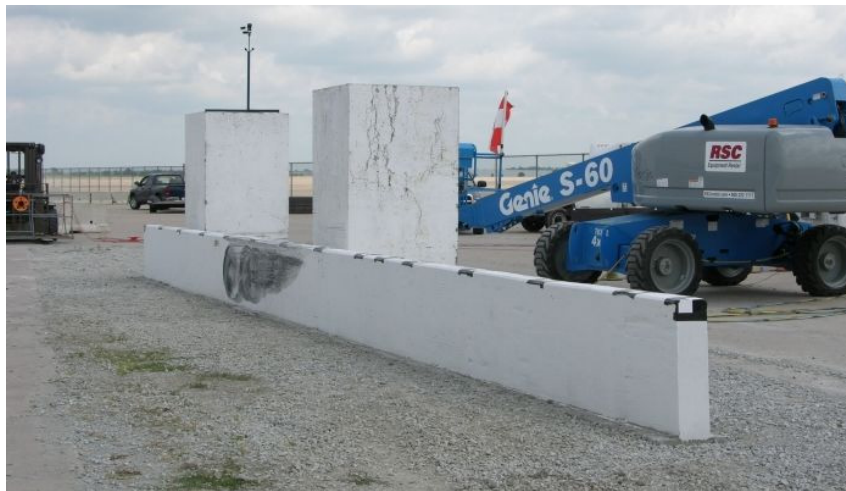
**Figure 18. System Damage, Test CBPP-1**

Damage to the barrier was minimal, as shown in Figures 18 through 22. The damage consisted of concrete cracks, spalling and gouging, and contact marks. All of the cracks found on the barrier were no wider than 2 mm (1/16 in.). Cracks on the front face of the barrier were diagonal and resembled the predicted yield line failure shape used for the structural analysis described in Chapter 3. The distance between the upstream cracks and the downstream cracks was 4,039 mm (159 in.) on the top of the barrier and 1,956 mm (77 in.) near the base of the barrier. The cracks on the back side of the barrier were nearly vertical and were located between the diagonal cracks on the front side of the barrier. All barrier cracks shown in Figures 20 and 21 were colored red to make them more visible. Any black lines represented cracks formed in the barrier during curing.

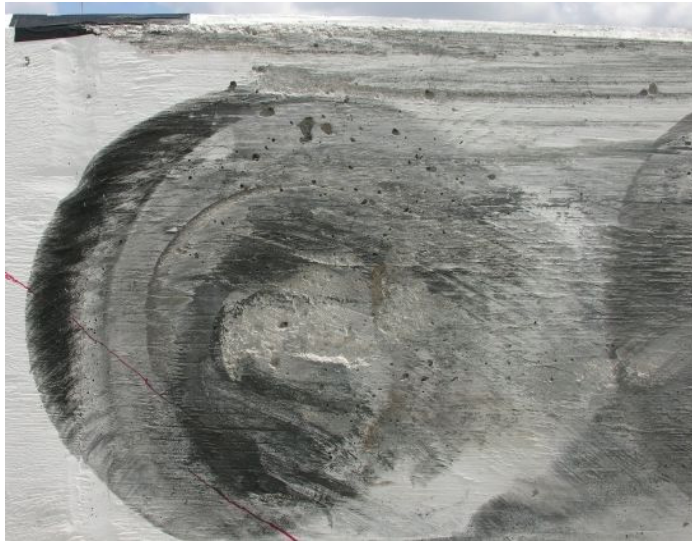
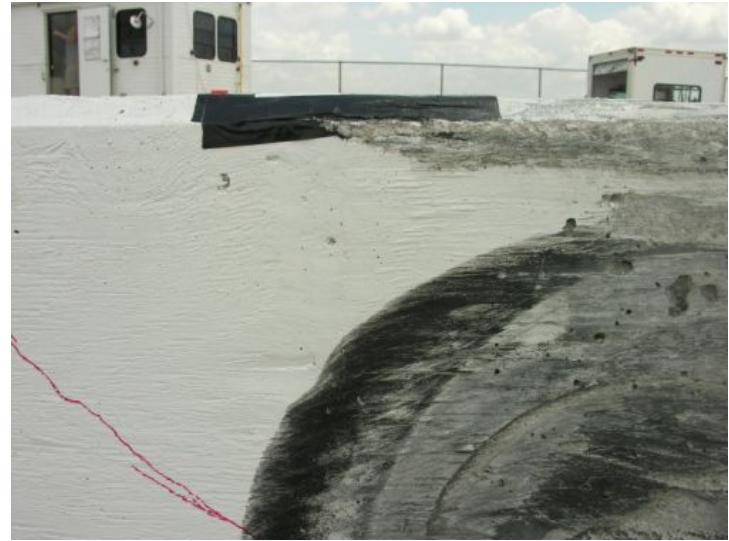
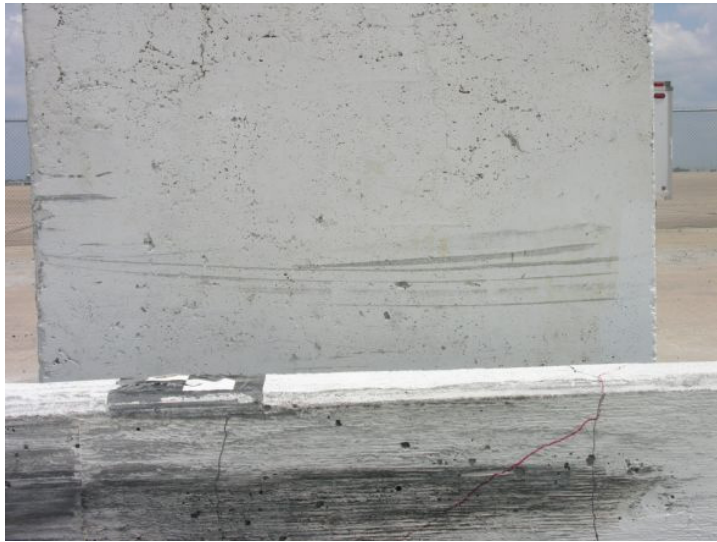
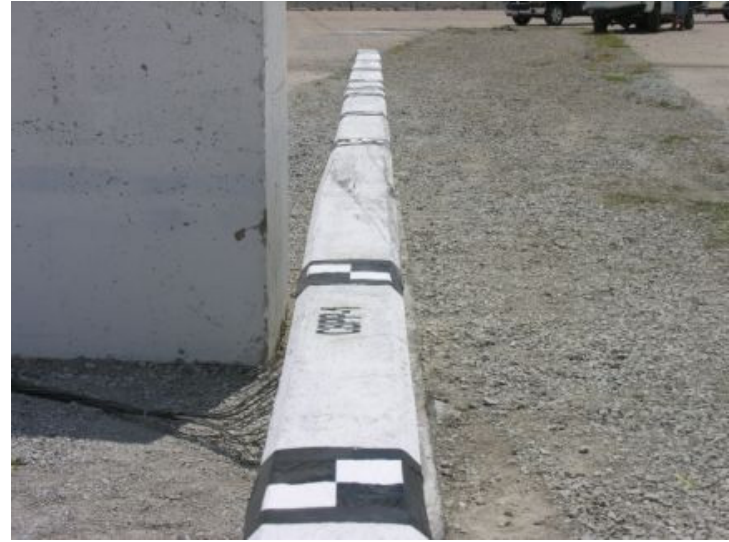
**Figure 19. System Damage, Contact Marks and Gouging, Test CBPP-1**

Contact marks were found on the barrier's front face, beginning 25 mm (1 in.) downstream of the initial targeted impact point and extending 3,378 mm (133 in.) downstream. Contact marks were also found on the front face of the bridge pier. Minor spalling was found along the front-top corner of the barrier, beginning 216 mm (8.5 in.) downstream of impact and extending 2,083 mm (82 in.) downstream. Also, a 216-mm (8.5-in.) long gouge mark was found

halfway up the barrier face 203 mm (8 in.) downstream of impact. These contact marks and instances of spalling and gouging are shown in Figure 19.

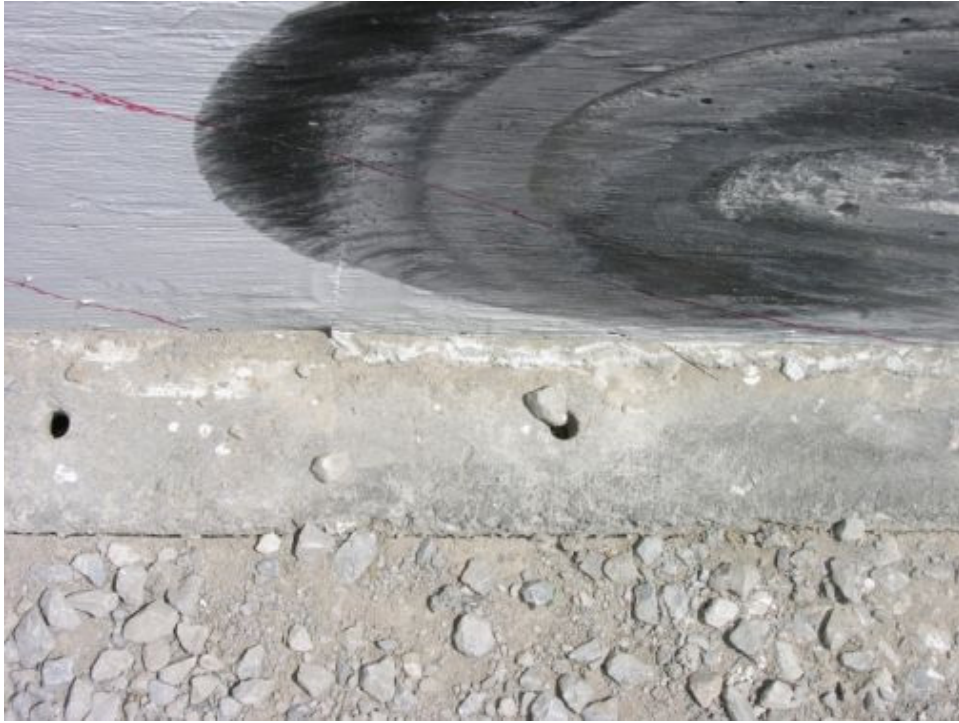
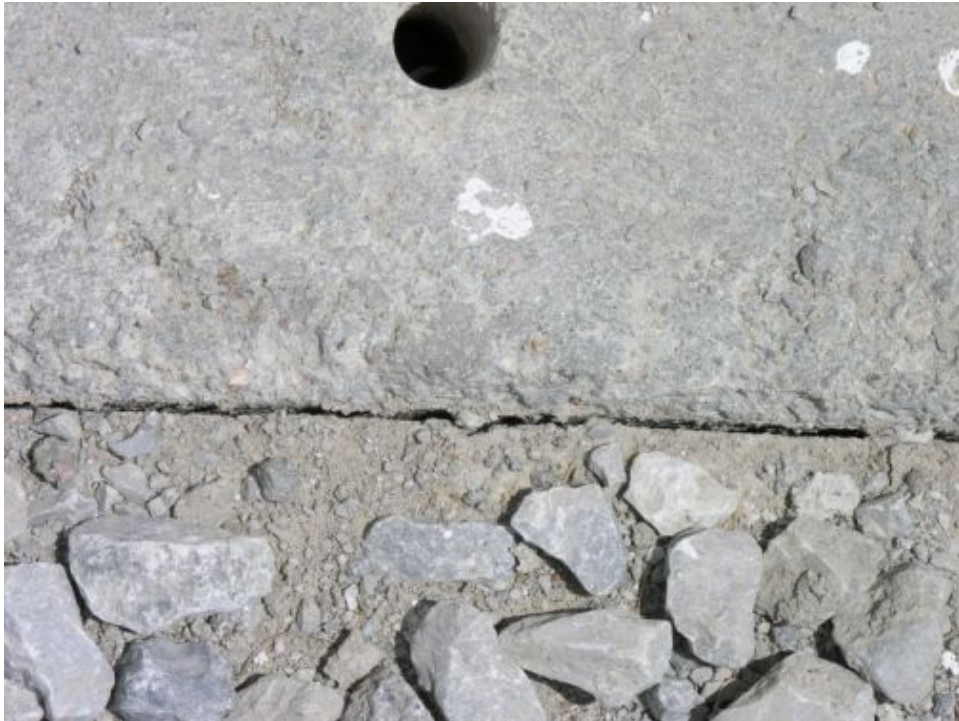
**Figure 22. System Damage, Soil Gap, Test CBPP-1**

Finally, a minor soil gap was found along the base of the barrier on the front side. The gap measured approximately 3 mm (0.125 in.) wide and extended through the area of impact. This gap is shown in Figure 22. The maximum dynamic deflection was 26 mm (1 in.) and the permanent set was negligible. The working width was found to be 504 mm (19.8 in.)

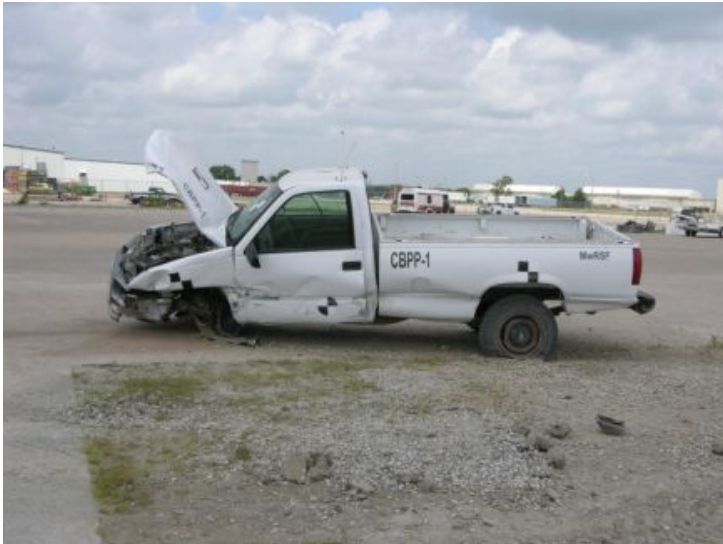
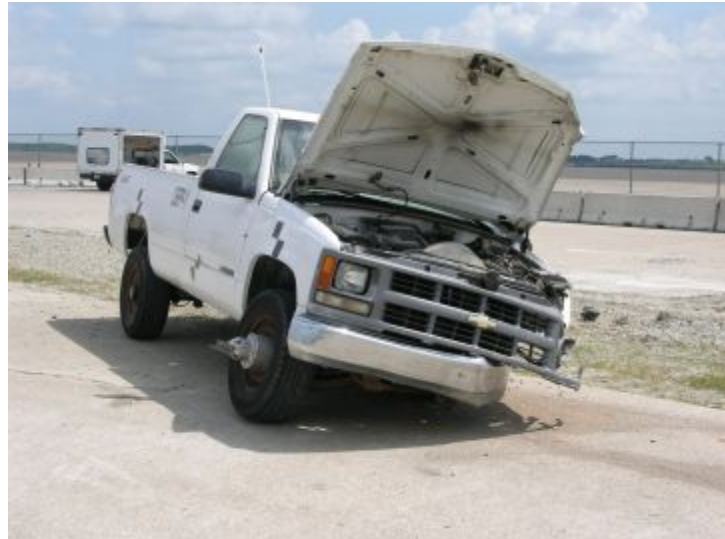
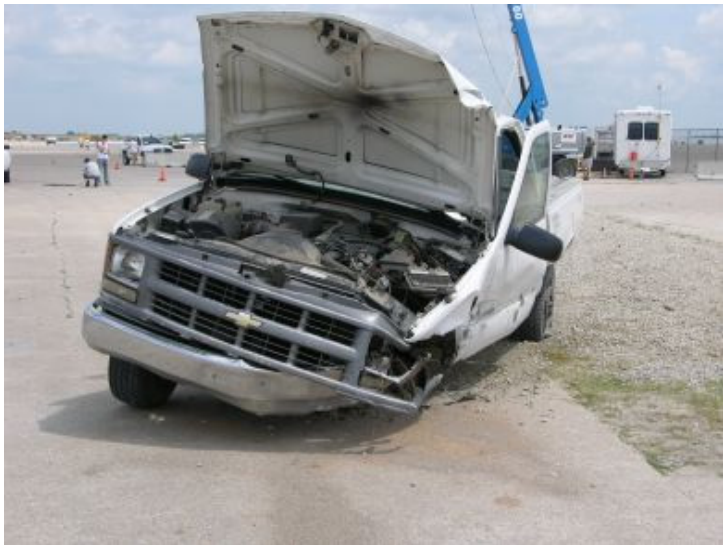
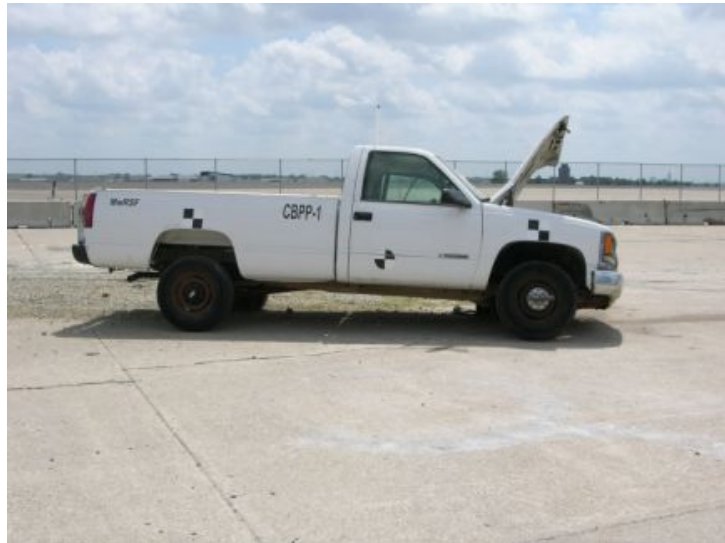
Figure 23. Vehicle Damage, Test CBPP-1

The damage to the vehicle was moderate, as shown in Figures 23 through 29. The most severe damage was located at the left-front region of the vehicle, as shown in Figure 24. The left-front corner of the vehicle was crushed inward toward the engine with the bumper buckling near the center. The left-front headlight disengaged, and the left-front tire was disengaged from the rim. Both the lower control arm and the anti-roll bar were also disengaged from the left-front wheel assembly.

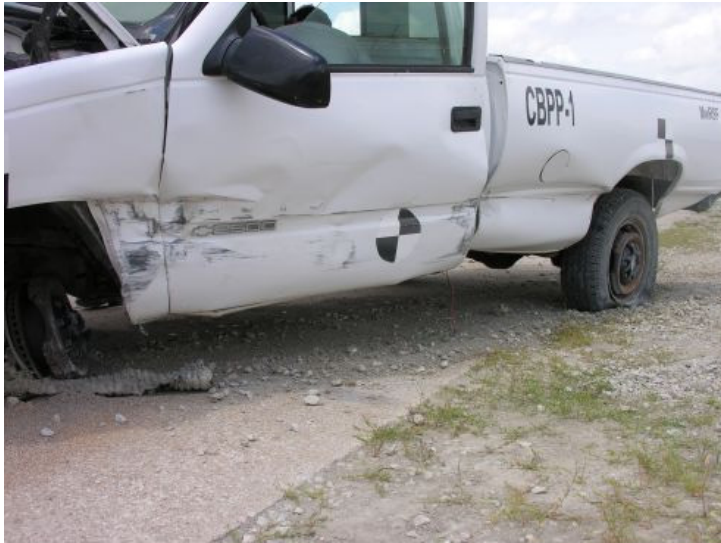
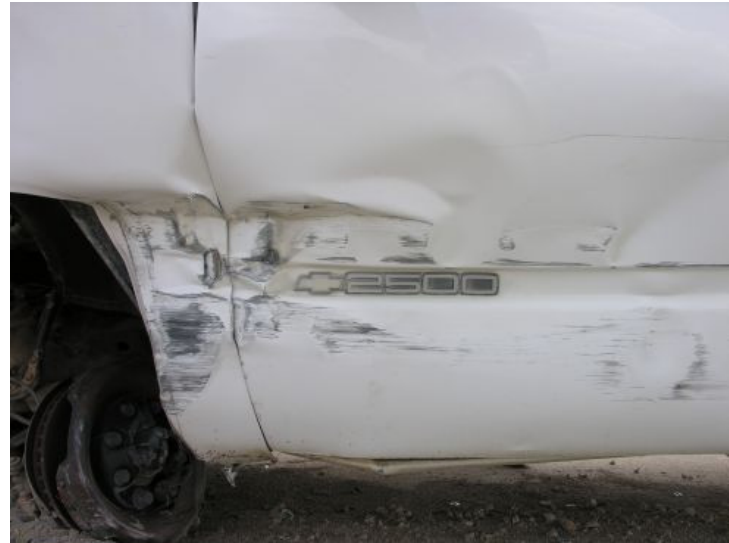
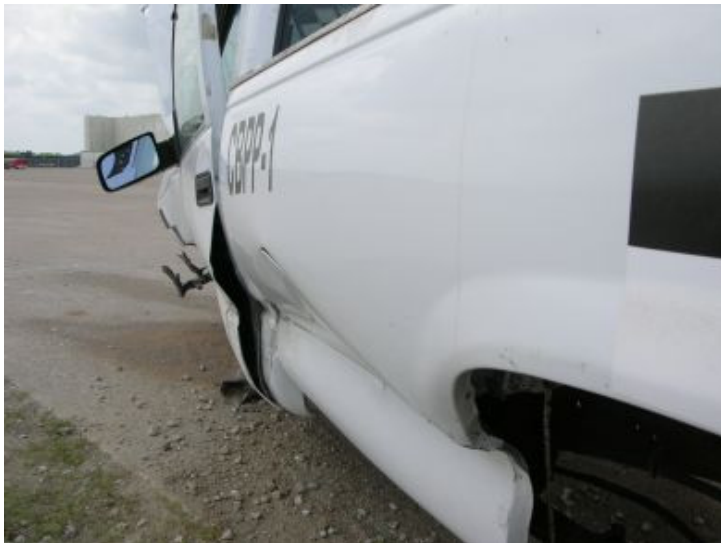
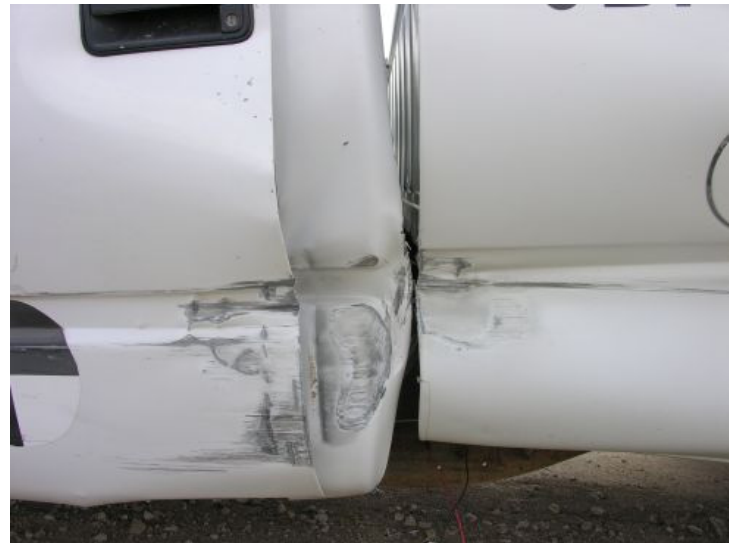
**Figure 25. Vehicle Damage, Left Side, Test CBPP-1**

Gouges, indentations, and scratches were found along the entire left side of the vehicle, as shown in Figure 25. Two gouges were found on the lower portion of the left-side door, each measuring about 25 mm (1 in.) wide. A major indentation, measuring 102 mm (4 in.) deep, was found directly in front of the left-rear wheel well. The top of the left-side door was separated from the rest of the cab, as shown in Figure 26, and the left-rear tire was deflated.

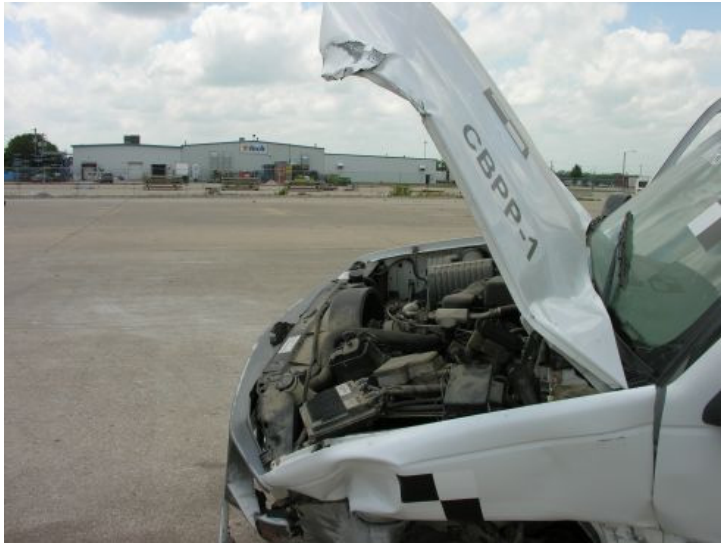
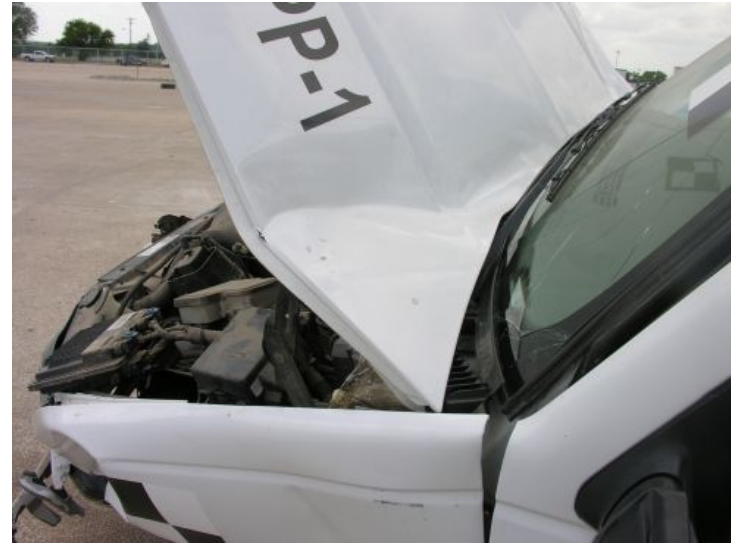
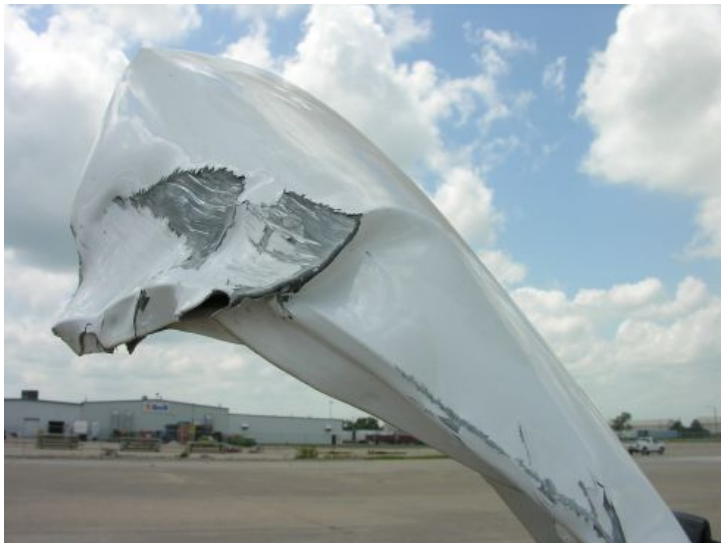
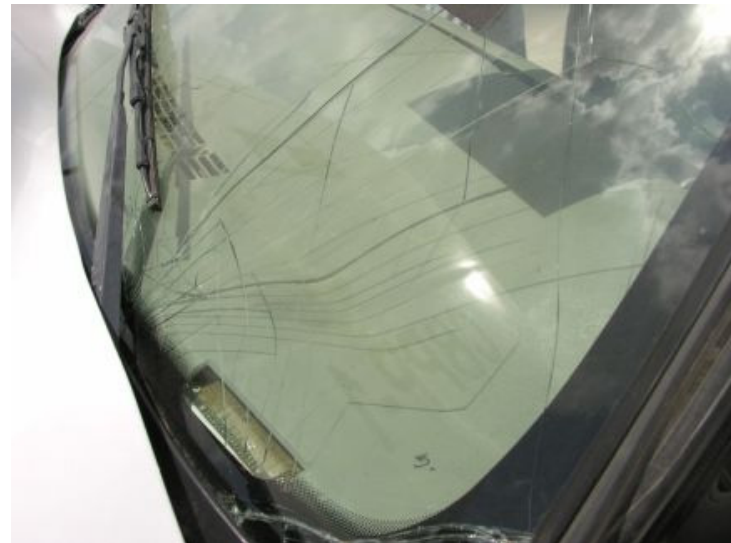
**Figure 27. Vehicle Damage, Hood and Windshield, Test CBPP-1**

As shown in Figure 27, the engine hood was dented and buckled. Localized damage in the form of folding and scrapes was found on the left-front corner of the hood from contact between the hood and the pier. The front of the hood was disengaged from the vehicle, and the hood was buckled near the windshield. Cracks were found in the windshield spreading from the left-lower corner to the top and middle.

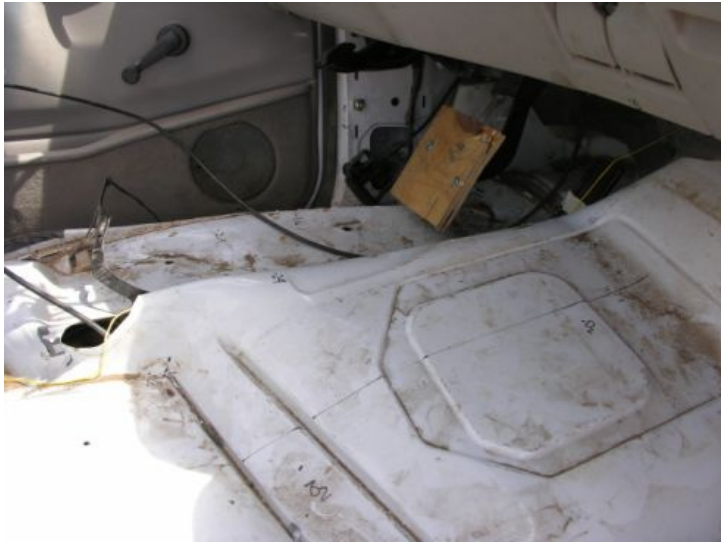
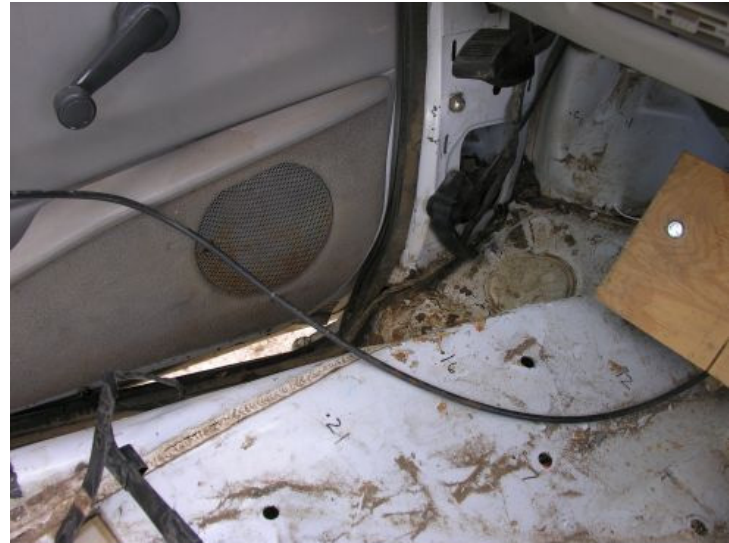
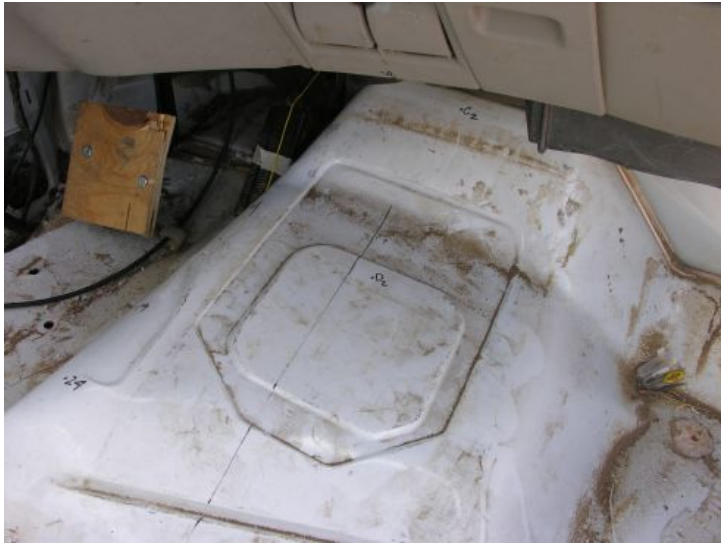
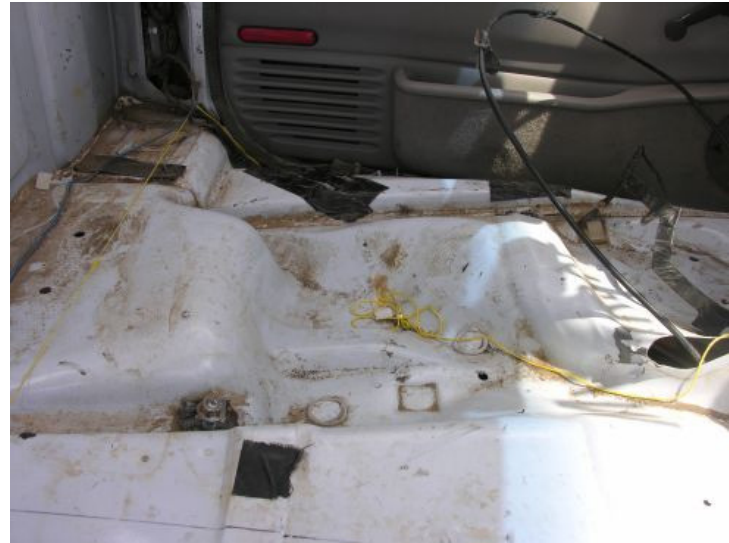
**Figure 28. Vehicle Damage, Occupant Compartment, Test CBPP-1**

Occupant compartment deformations to the left side and center of the floorboard, as shown in Figure 28, were judged insufficient to cause serious injury to the vehicle occupants. A maximum longitudinal deformation of 83 mm (3.25 in.) was located near the left-front side of the floorboard. A maximum lateral deflection of 133 mm (5.25 in.) was located along the left side of the floorboard. A maximum vertical deflection of 89 mm (3.5 in.) was located near the center of the floorboard. Deformations were recorded from two separate reference points before and after the test. Complete occupant compartment deformations and the corresponding locations are provided in Appendix E.

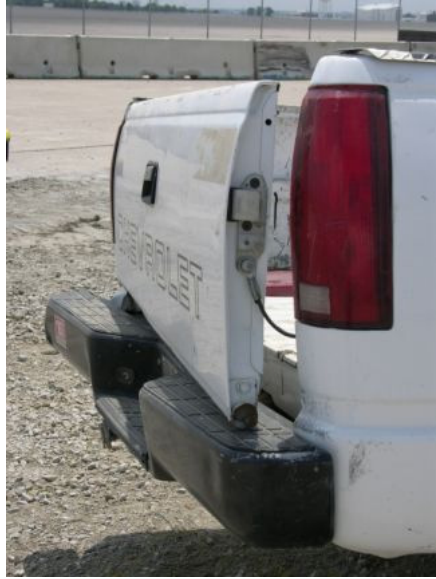
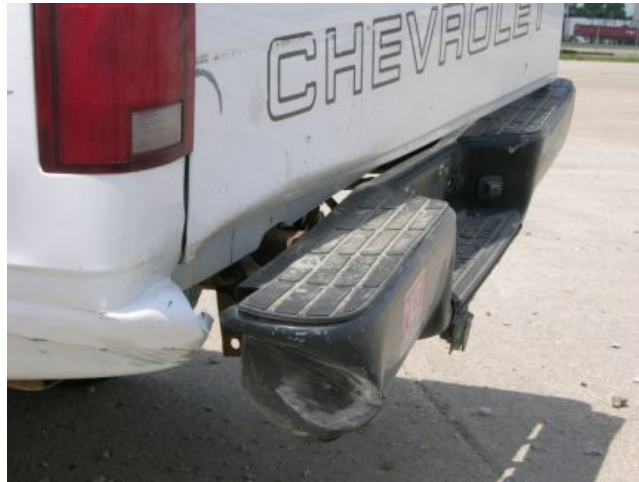
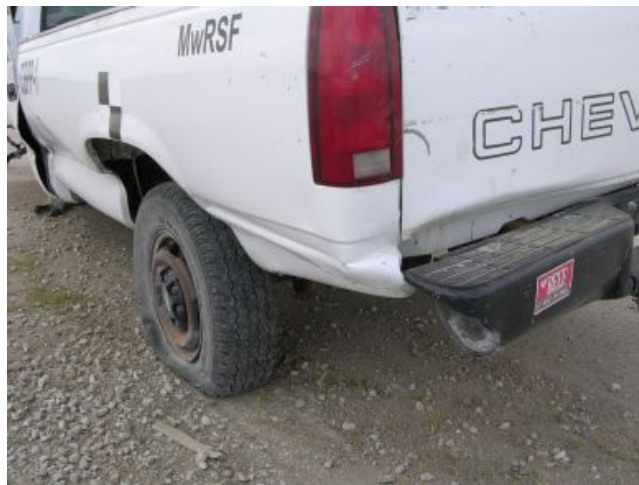
**Figure 29. Vehicle Damage, Rear of Vehicle, Test CBPP-1**

The rear of the vehicle received minimal exterior damage. As shown in Figure 29, the tailgate became detached from the right side of the pickup truck bed. The left-side face of the rear bumper had a 76 mm (3 in.) indentation, and the entire left side of the rear bumper was detached from the truck. Finally, the entire pickup truck bed was shifted 25 mm (1 in.) toward the left side of the cab.

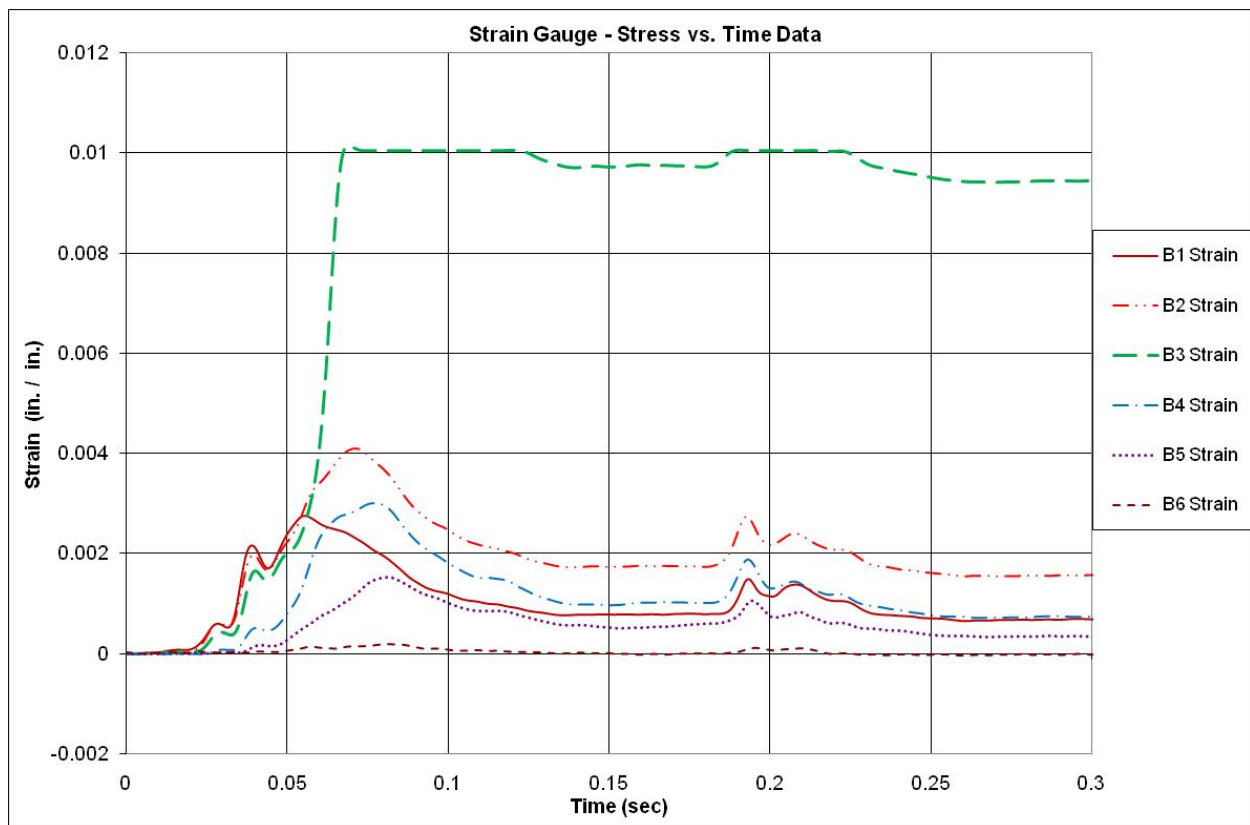
Figure 31. Strain vs. Time Data From Strain Gauge Results

In preparation for crash test CBPP-1, a total of sixteen strain gauges were installed on the steel reinforcement within the concrete barrier. However, during the test, technical difficulties were encountered, thus resulting in no discernable data being collected from the strain gauges located on the longitudinal reinforcement. Data was collected and analyzed from the remaining six gauges which were located on the front legs of the vertical stirrups in the barrier and throughout the impact region, as noted in Figure 4 of Chapter 4. This data is shown graphically in Figure 31 and each strain gauge is shown independently in Appendix G.

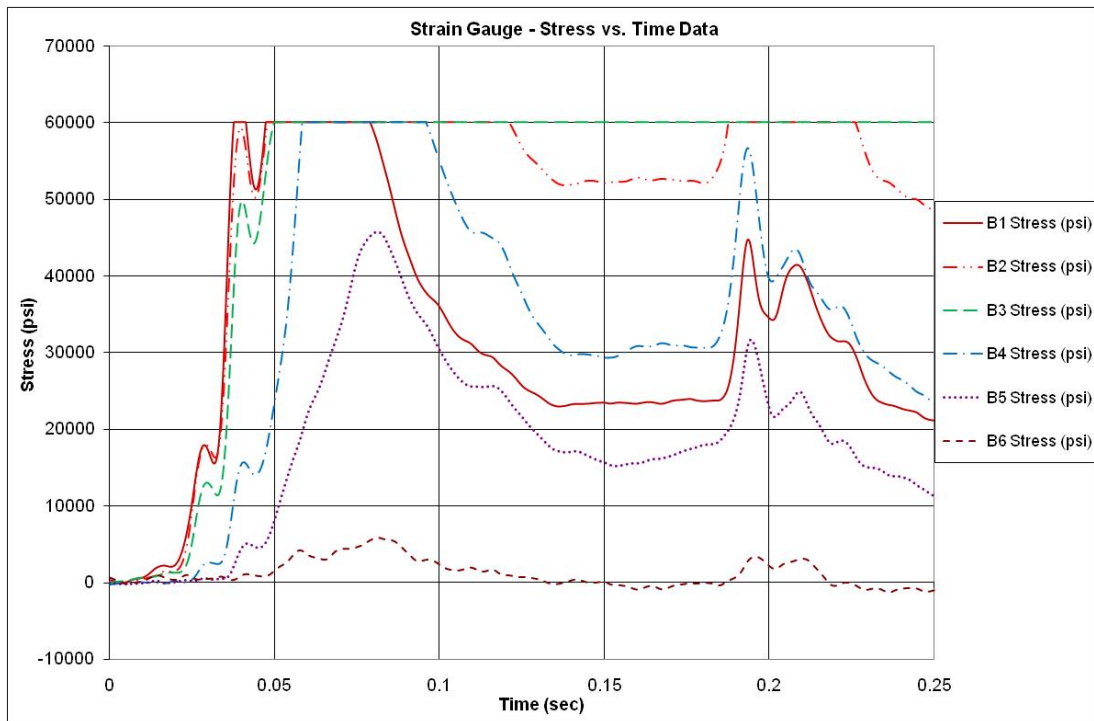
**Figure 32. Stress vs. Time Data From Strain Gauge Results**

The calculated stresses were limited to 414 MPa (60 ksi), at which point the rebar would hypothetically have begun to yield and where the linear-elastic relation between stress and strain no longer applied. Solving the more complex, plastic relation between stress and strain was

considered unnecessary since all of the design calculations were based on the yield-line capacity of barrier using minimum yield strength. With the absence of data from the longitudinal rebars, a more complete analysis of the load imparted to the barrier could not be performed. The resulting stress levels in the vertical bars are shown in Figure 32.

Strain gauge B3, which was located in the middle of the impact region, recorded the most deformation as it was the only gauge to bottom out. Thus, the stirrup at this location observed the highest strain. The recorded strains from the rest of the gauges decreased with an increased distance away from gauge B3. This fact was evident in Figure 32 by observing strains in gauges B2 and B4, which observed the next highest strains, followed by readings at gauges B1, B5, and finally B6. The time that the peak loading was observed from the strain gauge data, approximately 0.050 sec after impact, matched the time corresponding to the peak lateral impact
