10<sup>th</sup> International Conference of the International Institute for Infrastructure Resilience and Reconstruction (I3R2)  
20–22 May 2014  
Purdue University, West Lafayette, Indiana, USA

# Compare and Contrast Major Nuclear Power Plant Disasters: Lessons Learned from the Past

Sayanti Mukhopadhyay and Makarand Hastak  
Construction Engineering and Management, Purdue University

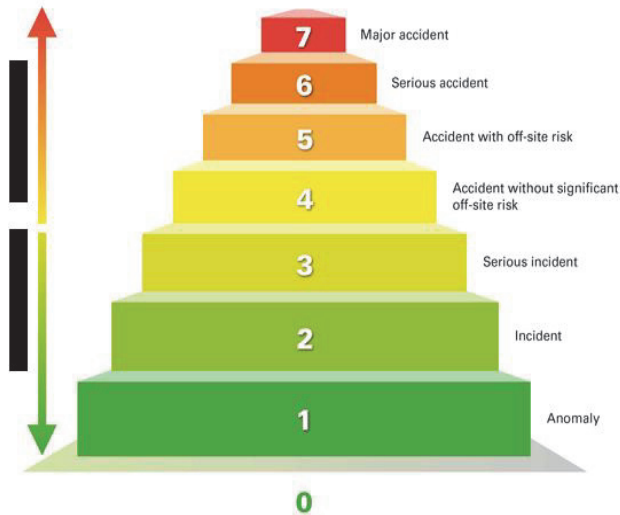
**Figure 1.** International nuclear and radiological event scale. Source: International Atomic Energy Agency [IAEA], 2013

Nuclear and Radiological Event Scale (INES) developed by the International Atomic Agency in 1990. The scale ranges from 1 to 7, where 1 represents least severe and 7 represents most severe. The ranking is interpreted as follows: “a nuclear event rated 4 in the scale is ten times worse than that rated at 3” (IAEA, 2013). Figure 1 is a pictorial representation of the INES Scale.
