Bridge Repair and Hydrodemolition of Wabash Memorial Toll Bridge, State Road 62

Indiana Department of Highways

This discussion covers the rehabilitation of the Wabash River Memorial Bridge which crosses the Wabash River seven miles west of Mt. Vernon, Indiana, and connects Indiana State Road 62 with Illinois State Road 141.

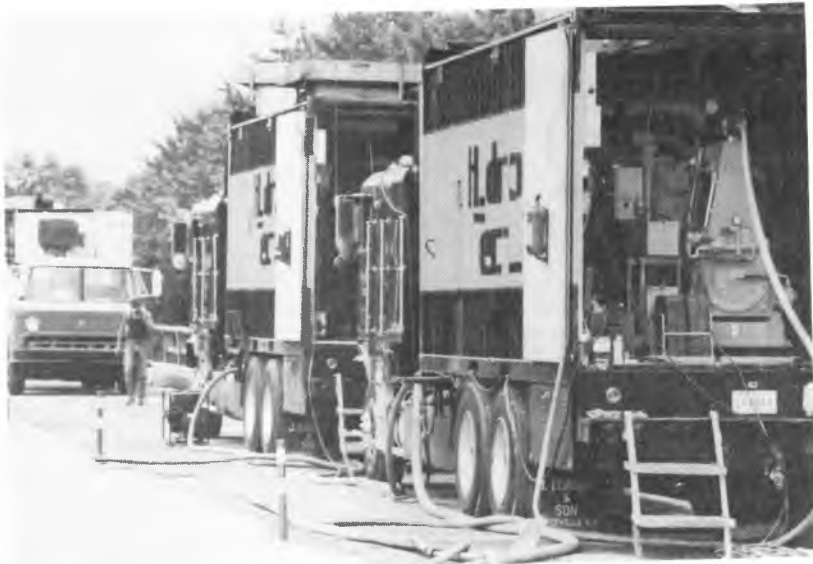
Each nozzle for hydrodemolition requires a truck containing a high pressure pump to provide 35 gpm at 17,000 psi.

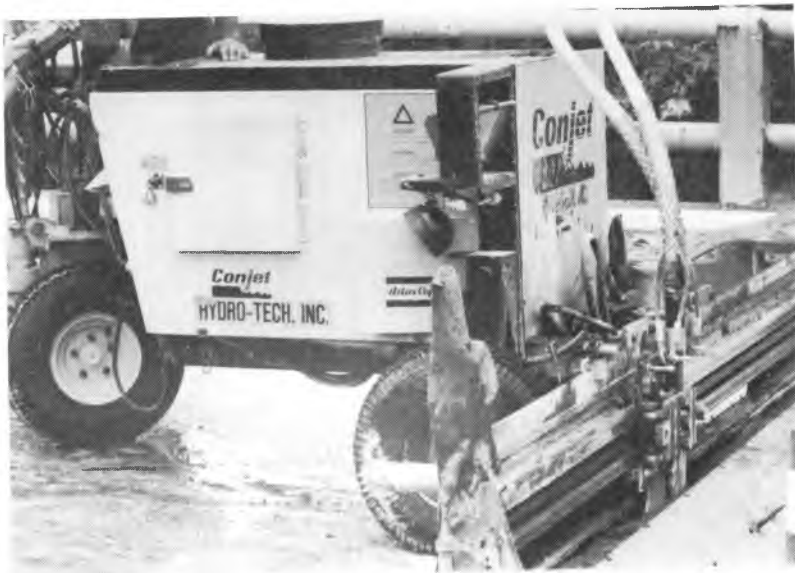
The slave used to remove concrete has two nozzles that connect to a high pressure pump and move along the front of the slave.

The self-propelled mobile unit contains high pressure water jets transversely mounted on a track at the back of the unit. As the robot incrementally advances, the nozzles sweep back and forth, scarifying a series of ribs. Controlled from a remotely located electronic console, the unit can be adjusted to vary the depth of sound concrete to be demolished. The jet water blast then automatically breaks out all deteriorated or delaminated concrete as it penetrates the slab down to the predetermined level of sound concrete. The upper, top layer of the reinforcing steel is fully exposed and clean when the unit has passed. There is no need to go back and sandblast the steel as is done in the impact or jackhammer method. The lower mat of steel usually is fully exposed at points of corrosion and delamination and partially exposed in sound concrete areas. Where there is evidence of corrosion in the bars, there is concrete lamination, visible or not. The hydro-robot finds it.

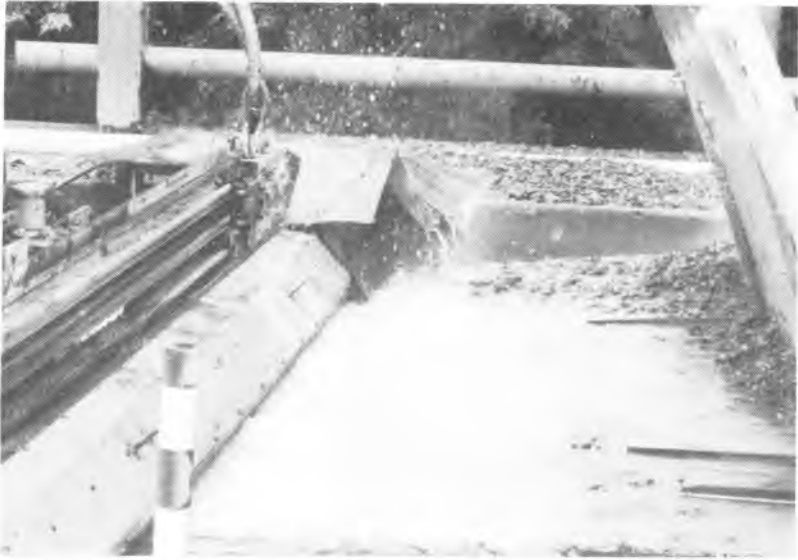
The slave is in action next to curb with protectors to keep removed concrete from being thrown into adjacent traffic.

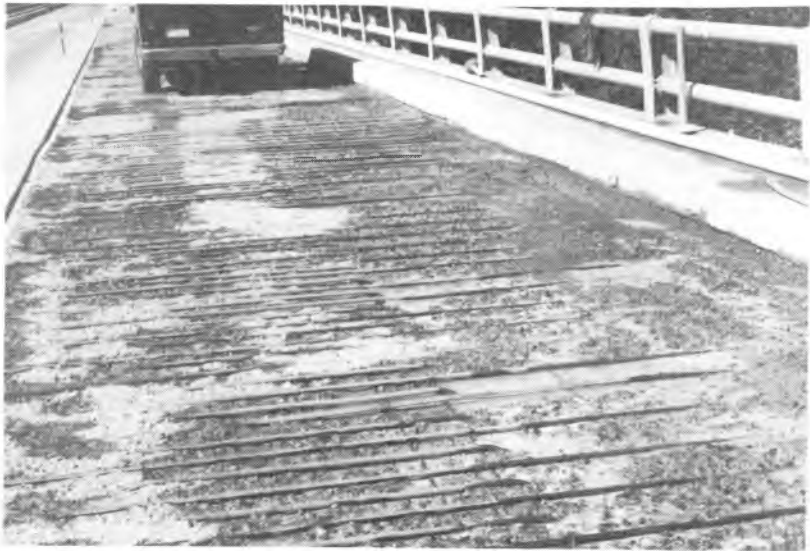
The finish section is ready for final cleaning; note excellent surface for bonding and clean re-steel.

The exposed deck is undamaged by the removal of the deteriorated concrete and free of fractures. The increased and rough surface area provides a higher bond strength between the old concrete and the new.

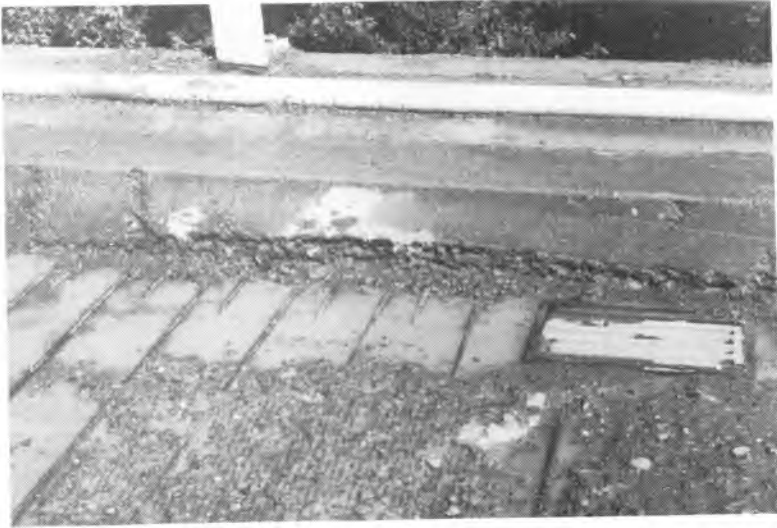
Finished curb section showing concrete surface for bonding and clean re-steel.
