# Analysis And Control Of Severe Vibration Of A Screw Compressor Outlet Piping System

## Analysis and Control of Severe Vibration of a Screw Compressor Outlet Piping System

The severe vibration of a screw compressor outlet piping system caused the fatigue failure of some thermowells and the unscheduled shut down of the system. The main reasons of the abnormal vibration in the outlet piping system were investigated by developing an acoustic model to simulate the gas pulsation and establishing two finite element models to conduct the mechanical vibration analyses. The acoustic analysis results showed that the pulsation amplitudes of most nodes in the outlet piping system exceeded the allowable values. The results of mechanical vibration analyses indicated that the insufficient stiffness of the outlet piping system and the first-order structure resonance occurred on thermowells were also the key factors inducing vibration. Several methods were put forward to attenuate vibration amplitude of the outlet piping system as well as the thermowells. A new pulsation attenuator was installed and the piping layout was rearranged to reduce pulsation amplitudes and shaking forces of all nodes i

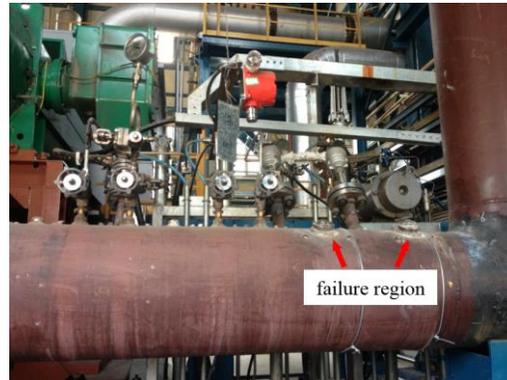
The serious vibration of a screw butadiene compressor outlet piping system caused the unscheduled shut down of the system. The compressor operates at rated condition most of the time. The rated speed is 2950 rpm, rated motor power is 1500 kW, rated flow rate is 15277 m<sup>3</sup>.h<sup>-1</sup>, the inlet pressure and temperature are 159 kPa and 318 K, and the outlet pressure and temperature are 530 kPa and 374 K, respectively. The vibration velocity at the first elbow after the outlet silencer was 38.8mm/s, much exceeding the allowable value. Worse still, the small-bore appendages attached to the mainline vibrated violently, and the fatigue fracture happened on the junction of some thermowells and mainline, as shown in Figure 1. Although the temporary measure of changing the elastic support near the outlet silencer to guide support was adopted, there were still severe vibrations. As a result, vibration caused analysis and eliminating measures are urgently needed to ensure the safety and reliability of the system.

Figure 1: Fatigue fracture of the thermowells

improve the stiffness of the overall piping system, as shown in Figure 9. The thermowells were reinforced by adding four gussets between the thermowells and the connection flanges, as shown in Figure 10.

After above modifications, the first order natural frequency of the outlet piping system improved from 0.9Hz to 1.67Hz, and the calculated maximum vibration velocity was 11.4 mm/s, far less than the allowable value, which indicated that the stiffness of the outlet piping system increased. The first order natural frequency of the thermowell improved from 207.4Hz to 280.7Hz, away enough from the excitation frequency of 196.67Hz, and the first order structure resonance could be avoided. The maximum equivalent stress of the modified model at the excitation frequency of 198Hz was 2.65 MPa, occurred on the welding location between a gusset and the thermowell, as shown in Figure 10, which indicated that the fatigue life of the thermowell was improved.
