SHAKE TABLE TESTS FOR THE SEISMIC FRAGILITY EVALUATION OF HOSPITAL ROOMS

The present paper is aimed at establishing the limit states for a typical health care room and deriving empirical fragility curves by considering a systemic approach. Towards this aim, a full scale three-dimensional model of an examination (out patients consultation) room is constructed and tested dynamically by using the shaking table facility of the University of Naples, Italy. The sample room contains a number of typical medical components, which are either directly connected to the panel boards of the perimeter walls or behave as simple free-standing elements. The outcomes of the comprehensive shaking table tests carried out on the examination room have been utilized to derive fragility curves based on a systemic approach.

Hospital building contents, Nonstructural components, Shake table test, Seismic fragility, Fragility curve.

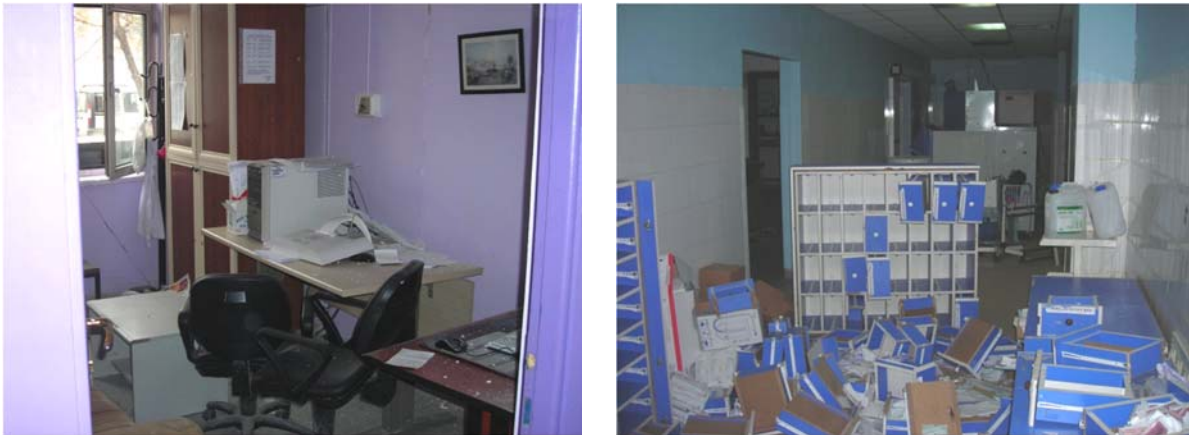
Figure 2. Damage to the building contents surveyed in the aftermath of the 2011 Van (Turkey) earthquake in the Yüzüncü Yil University – Faculty of Medicine Hospital.

Yil University – Faculty of Medicine Hospital. The losses of internal and external services as well as the damage to back-up systems were extensive, thus the nearly 500-beds hospital had to be completely closed and emergency response facilities relocated.

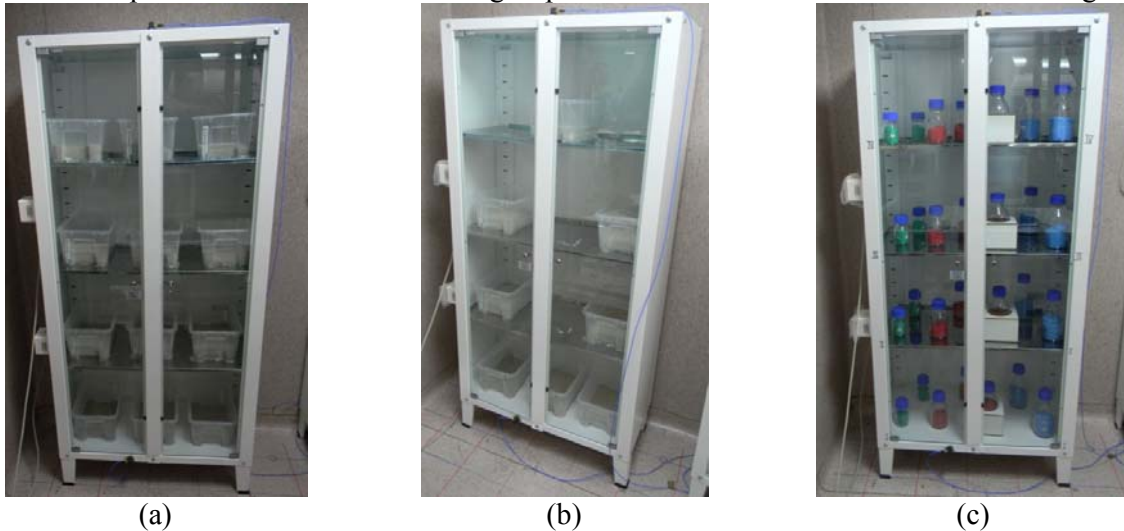
Figure 6. Double-window cabinet in (a) test groups 100 and 400, (b) test groups 200 and 500 and in (c) test groups 300 and 600.

Typical glass contents are tested in test group 300, as shown in Figure 6c. The contents are equally placed on the different shelves of each cabinet. Glass bottles with different dimensions, i.e. 100 ml, 250 ml and 500 ml, are placed in the double-window cabinet whereas 250 ml and 100 ml flasks, test tubes and glass beaker are placed in the one-window cabinet. They are filled with colored sand, that simulates the presence of water. In this test group the behavior of real contents is also investigated
