Scanning electron microscopy and energy-dispersive x-ray spectroscopy (SEM-EDX) confirms shooting of a hen harrier (*Circus cyaneus*)

Journal:	<i>Veterinary Record Case Reports</i>
Manuscript ID:	vetreccr-2015-000241
Manuscript Type:	Wildlife
Species:	Birds
Date Submitted by the Author:	03-Sep-2015
Complete List of Authors:	Hopkins, Timothy; Institute of Zoology, Zoological Society of London, Disease Risk Analysis and Health Surveillance Peniche, Gabriela; Institute of Zoology, Zoological Society of London, Disease Risk Analysis and Health Surveillance Murphy, Stephen; Natural England, Carter, Ian; Natural England, Sainsbury, Anthony; The Institute of Zoology
Keywords:	Wildlife, Wild birds, Forensic medicine, Expert witness, conservation
Topics:	Trauma, Imaging, Pathology
Abstract:	The hen harrier (<i>Circus cyaneus</i>) remains severely restricted as a breeding species in England despite sufficient habitat for over 300 breeding pairs (Fielding and others 2011). Human persecution is the main limiting factor and in the UK, there have been 45 confirmed incidents of shooting of hen harriers since records began (RSPB unpublished data). Since 2002, Natural England's Hen Harrier Recover

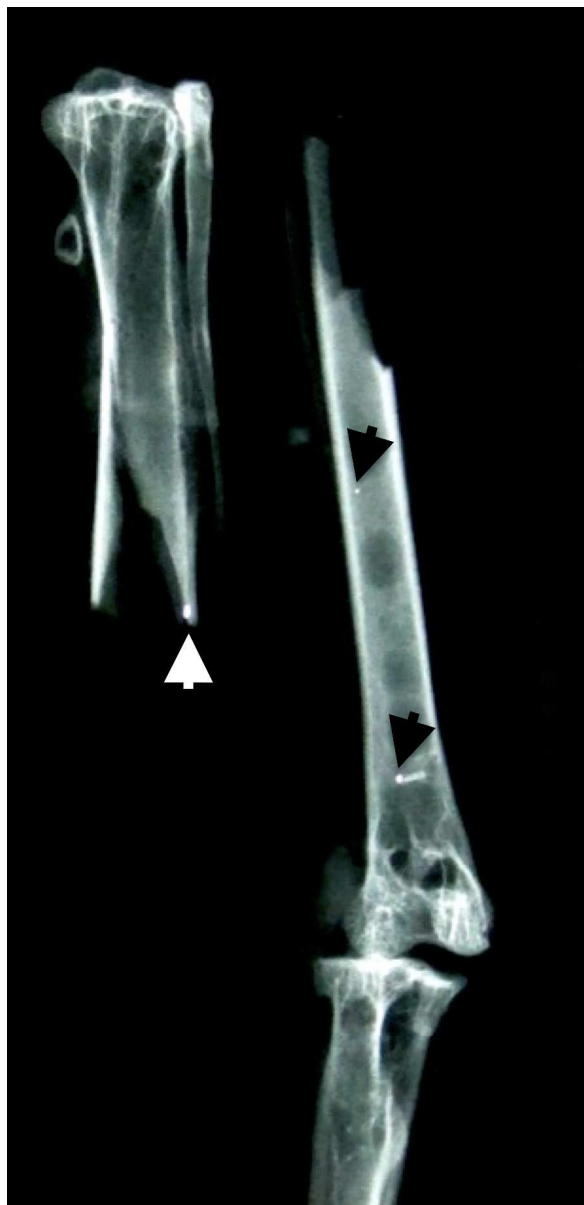
Lateral and cranio-caudal radiographs of the left and right leg (Ultralight 300; 50Kv, 60mA, 0.03s using mammography film) were taken (Figure 1). Three objects with metallic radiodensity were seen within or adjacent the fracture fragments. These objects were consistently located on both lateral and cranio-caudal views and using different radiographic cassettes.

Figure 1. Plain cranio-caudal radiograph of the left tibiotarsus and tarsometatarsus showing three radio-dense objects (white and black arrowheads).

The presence of the fracture of the left tibiotarsus and three foreign objects of a similar radiodensity to metal within the left tibiotarsus suggested this bird had been hit by a metal projectile and that the fracture was associated with the projectile's kinetic energy. The tail feather damage was consistent with acute trauma, such as shooting, fighting or a collision (pers. comm. Brian Etheridge, 18th July 2013). SEM-EDX of the radio-dense object embedding in the bone, and the associated damage, provided convincing evidence that one or more high-energy, predominantly lead projectiles caused the fracture. Alternative hypothetical causes of this fracture and the origin of the foreign objects (eg. blunt trauma, predation and/or scavenging behaviour) were thus rejected and we concluded the bird was shot. As there was no significant bone resorption or remodelling around the metal or adjacent bone, we inferred that the injury likely led to the rapid death of this hen harrier.

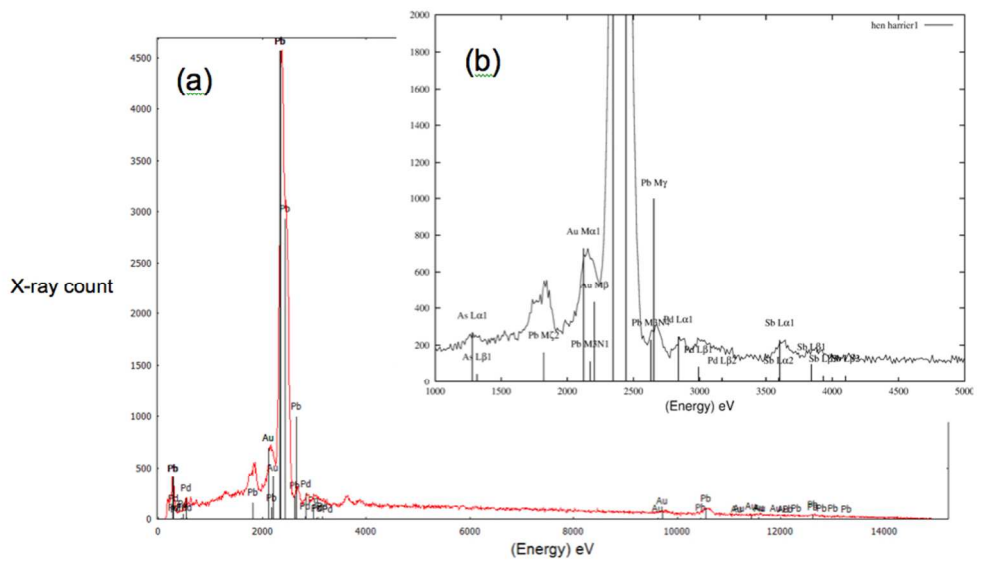
The proximal fragment of the left tibiotarsus was coated with a layer of gold-palladium to improve conductivity and reduce charge accumulation during scanning. Scanning electron microscopy (JEOL JSM-5500LV) of the largest radio-opaque object showed a deformed area of foreign material embedded in, and damaging, the bone (Figure 2). Selected areas were chosen for energy dispersive x-ray spectroscopy. The spectrum of energies emitted from the object initially revealed a high proportion of lead (Pb) and a smaller proportion of niobium (Nb).

Figure 2: Scanning electron micrograph of the foreign object (white) embedded in the proximal tibiotarsal bone fragment of the hen harrier (grey). The red square is the target for energy dispersive x-ray spectroscopy.
