A REALISTIC FULL CFRP RETROFIT OF RC BEAM-COLUMN JOINTS COMPARED TO SEISMICALLY DESIGNED SPECIMENS

Abstract

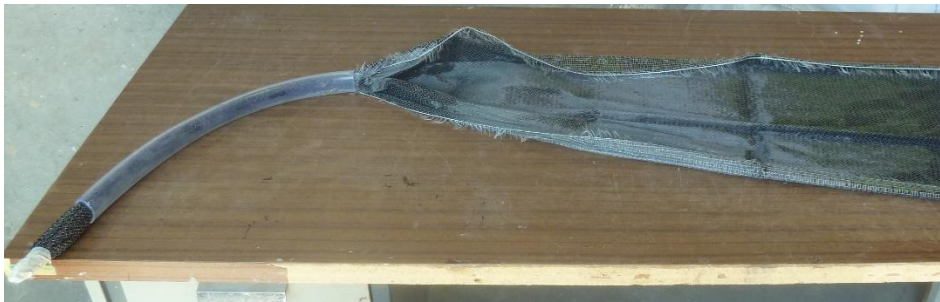
Fig. 3. FRP “strand”: rolled FRP sheet passed through plastic tube

1. Continuity of the longitudinal strengthening is required through the beam-column joint and this can be achieved by means of FRP “strands” (see Fig. 3).
2. For realistic specimens with slabs, a change in failure mechanism to comply with capacity design objectives can only be achieved by “selective weakening” of the slab, i.e. cutting through the slab reinforcement close to the joint. This does not affect the serviceability performance of the slab as the cuts are not in a zone of high moments under gravity loading.
3. Strengthening and confinement of the beams close to the joint is required for plastic hinge relocation within the beam and protection from plasticity spreading into the joint.
4. Joint strengthening is required when increasing the overall lateral capacity of the specimens.

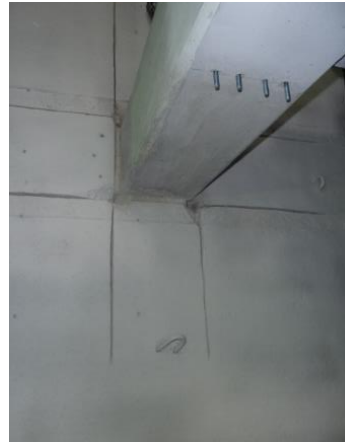
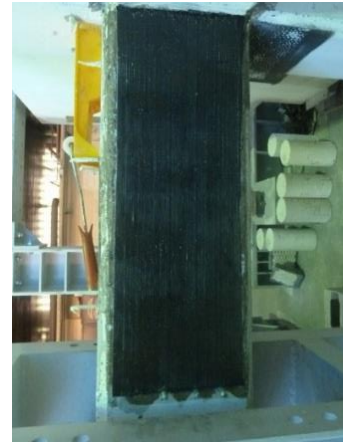
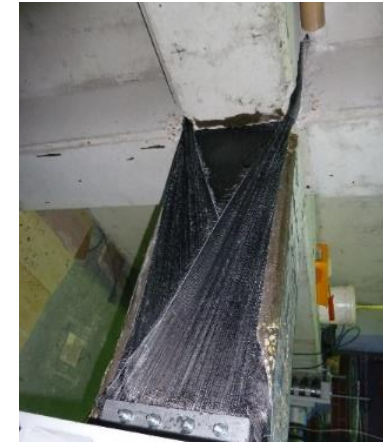
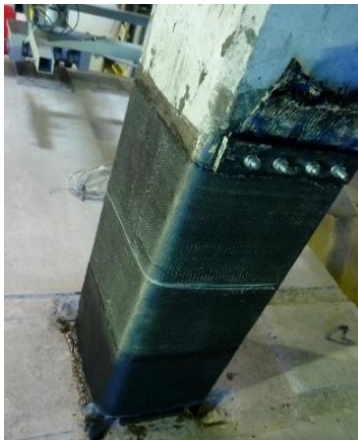
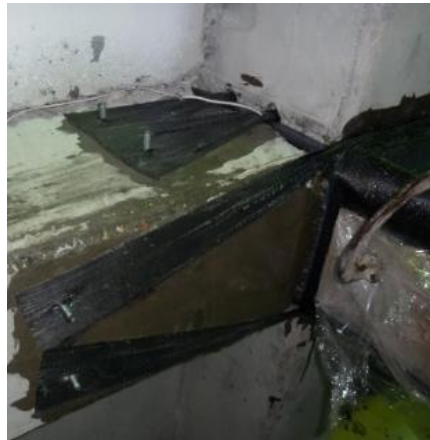
Schematic of retrofit RT-B-sw

Step 1: Selective weakening cuts and holes for FRP strands

Step 2: Application of a base layer of FRP on the column

Steps 3 & 4: Application of FRP strands through slab, splayed out onto columns

Step 5: Column confinement and shear strengthening

Step 6: Strengthening of beams and joint with FRP strands

Step 7: Application of strips of FRP for shear strengthening and anchorage in beams; additional anchorage with bolted steel plates

Fig. 4. Step-wise retrofit of specimen C1-RT-B-sw

The objective of retrofit scheme B-sw is to achieve a similar performance to a structure designed to modern guidelines (C-EC8). In particular, the retrofit aims to increase the strength of the sub-assembly to reach a level close to 80% of C-EC8, while achieving ductile failure by promoting the formation of a beam-sway mechanism with a plastic hinge forming in the beams, at one beam-depth (450 mm) from the beam-joint interface. To achieve this, the step-wise retrofit presented in Fig. 4 is proposed.

Following the design philosophy in Eurocode 8, FRP flexural strengthening of columns, as well as confinement and shear strengthening are applied to attain a strong-column/weak-beam mechanism. To achieve continuous flexural strengthening through the slab and joint, vertical FRP strands are used to connect the bottom and top column retrofit. In order to move the plastic hinge to the beam, away from the joint interface, next to FRP strengthening, selective weakening of the slab is performed by means of cutting the slab reinforcement in the potential plastic hinge zone.

The relative strength of the retrofitted members is evaluated by non-linear FE modelling and current guideline equations [11] in order to ensure the capacity of the retrofitted columns is higher than that of the beams by a factor greater than 1.3. From this evaluation, a total of six layers of vertical FRP over a length of 750 mm and three layers of horizontal strengthening are required for the columns, while two 100 mm wide strips are applied in the beams over a length of 450 mm. The transverse strengthening of the beams consists of 50 mm wide strips spaced at 75 mm and is applied as full wraps through holes in the slabs. Finally, as the specimen is designed to pre-seismic design codes, the joint shear capacity is very low and FRP strengthening of the joint by means of horizontal strands through its core is also provided. This consists of two 150 mm wide strips that are extended for 300 mm onto the beams for anchorage. All FRP sheets are additionally anchored using bolted steel plates to avoid end-debonding.

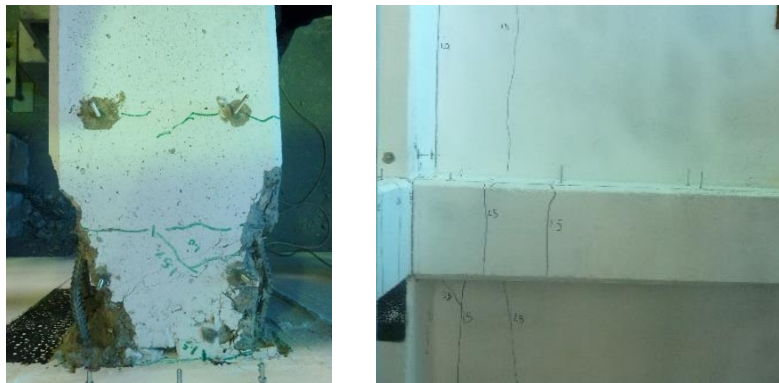
Fig. 5. Final damage state in C1; left: superior column, right: beam underside

The results for two control specimens are presented in this section. For C1, the specimen designed to pre-1970’s guidelines, a brittle failure mechanism dominated by plastic hinge formation and buckling of the superior column bars is observed. As shown in Fig. 5, very limited damage is observed in the rest of the specimen. In a full structure this type of mechanism would lead to a single-storey failure. Due to the contribution of the slab, limited rotation of the beams and no yielding of beam bars are observed. After plastic hinge formation in the column, the ultimate state is reached by concrete crushing and buckling of the column bars just above the column–slab interface. As expected for a non-seismically designed structure, a relatively low lateral capacity of 63.1 kN, as well as a very low ultimate drift (2.3%) and displacement ductility (3.6) are recorded for C1. As shown in Table 2, the inadequate seismic performance of the specimen is underlined by a very low energy dissipation (32.1 kN.m) and large post-peak softening, indicating a low residual strength.

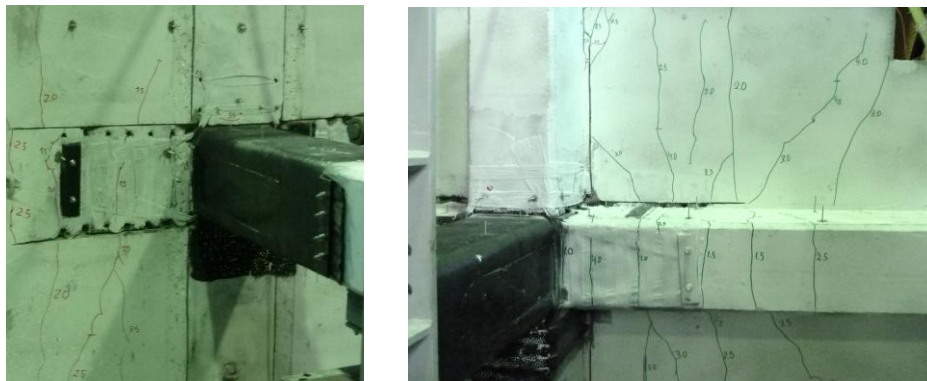
Fig. 7. Final damage state in C1-RT-B; left: column and slab, right: beam underside

The aim of the combined retrofit and selective weakening scheme (RT-B-sw) is to achieve a strength increase up to 80% of C-EC8, with a similar failure mechanism and ductility. As shown in Fig. 7, the envisaged hierarchy of strengths from the retrofit design is confirmed, with damage spread along the length of the beams and slab, similarly to C-EC8, and no damage in the columns for the retrofitted specimen. The continuous FRP strengthening of the columns allows a symmetrical rotation of superior and inferior columns, which hence prevents the brittle single-storey failure observed for C1. No debonding of the FRP is observed throughout the test, while partial rupture in the beam FRP strand is noticed towards the end of the test (at 5.0% drift). The maximum recorded strain in the vertical FRP strands is significantly lower than the debonding or rupture strain (0.19%).
