Neris, J., Santamarta, J., Doerr, S., Prieto, F., Agulló-Pérez, J. & García-Villegas, P. (2016). Post-fire soil hydrology, water erosion and restoration strategies in Andosols: a review of evidence from the Canary Islands (Spain). *iForest - Biogeosciences and Forestry*, 9(4), 583-592.

Post-fire soil hydrology, water erosion and restoration strategies in Andosols: a review of evidence from the Canary Islands (Spain)

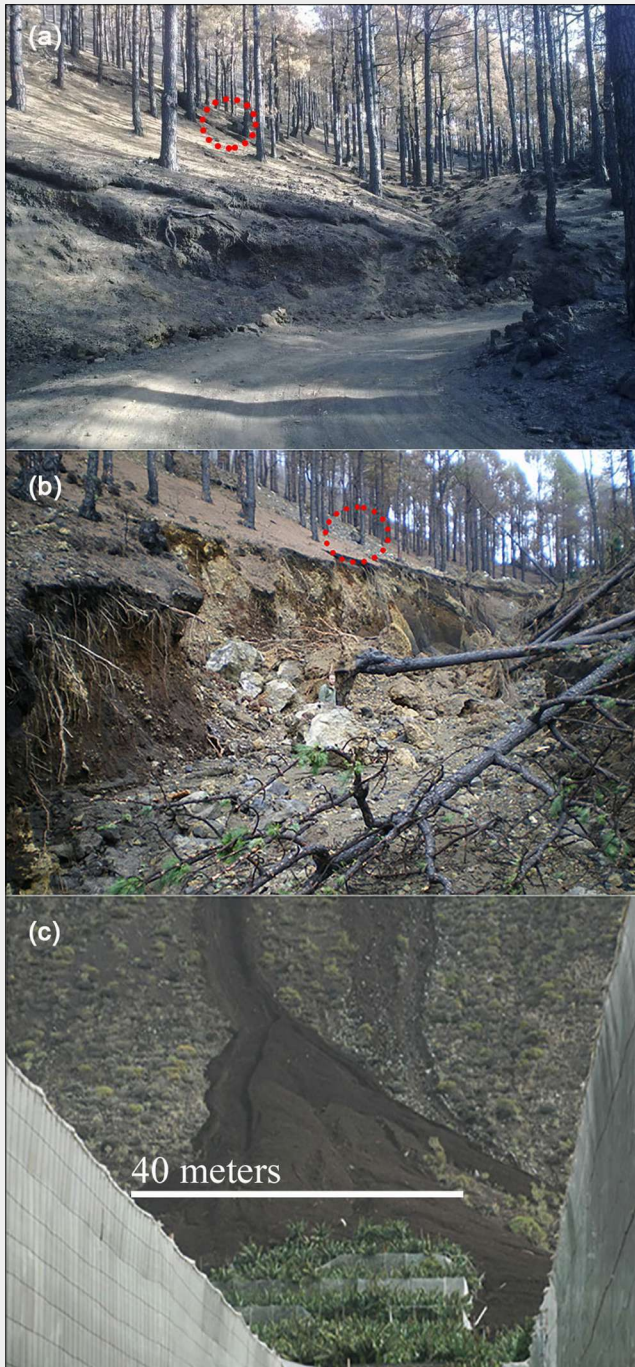
Fig. 2 - Landslides after the forest fire in La Palma (2009). Forest road before (a) and after (b) the torrential rains and subsequent landslides in 2009. Sediment deposition after the landslide affecting banana crops near the southern coastline of La Palma (c).

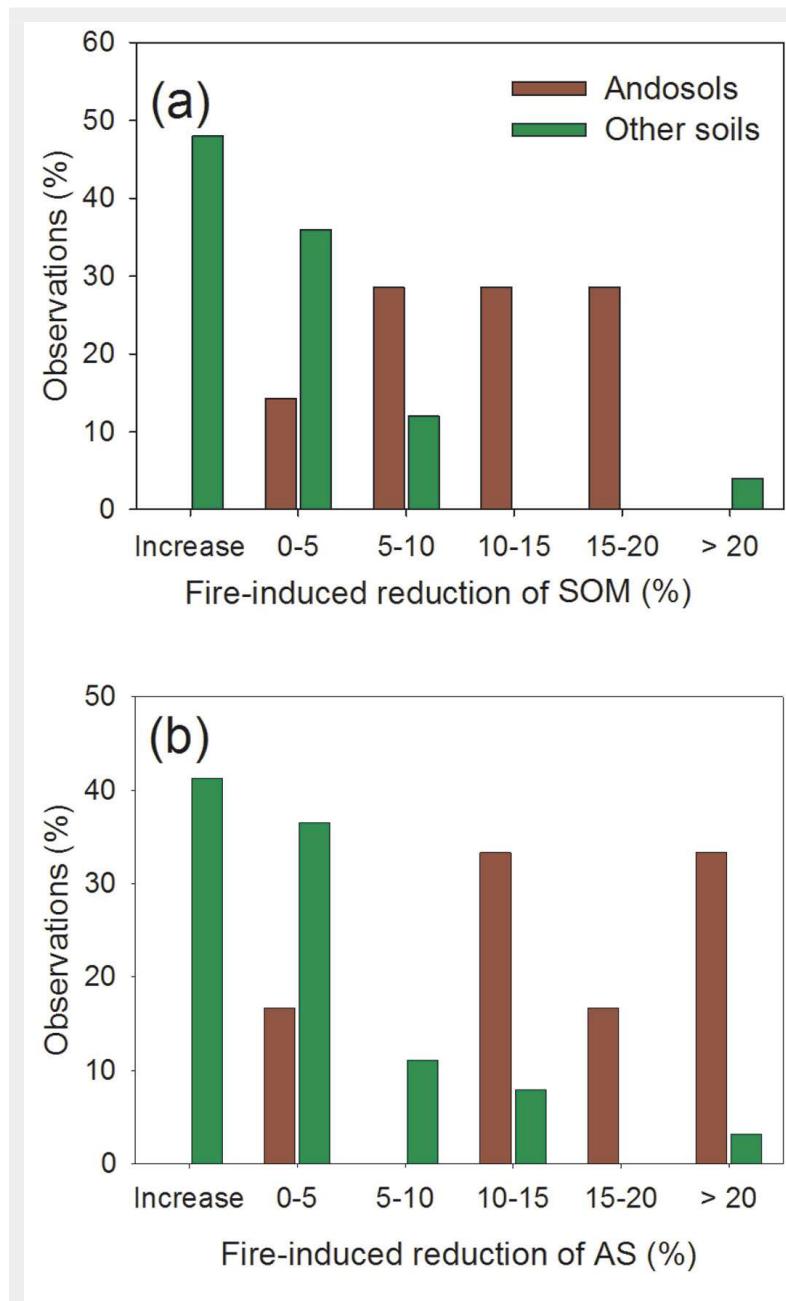
Fig. 4 - Comparison of the impact of fire on key soil properties in Andosols (red) and other soil types (green). Distribution of results reporting fire-induced reduction/increase in (a) soil organic matter (SOM: %) and (b) aggregate stability (AS: %) for Andosols (N = 7 for SOM and N = 6 for AS) and other soil types (N = 25 for SOM and N = 63 for AS) from published data. Values calculated as Unburned value minus Burned value. Data source: Andosols (De La Rosa et al. 2013, Morales et al. 2013, Neris et al. 2013b); other soil types (González-Pérez et al. 2004, Marcos et al. 2007, O’Dea 2007, Campo et al. 2008, Terefe et al. 2008, Are et al. 2009, Varela et al. 2010, Certini et al. 2011, Mataix-Solera et al. 2011, Badia-Villas et al. 2014).

Fire affects several properties of Andosols that are relevant to their hydrological and erosional responses. Andosols have shown a substantial decrease of aggregate stability (AS) after wildfire both in Canary Islands (Neris et al. 2013a) and South America (Morales et al. 2013), which can reduce their infiltration capacity and enhance erosional processes. Data published by the above authors shows that AS figures decreased more than 15% in half of the fire-affected Andosols studied, whereas 30% of those Andosols showed a decrease of AS exceeding 20% (Fig. 4b). In contrast, the decrease in AS after fire reported for other soil types rarely exceeded 15% (Marcos et

al. 2007, O'Dea 2007, Campo et al. 2008, Terefe et al. 2008, Are et al. 2009, Varela et al. 2010, Mataix-Solera et al. 2011, Badia-Villas et al. 2014 – Fig. 4b). According to Mataix-Solera et al. (2011) this is the typical response of soils such as Andosols, whose main binding agent is SOM (Candan & Broquen 2009). As reported by several authors (De La Rosa et al. 2013, Morales et al. 2013, Neris et al. 2013a, 2014), Andosols' SOM can be severely reduced and its chemical composition altered by fire. According to the aforementioned authors, fire-induced SOM reduction ranges from 20 to 4 g 100 g⁻¹ and > 50% of the fire-affected soils evaluated showed a decrease in excess of 10 g 100 g⁻¹ (Fig. 4a). Contrastingly, the reduction of SOM in non-volcanic soils rarely exceeds 5 g 100 g⁻¹ (González-Pérez et al. 2004, Varela et al. 2010, Certini et al. 2011 – Fig. 4a). Additionally, several authors have reported a significant decrease in AS and the alteration of soil porosity of volcanic soils under severe drying processes (Buytaert et al. 2002, Woignier et al. 2008, Dorner et al. 2010). The combined impact of fire on both SOM and soil mineralogy could explain the considerably high reduction of AS exhibited by Andosols.

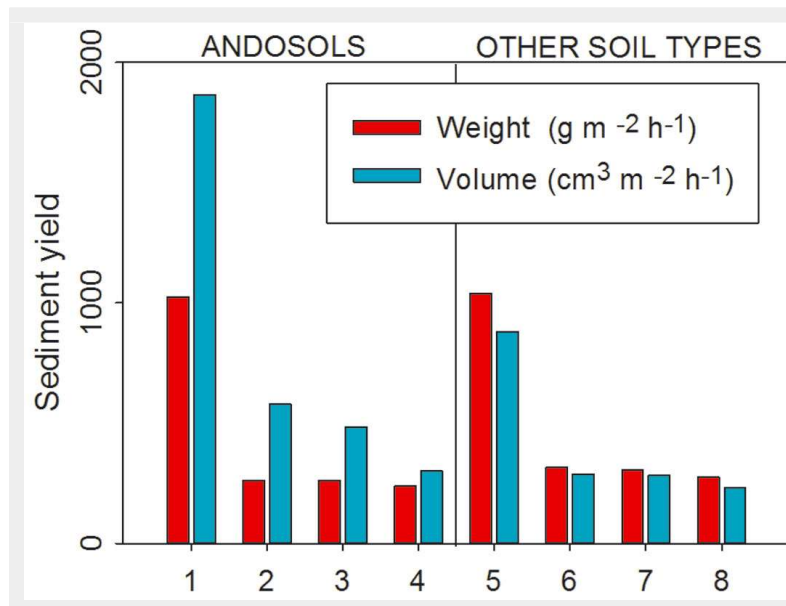
Fig. 5 - Comparison of post-fire sediment yields in Andosols and other soil types reported using rainfall simulations. Yield measured in weight (red) and volume (blue) for Andosols (left) and other soil types (right). Data source: (1): Morales et al. 2013; (2): Neris et al. 2013a; (3): Neris et al. 2013b; (4): Poulenard et al. 2001; (5): Woods & Balfour 2008; (6): Pierson et al. 2009; (7) Cerdà & Doerr 2008; (8): Woods & Balfour 2008.

dosols follow the generally reported trend of fire-induced enhancement of soil loss, with figures from rainfall simulation experiments ranging from 30 to 2000 g m⁻² h⁻¹ depending on fire severity and rainfall intensity (Poulénard et al. 2001, Morales et al. 2013, Neris et al. 2013a). Most authors hypothesize that this general response may be due to: (i) the increase in runoff; (ii) the decrease in soil cover and the protective effect of vegetation and organic layers (forest floor); and (iii) the reduction in aggregate stability (Shakesby & Doerr 2006). For Andosols, Poulénard et al. (2001) attributed the increase in soil loss to the rise in runoff and decrease in aggregate stability causing surface sealing. Neris et al. (2013a) hypothesized that the reduction in structural stability and the loss of soil cover are the key factors in the erosional response, as no significant changes were found in infiltration after the fire. Morales et al. (2013) highlight three factors (runoff, soil cover and aggregate stability) as being responsible for soil loss increase. Additionally, both Morales et al. (2013) and Neris et al. (2013a) suggest that fire severity plays a key role in the erosion process as it greatly influences the soil cover and, thus, the protection against raindrop impact and detachment by runoff in the post-fire period. Soil erosion from rainfall simulation experiments by Neris et al. (2013a), Poulénard et al. (2001) and Morales et al. (2013) for fire-affected Andosols is comparable to that reported for other soil types and environments (Benavides-Solorio & MacDonald 2001, Cerdà & Doerr 2008, Woods & Balfour 2008, Pierson et al. 2009). However, it has been demonstrated that Andosols' low bulk density is half or even one third of that of other fire-affected soil types (Neris et al. 2013a). Therefore, the expected volumetric soil loss can be considerably higher and its impact downslope can be catastrophic (Fig. 5). Regarding the erosion mechanism, Andosols show a distinctive behavior. According to previous studies, the erosion of this soil type is not a consequence of the dispersion of clay and transport of primary particles, but occurs mainly by detachment of small, highly water repellent, low bulk density, stable aggregates and their transport by flotation on the runoff (Poulénard et al. 2001, Rodríguez Rodríguez et al. 2002, Morales et al. 2013, Neris et al. 2013a).

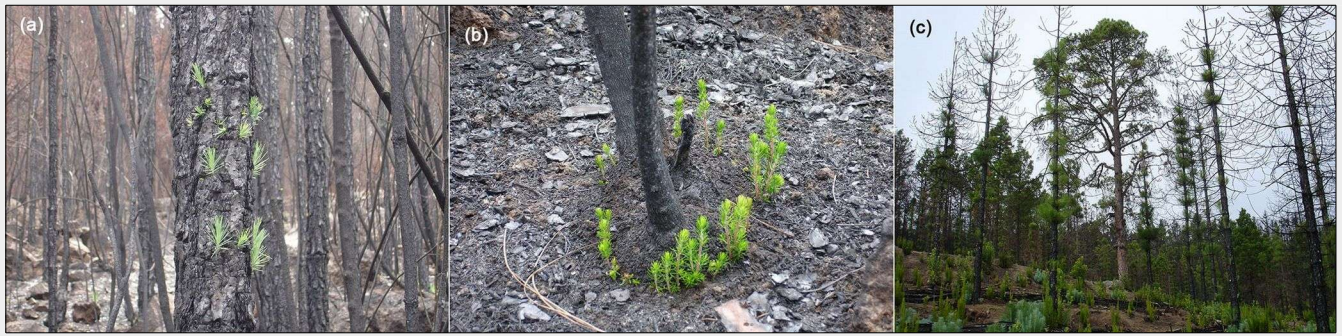
Fig. 6 - Examples of sprouting behavior of forest species after a wildfire. *Pinus canariensis* (a) and *Erica* sp. (b) sprouting 3 months after the forest fire. Forest recovery 1 year after the forest fire (c).

in forested areas that experience frequent fires (Fig. 6). *Pinus canariensis*, the endemic pine species in the Canary Islands, shows several fire adaptations including thick bark and buds, long needles, tall growth habit and sprouting capacity (Climent et al. 2004). Additionally, one of the main genus present in the Canarian rainforest, *Erica*, also exhibits high sprouting capacity after fire (Lloret & Vila 2003). According to the aforementioned agencies, the fast recovery after fire makes reforestation unnecessary. Instead, silvicultural practices on the affected area are carried out, including the removal of dead individuals and the pruning of charred branches of surviving trees to reduce infestation threats and strengthen their recovery (Fig. 7). However, recent observations after a forest fire that affected La Gomera in 2012 suggest that these silvicultural practices could delay vegetation recovery after fire. In order to

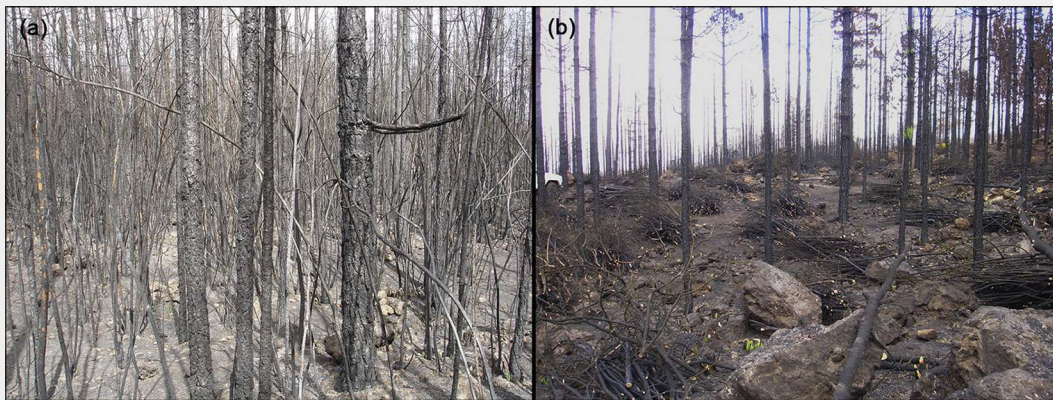
Fig. 7 - Example of restoration works after the large forest fire of 2007 in Tenerife. Fire-affected forest area before (a) and after (b) silvicultural practices.

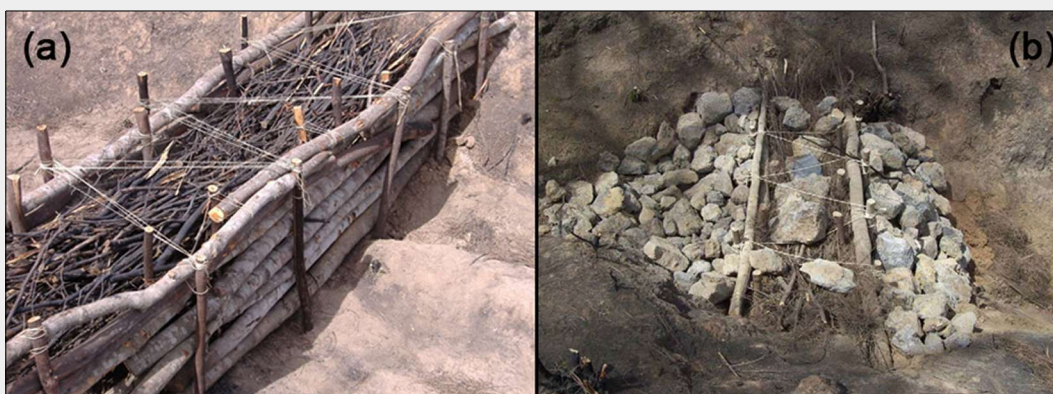
Fig. 8 - Construction process of the rock and biomass mixed dam. Trench constructed and filled with debris from the silvicultural works (a) and reinforced by rocks (b).

In addition to the traditional channel treatments, an innovative structure adapted to local conditions, called rock and biomass mixed dam, was developed after a forest fire in Tenerife that burned 17 000 ha in the summer of 2007 (Ministerio de Medio Ambiente y Medio Rural y Marino 2008). Due to the magnitude of the wildfire and the resulting risks, the structure was designed to be low-cost, easy and rapid to be implemented to reduce hydrological risks. The mixed dam is a temporary structure that combines different mitigation techniques such as contour logs, contour trenches and rock dams. Similarly to other channel treatments, its main objective is to reduce water velocity and enhance infiltration and sediment deposition. The mixed dam consists of vegetal debris used as vertical stakes (mainly burned logs

of *Erica* sp. and *Myrica faya*) and horizontal logs (mainly from burned *Pinus canariensis*) and biodegradable rope to tie the stakes and logs together as a trench and to anchor the whole structure to adjacent trees. The trench is reinforced on the outside by the rock slope to gain stability (less than 50% slope angle) and filled on the inside with vegetal debris obtained from silvicultural work and topped again with rocks (Fig. 8). Its dimensions vary depending on the channel width, although always ranging from 1 to 2 m in height and 8 to 10 m in width. A prediction of the maximum water flow and water level expected in the post-fire period are essential to design these structures. Additionally, the rock density, the resistance to flexion of the wood stakes and logs, the resistance reduction coefficients and the load increase coefficients for both permanent (structure weight) and temporary loads

(water flow) are taken into account in their design. The distance between these structures in a channel is determined according to the structures' height and the channel slope angle (Tardío Cerrillo & Caballero Serrano 2009).

This structure is usually used as a principal treatment in ephemeral or small-order channels and as a secondary treatment complementing rock dams and gabions in larger channels. Due to the biodegradable nature of most of their components, these structures can also facilitate colonization by plants (Tardío Cerrillo & Caballero Serrano 2009 - Fig. 9). This innovative structure has several useful features: (i) it reduces the channel slope and, thus, water speed and detachment capacity; (ii) promotes infiltration and sedimentation; (iii) economizes resources and time by using on-site material for its construction; (iv) enhances the colonization of vegetation due to the biodegradable nature of most of its components. The advantages attributable to this mixed dam are: (i) notable sediment storage capacity, mainly large material as vegetal debris or rocks; (ii) high adaptability of the design and the components used to the environment conditions; (iii) notable vegetation recovery and colonization of the channels due to the nature of its components.

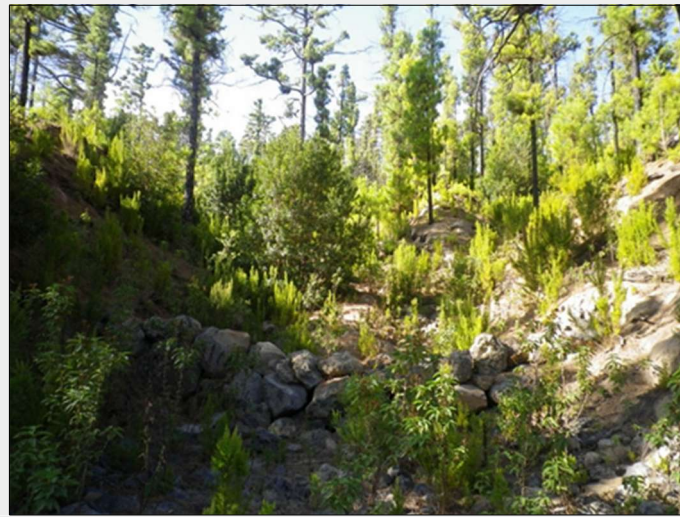
Fig. 9 - A mixed dam structure built in Tenerife after the large wildfire of 2007, colonized by forest species one year after its construction.

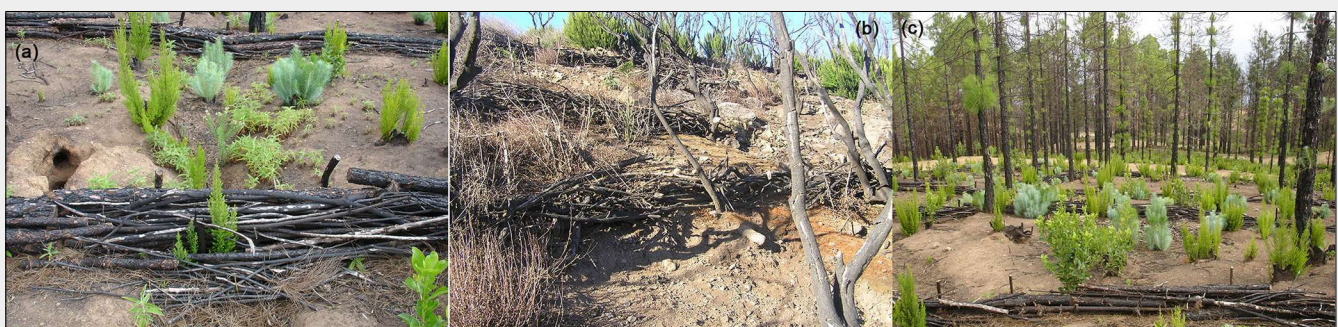
Fig. 10 - Example of surface treatments after the large wildfire of 2007 in Tenerife. Small dams built using on-hand logs and branches.

Regarding hillslope treatments, the construction of erosion barriers to reduce runoff and sediment transport is the most used mitigation action in the Canary Islands. It includes contour-felled logs and small dams constructed using vegetal material, mainly small burned logs and branches obtained from the silvicultural work (Fig. 10). Due to budget constraints, no monitoring programmes have been put in place to evaluate the effectiveness of these treatments for Andosols. However, erosion barriers, widely used at the beginning of the century as an effective on-site control of runoff and erosion in Spain (Fernández et al. 2011, Badia et al. 2015, Ferreira et al. 2015) and elsewhere (Raftoyannis & Spanos 2005, Robichaud et al. 2008, Myronidis et al. 2010, Ahn et al. 2013, Aristeidis & Vasiliiki 2015), have been replaced lately by dry mulch treatments by land managers. This treatment aims to provide cover to the mi-
