Geotechnical properties of gullyng in Tomsk Oblast

Abstract. The article deals with causes, conditions and factors of gullyng in Tomsk Oblast, the case of site Grodnenskaya. A nuclear-power station was planned to be constructed in Closed Administrative Territorial Unit Seversk, which led to geotechnical investigation of the area to study the geological processes developing there. The investigation included reconnaissance traverse of the area, geological and geomorphic descriptions, and sampling. The area and percentage of the territory affected by the geological processes were estimated. As a result, it was proved that the geological processes of the area are conditioned by surface water activity leading to gullyng and river erosion, and by both ground water and surface water activity resulting in bog formation. It appears that gullyng is caused not only by natural factors but also by technogenic ones.

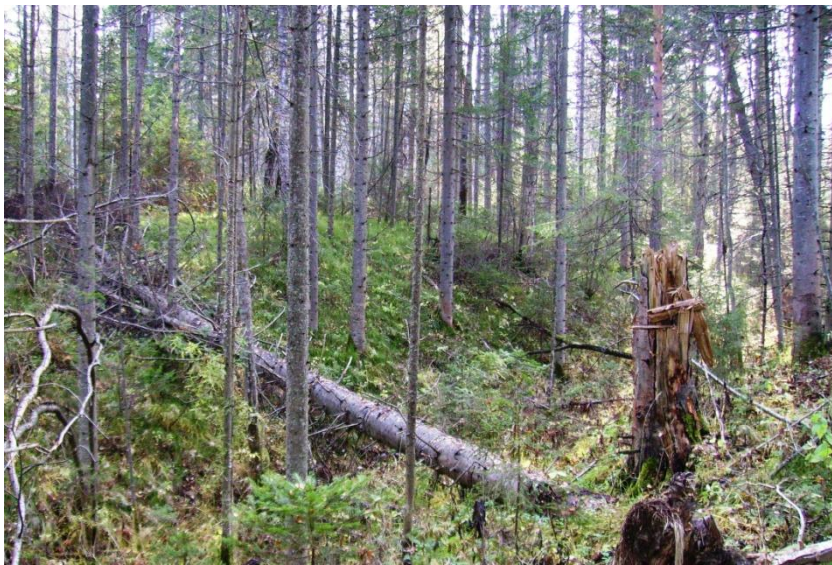
Figure 1. The gully on the studied site.

Gullying is the most developed geological process on Grodnenskaya site, which occupies almost 40% of the site [2] making the areas unsuitable for construction (fig.1).

The gully network can be classified as highly eroded [3]. A developed gully network with both dry and wet gullies spreads from the top of the site down toward the river valleys. Most of the gullies are grass-covered and forested; however, there are rare cracks and failures of the sides, which means that the erosion still continues.

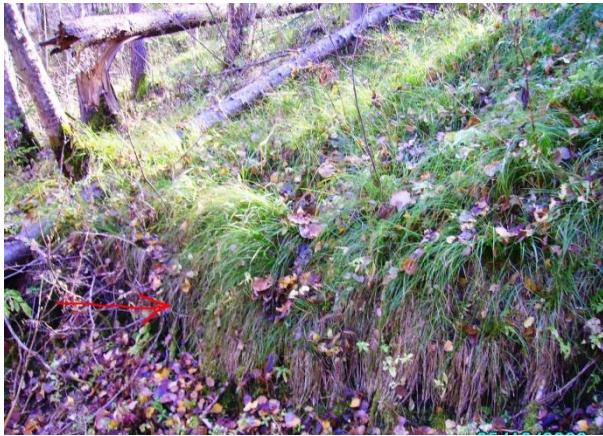
Figure 2. Slumping.

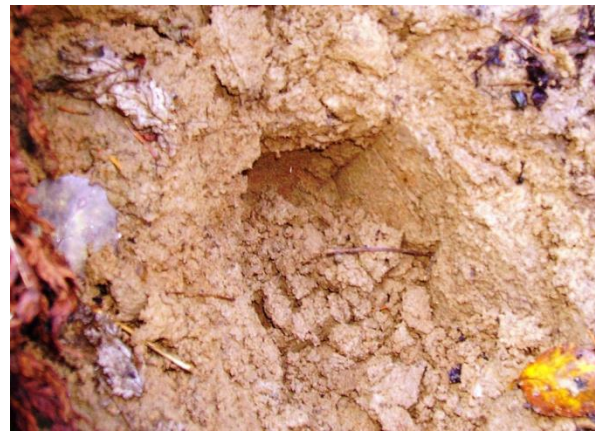
Figure 3. Sand clay in the gully side.

The gullies of the studied area are of different size: from 2 to 43 m wide, with 0.5-7.0 m deep. They are at different stages of development: from water galls and developing gullies to grass-covered and forested ravines. The length of the gully network is 1.5 km and more. The side slopes are usually covered with grass and subdued. The longitudinal section has the form of a smooth curve. The cross-section is of U-type. The slopes of gullies and ravines are covered with birch, aspen, abies, and small spruce (up to 40 cm high). There are a lot of windthrown trees. The sides are covered with thick grass: sedge, horsetail, fern, and etc. There occur small hills of sedge 7 cm high and of a diameter up to 25 cm, they are covered with moss. The side slopes are prone to slumping, cracks and paps (fig. 2). As a rule, a temporal flow cuts the gully bottom. The observed fresh cut, 40-105 cm wide and 15-30 cm deep, continues to develop the gully. Sand and sand clay are exposed in the cut (fig. 3).
