OIL AND GAS TRANSPORTATION AND STORAGE

Influence of installation elastic bending on stress-strain state of pipeline aboveground passages in mountains

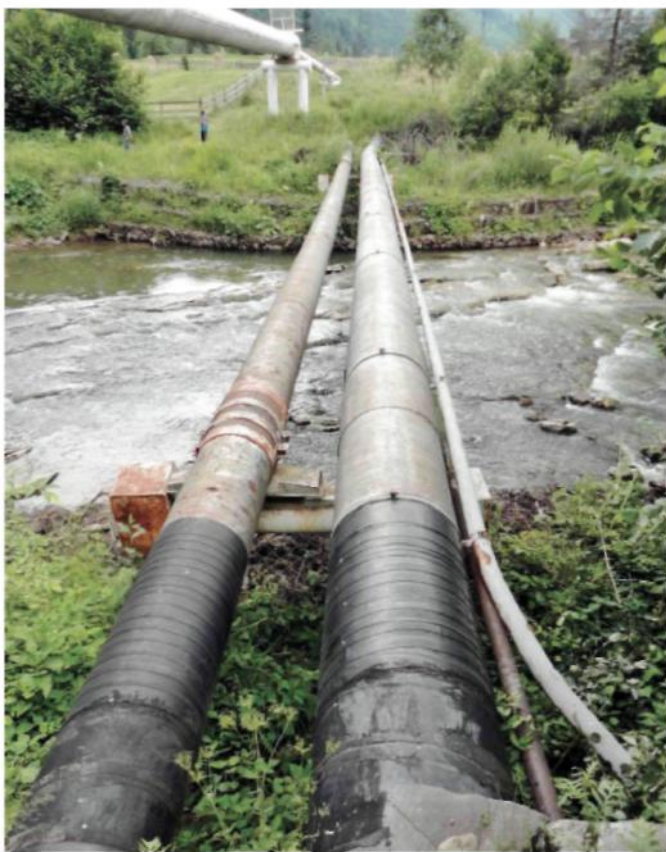
Fig. 1. Overall view of aboveground passages of “Druzhba” oil pipelines through the Oriava river

The aboveground passages of both girders of oil pipelines were constructed according to the balk structure with two intermediate concrete supports located not far from the passage edges (Fig. 1). On the edges the pipelines lean directly against the ground.

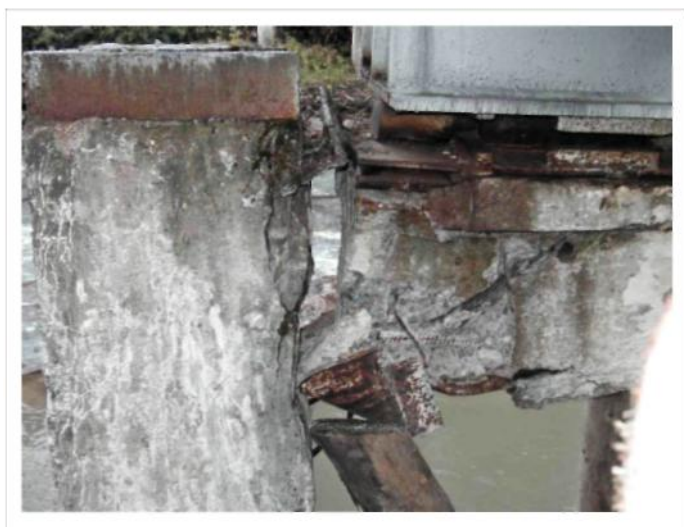
Fig. 2. Destruction of the mounting group of the second oil pipeline support $D = 720$ mm

After long-term operation (33 years), destruction of the rear cap and mounting group was revealed up to the riser of the second (along the oil flow) U-shaped concrete support (Fig. 2) installed in 1961 during construction of the “Druzhba-2” oil pipeline. The aboveground section of the “Druzhba-2” oil pipeline was laid onto this support in August 1969.

The main reason for destruction of bearing elements of the supports of the abovementioned objects is their overloading by the forces giving rise to elastic bending of the pipe in the vertical plane as a result of essential elevation of the support points over the designed height during construction of the “Druzhba-2” oil pipeline. It is evidenced by the downshift of the pipeline rider with the diameter of 720 mm connected with destruction of the mounting groups in relation to the initial position after the installation one of about 180 mm.

Destruction of the support as a result of gradual development of cracks occurred during a long period of time and began with breakage of welded joints made of the elbow of the cap sills to which the base plates of aboveground pipeline frames were welded. Growth of cracks can be explained first of all by seasonal changes of the pipe temperature with increase of the loading affecting the support at extreme temperatures, especially during stoppage of oil pumping.

In order to renew the bearing capacity of the supports, the top part of the concrete risers was implanted by the metal with the width of 12 mm, the destructed concrete girders were replaced by the metal ones taken from the pipe and channel beam which were installed below the previous location of the concrete girders (Fig. 3), which allowed significantly decreasing of operating loads onto the supports. The result of measurements of the loading onto the girder of the first and the second supports of the pipeline with the diameter of 720 mm showed that they made up accordingly 90.5 and 99.0 kN.

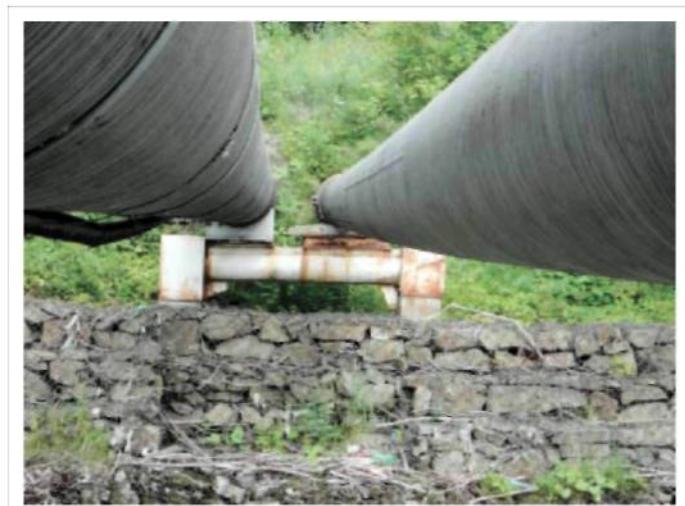
Fig. 3. Overall view of of the first (along the oil flow) bearing after repair.

case of the investigated aboveground passage (see Fig. 3). In addition, it should be noted that on this section of the route the oil pipeline is operated under relatively low pressures (< 1.5 MPa).

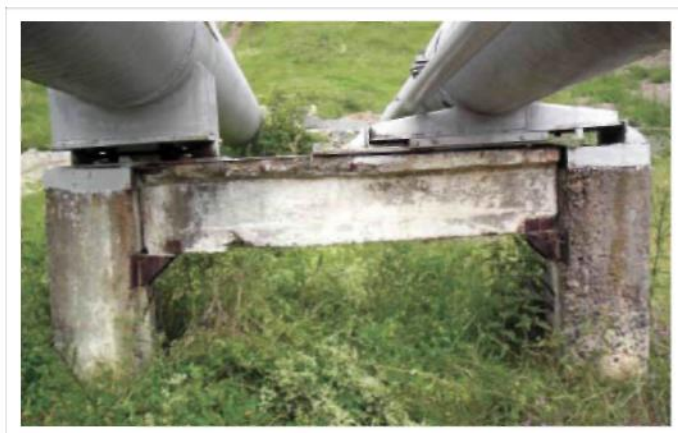
Fig. 5. Overall view of the mounting group of the oil pipeline with the $D = 720$ mm, whose frame is leaned onto the riser and girder.

It can be explained by location of the essential portion of the supporting frame immediately above the riser (Fig. 5), and, correspondingly, the girder mounting group undergoes considerably lesser stresses as compared to location of the frame only above the girder, as we can see it in the
