## Coastal Risk Mitigation by Green Infrastructure in Latin America

Silva, Lithgow, Esteves et al., 2017. Coastal risk mitigation by green infrastructure in Latin America. *Proceedings of the Institution of Civil Engineers: Maritime Engineering* (accepted on 14 March 2017), <http://dx.doi.org/10.1680/jmaen.2016.13>.

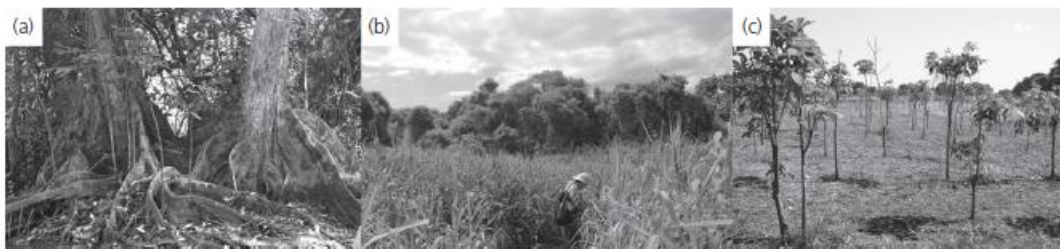
**Figure 2. (a) View of a swamp dominated by *Pachira aquatica*, (b) an area within the swamp covered with grasses, including *Leersia* spp., favoured by cattle and (c) the same area planted with young *P. aquatica* trees, during the dry season**

In 2015, a project was designed to restore the original tree cover of the flooded forest by planting *Pachira aquatica* (Figure 2). The main aim of the restoration was to recover the flood mitigation benefits of the wetland by improving vegetation and soil characteristics, such as organic matter and porosity. Thirty hectares were planted with a survival rate of over 70% of the trees. The project has been financed by the National Forestry Commission with an investment of 150,000 US dollars.

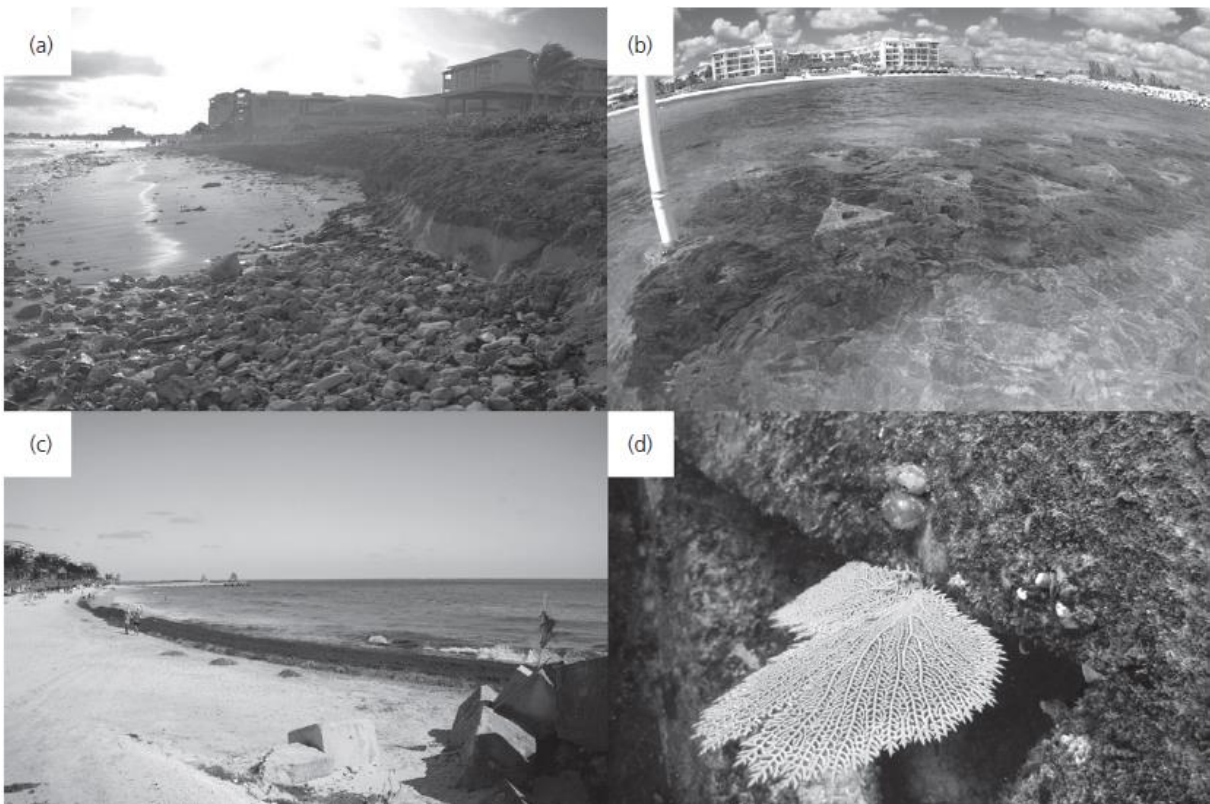
**Figure 5. An artificial reef improves coastal protection. (a) Erosion in hotel grounds, (b) prefabricated concrete structure, (c) seagrass crisis and (d) coral colonies established on the structure after 5 years**

The reef was constructed 120 m offshore (Figure 5b) and made of prefabricated concrete elements, known as Wave Attenuation Devices (WAD©), approved by the Environmental Protection Agency (EPA). The spatial design was established, based on small scale laboratory tests (Burcharth, et al., 2015) at the Coastal Engineering Laboratory of the National Autonomous University of Mexico (UNAM for its initials in Spanish). Five years later, the structure had contributed to the recovery of a wider beach, with a natural cycle of growth and retreat, and a large number of fish and coral species from the Mesoamerican Reef

had colonised the structure (Figure 5-d). The reef colonisation experienced a temporary decline in 2015 due to a substantial regional increase in *Sargassum*. A variety of brown seaweeds normally float freely in the ocean and occur naturally in small quantities, representing an important element of beach stability and providing habitat to several species. However, in 2015, some *Sargassum* species consolidated on large, island-like, floating mats which changed the physicochemical properties of the sea water (PH, water transparency etc.), washed ashore and affected tourism. Since then the reef system has been recovering its biological richness without any human intervention.
