Theses and Dissertations

# A meta-analysis of corrosion studies for Maritime Patrol and Reconnaissance Aircraft (MPRA)

**A META-ANALYSIS OF CORROSION STUDIES FOR  
MARITIME PATROL AND RECONNAISSANCE  
AIRCRAFT (MPRA)**

September 2016

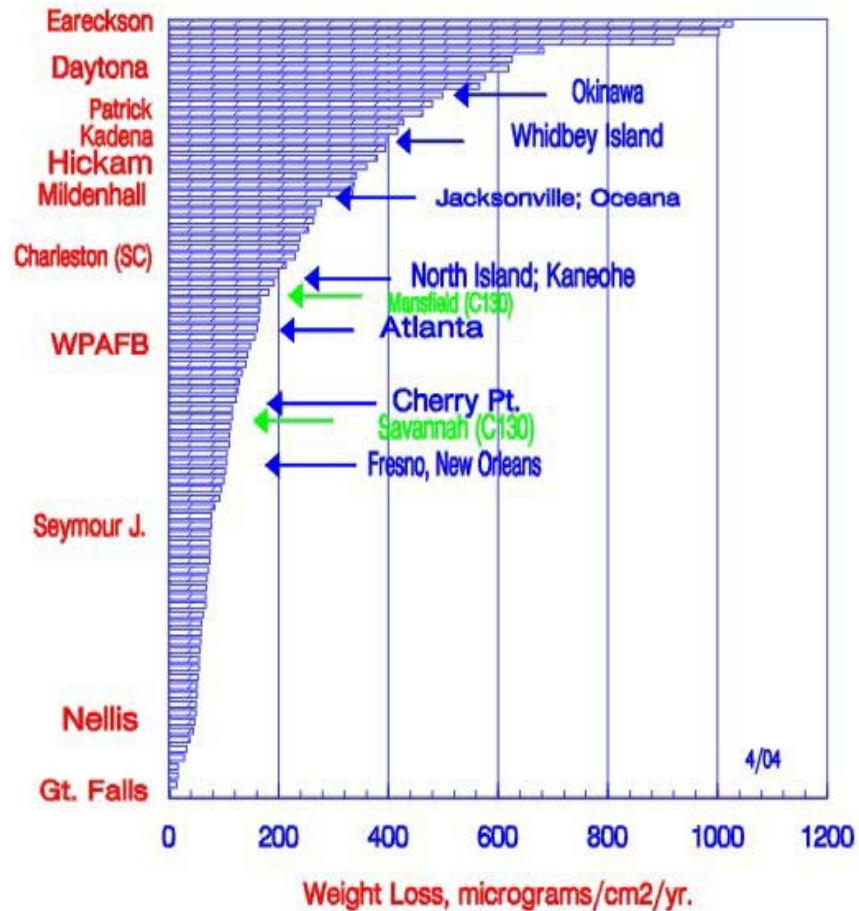
Figure 2. Corrosive Severity Distribution for Military Bases World-Wide (Based on 1 Year Weight Loss Values for 6061 T6 Aluminum). Source: Abbott, Columbus, and Beals (2009, 3).

Abbott and Kinzie (2007) conducted a series of tests in the P-3 Wash Rinse Interval Study. The results were reported in the “Effects of Wash Rinse Intervals on Corrosion: Early Results of a Ground Based Study.” Their data clearly demonstrated “that there was no significant difference in the advancement of corrosion from extending P-3 wash intervals from 28 to 112 days.” These findings provide a firm basis supporting the extension of P-3 wash intervals fleet-wide. Further studies and analysis may extend aircraft wash intervals for other types of naval aircraft as well. The Abbott and Kinzie (2007) aircraft wash interval study consisted of 14 P-3 aircraft. The intent of this study was to maintain seven aircraft at the standard 28-day wash interval. The other seven were extended to 112 days. Figure 2 shows the “dispersal of corrosion harshness detected by sensors mounted in strategically located areas measured as “Environmental Severity Index ESI” for military bases Jacksonville, Whidbey, and Kaneohe Bay (Abbott, Columbus, and Beals 2009, 10–14).

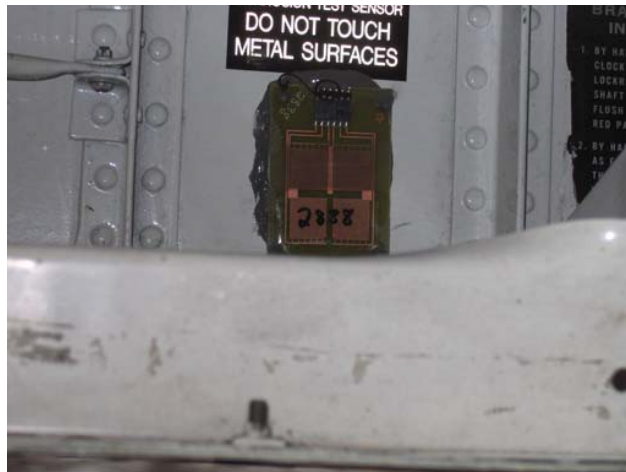
Figure 3. Sensor Located in NG. Source: Abbott, Columbus, and Beals (2009, 4).

Corrosion sensors were attached in 10 locations on each aircraft. This attachment was required because corrosion exposure and build up vary along the outer mold line of the aircraft. Thus, each corrosion sensor provides a recorded corrosion severity plotted as an out values, which are important to observing corrosion severity levels over time. Figures 3, 4, and 5 are photographs of the sensor installations at three different locations. Seven of the 10 locations were considered a must to evaluate as they are very susceptible to corrosion build up. The landing gear wheel wells were the most susceptible to moisture and exposure to corrosive contaminants.

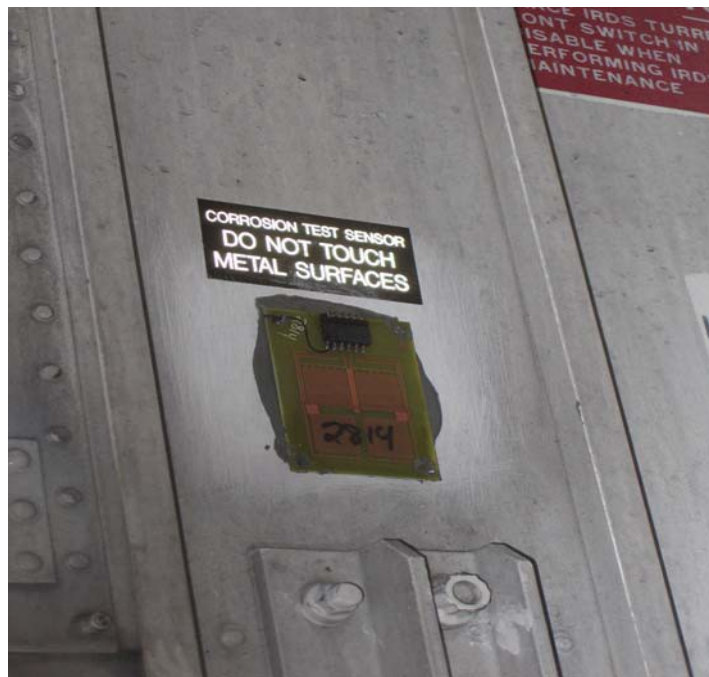
Figure 4. Sensor Located in MLG. Source: Abbott, Columbus, and Beals (2009, 4).

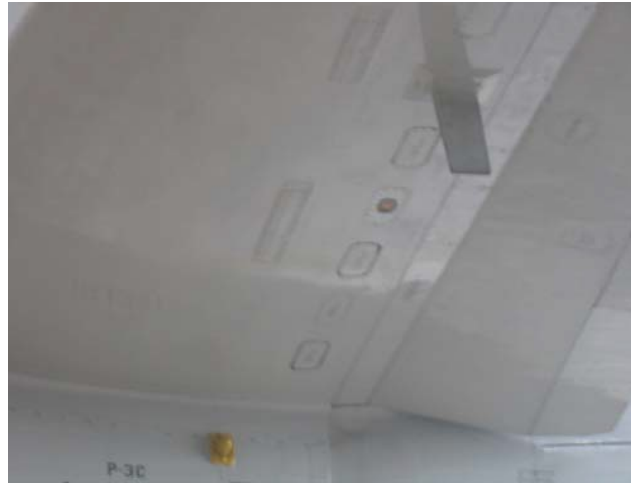
Figure 5. Sensor on Access Panel in Lower Surface of Left Horizontal.  
Source: Abbott, Columbus, and Beals (2009, 5).

Additional sensors were mounted on external surfaces of the P-3 aircraft. All sensors functioned properly and there was no loss of sensors or data on any of the aircraft.

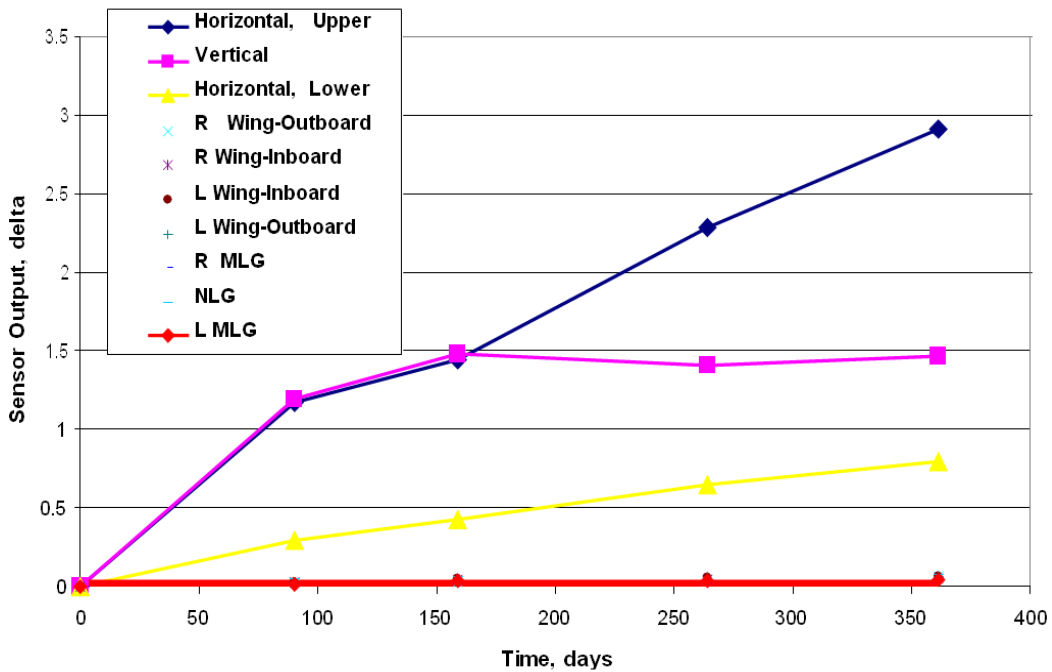
Figure 6 displays the sensor outputs for P-3 BUNO 159513 based at NAS Jacksonville FL. The sensors clearly illustrate high corrosion levels for the horizontal upper surface and the vertical surface over time. The sensor outputs for the horizontal lower surface are moderate but increasing over time. This type of corrosion sensor data from numerous P-3 aircraft stationed at various bases will be very helpful in generating resource loaded schedules to optimize depot maintenance requirements. The essence of the study is that aircraft parked outside in the elements at bases within coastal areas with higher humidity have higher corrosion sensor values.

Figure 6. Sensor Output for Locations on BUNO 159513, Based at Jacksonville. Source: Abbott, Columbus, and Beals (2009, 6).

The “shielding effect,” which is suspected in Figure 6, is a good example of how variances can exist. For example, areas of the aircraft, which are located within natural shadow zones, have lower corrosion sensor outputs. Aircraft stored in hangers for extended periods of time also exhibit the same shielding effect. The results of shielding

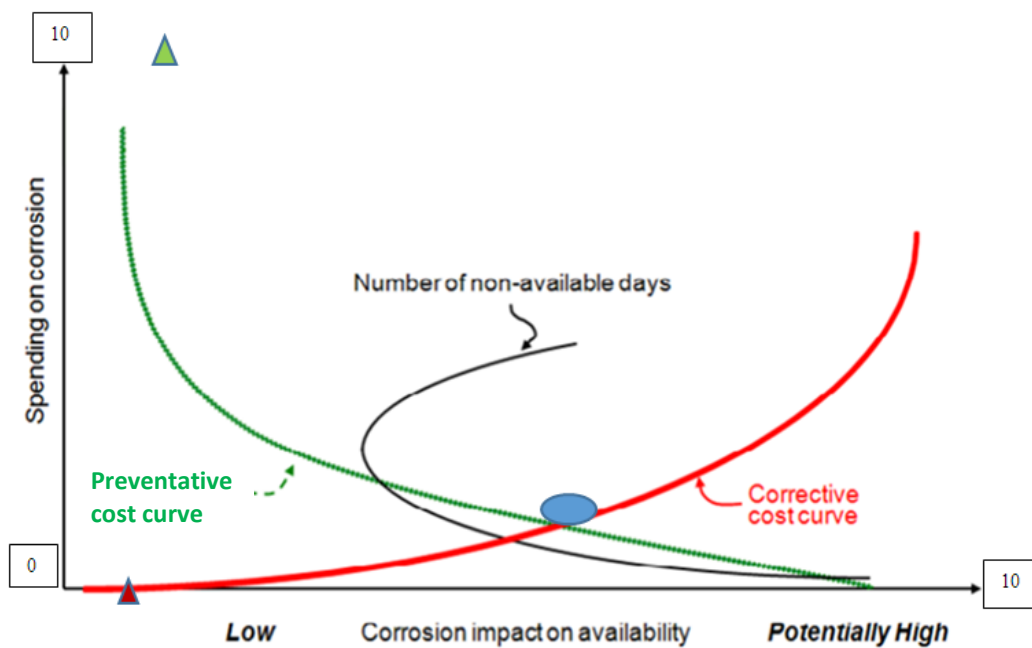
Figure 9 illustrates the delicate line of balance between corrosion correction and preventive cost. If too much corrosion prevention is performed, it could result in high labor hours and a reduction in the number of aircraft available for tasking. Too little corrective maintenance actions could cause an overall negative impact on airworthiness. The relationship between corrosion prevention and treatment cost almost seem to be inversed. The more funds dedicated to one, the fewer remain for the other. However, one other

constraint must be considered, and it is readiness. Therefore, a balanced optimized approach seems to be the most desirable. The MPRA preventative corrosion man-hours for January 2012 through December 2013 were 120,000. The corrective man-hours for MPRA corrosion for the same period are approximately 13,333 man-hours. As illustrated in Figure 9, a more optimal solution is to reduce corrosion prevention hours in areas the data supports, thus balancing the preventative vs. corrective costs. For example, the 120,000 preventative corrosion man-hours are represented on the plot as the green triangle. The 13,333 treatment corrosion man-hours are plotted as the red triangle. The blue oval represents an optimal solution. Therefore, decreases along the preventative cost curve saves funding, while increases along the corrective cost curve can cause increased spending.

Figure 9. Adapted from Herzberg Preventative vs. Corrective Cost Curve. Adapted from Herzberg et al. (2011, 1–5).

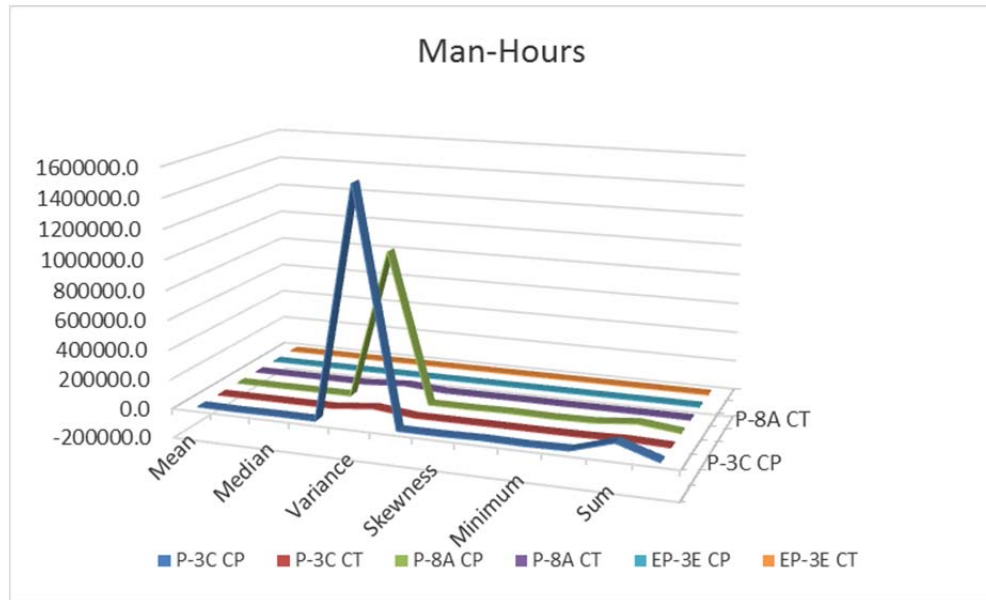
Figure 10 exemplifies the total corrosion man-hours across all MPRA-type model series aircraft. As expected, the aging P-3C has the highest number of corrosion man-hours. However, it appears that corrosion activities are trending downward. EP-3E and P-

8 are fairly stable with P-8A having a significant spike increase from September 2013 to November 2013 cause unknown.

Figure 10. Analyses of MPRA Corrosion Man-Hours from NALCOMIS

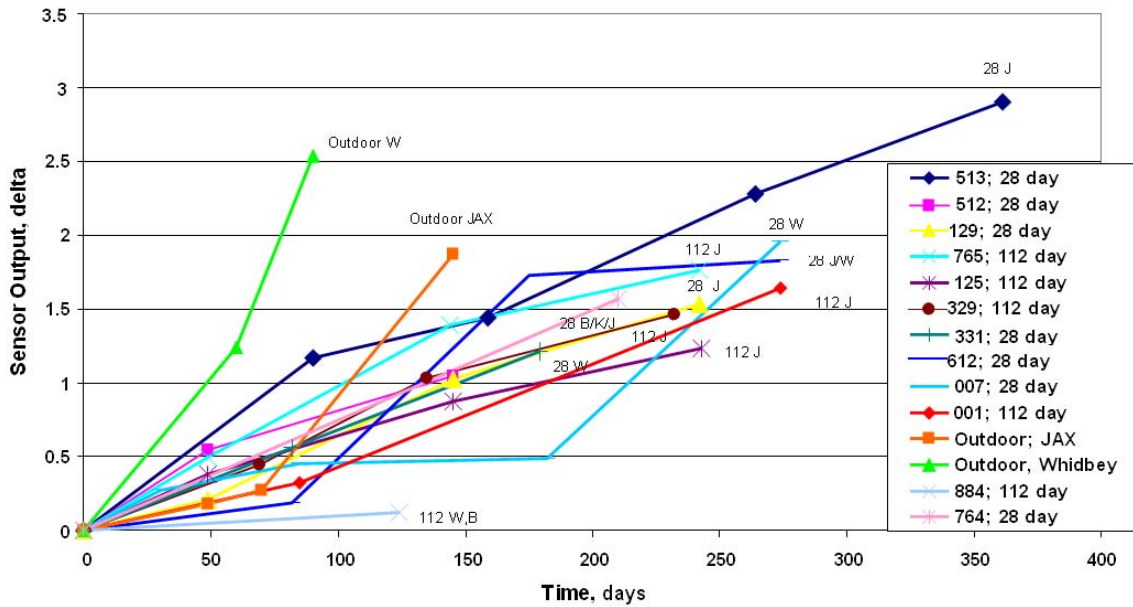
This figure contains the upper horizontal P-3 surface area corrosion sensor response for all aircraft. It also contains reference data for salt and humidity levels at the various P-3 operating bases. Sensor data was extracted at 28 days and 112 days for comparison and analysis. Plots along x axis are sensor outs and the y axis time in days. Data plots for outdoor storage in Jacksonville, as well as Whidbey, are also shown, which can be used as a comparison for a better understanding of habitat vs. natural shielding.

Sensor Response for Upper Horizontal; J=JAX; W=Whidbey; K= Kaneohe; B= Brunswick. Source: Abbott, Columbus, and Beals (2009).
