Yang, Xuechun and Luo, Xichun and Cai, Yukui (2017) Frictional characteristic of micro structures for wooden pallets. In: 2017 World Congress on Micro and Nano Manufacturing, 2017-03-27 - 2017-03-30, Garden Villa. ,

Abstract

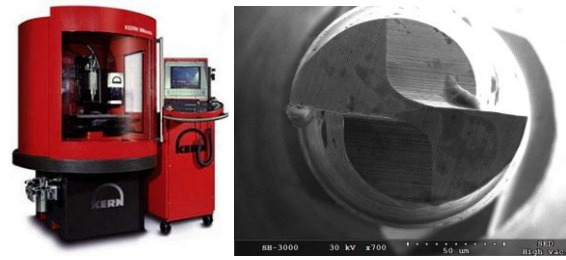
A five-axis micromachining center (KERN-2520) was employed to carry out the micro milling experiments. The maximum rotational speed is 50,000 rpm and axis travels are 250 mm for X, 220 mm for Y, 250 mm for Z, respectively. It is equipped with a laser Control NT to measure the micro milling tools.

Flat end mills with diameter 0.2mm (See Fig. 2 (b)) and 0.5mm were employed to manufacture the micro-textured surface.

(a) KERN-2520 (b) $\Phi 0.2\text{mm}$ flat end mill

Fig. 2. micromachining center and milling tool

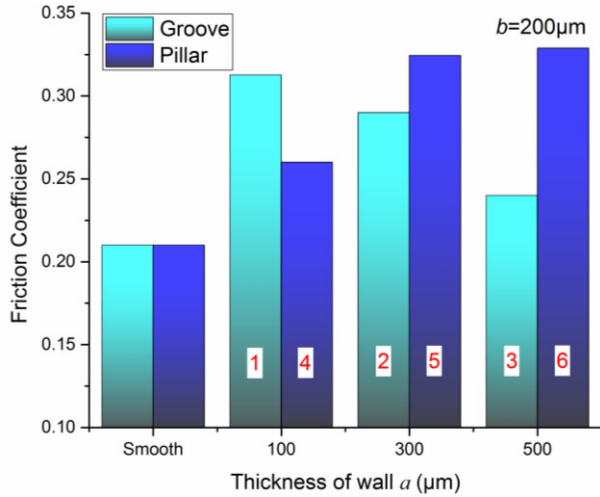
In this research, the friction coefficient of the smooth surface is also being investigated. Thereby, it is possible to exhibit the increase of the frictional resistance of the microstructure. The friction coefficient test results of different samples are shown in Fig. 5.

Fig. 5. Friction coefficient of different samples

From Fig. 5, it can be seen that friction coefficient between the smooth wooden pallet and corrugated box, which exhibit a friction coefficient about 0.21, are smaller than micro-patterned ones.

Therefore, microstructures can increase the friction coefficient, due to the corrugated box belong to easily deformable material and has lower elastic modulus. In Fig. 5 (a), for samples #1, #2 and #3, sample #1 has the larger friction coefficient due to it

has more burrs and structural damage than others. Samples with pillars, such as samples #5 and #6, has larger friction coefficient than grooved samples #2 and #3. However, Sample #4 has smaller friction coefficient than sample #1 mainly due to the pillars of sample #4 (see Fig. 3 (c)) are damaged and has weak structural strength. Therefore, for spacing with 200μm samples, sample #6 has the largest friction coefficient, compared with the smooth one its friction coefficient was significantly increased by 57% (from 0.21 to 0.33). Fig. 5 (b) shows similar trends with Fig. 5 (a). For spacing with 500μm samples, sample #11 has the largest friction coefficient, which is 0.31.
