# “Litter marks” around oil palm tree base indicating infiltration area of stemflow-induced water

Nor Suhada Abd Rashid<sup>1</sup>, Muhamad Askari<sup>2</sup>

<sup>1</sup>*Dep. of Hydraulics and Hydrology, Universiti Teknologi Malaysia,  
81310 Johor Bahru, Malaysia.*

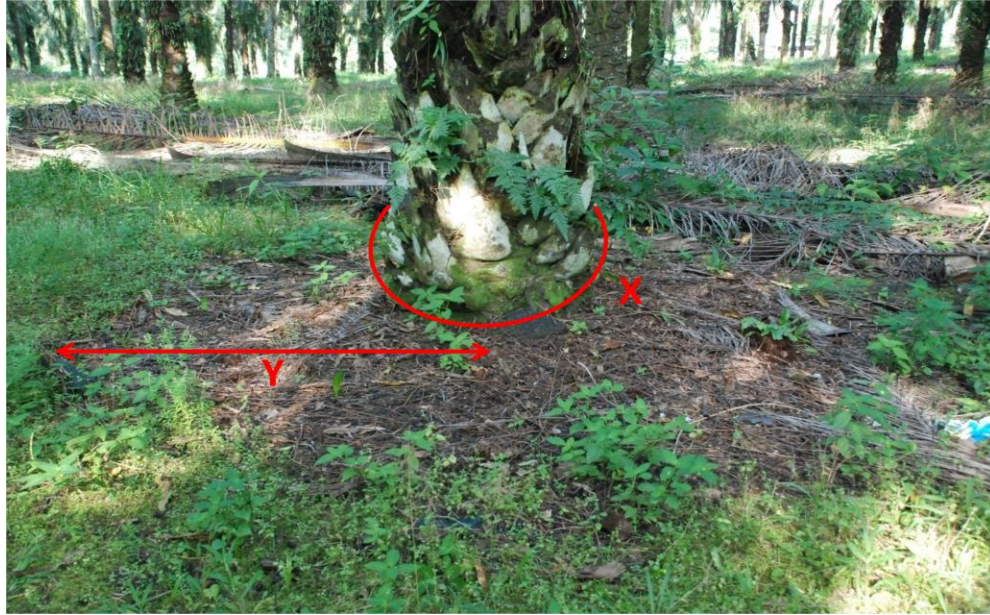
The measurement litter marks of oil palm trees (*Elaeis Guineensis*) were carried out at oil palm plantation, Kangkar, Johor Darul Takzim, Malaysia. The plantation was established around 19 years ago. Figure 1 show the litter mark found around the tree base of oil palm tree respectively. From the figure, it is obviously shows that the shape of the litter marks almost circle. The radius of litter mark,  $y$  from the center of oil palm tree stem and diameter of the tree base,  $x$  were determined by tape measures. There are 30 oil palm trees were measured in this experiment.

Figure 1: Litter mark around the tree base of oil palm tree (*Elaeis Guineensis*).

The dark color and shape like a circle was found around the oil palm tree base (see Figure 1). This finding was corresponded with the shape of infiltration area marks of stemflow reported by Tanaka et al. (1991) for the Keyaki stand, Japanese zelkova and Iida et al. (2005) for Famosa sweet gum and evergreen oak.

The litter marks under oil palm tree was occurred naturally. During rainfall event, the intercepted rainfall will funnels down along the stem and indirectly bring down all the litters around the fronds to the soil surface. Furthermore, the physical characteristic of oil palm stem which are having rough appearance because it was wrapped in fronds will make the stemflow take a long time to reach the soil surface. However, the amount of rainwater infiltrate into the soil by stemflow was higher compared to throughfall. For example, Liang et al. (2007) observed

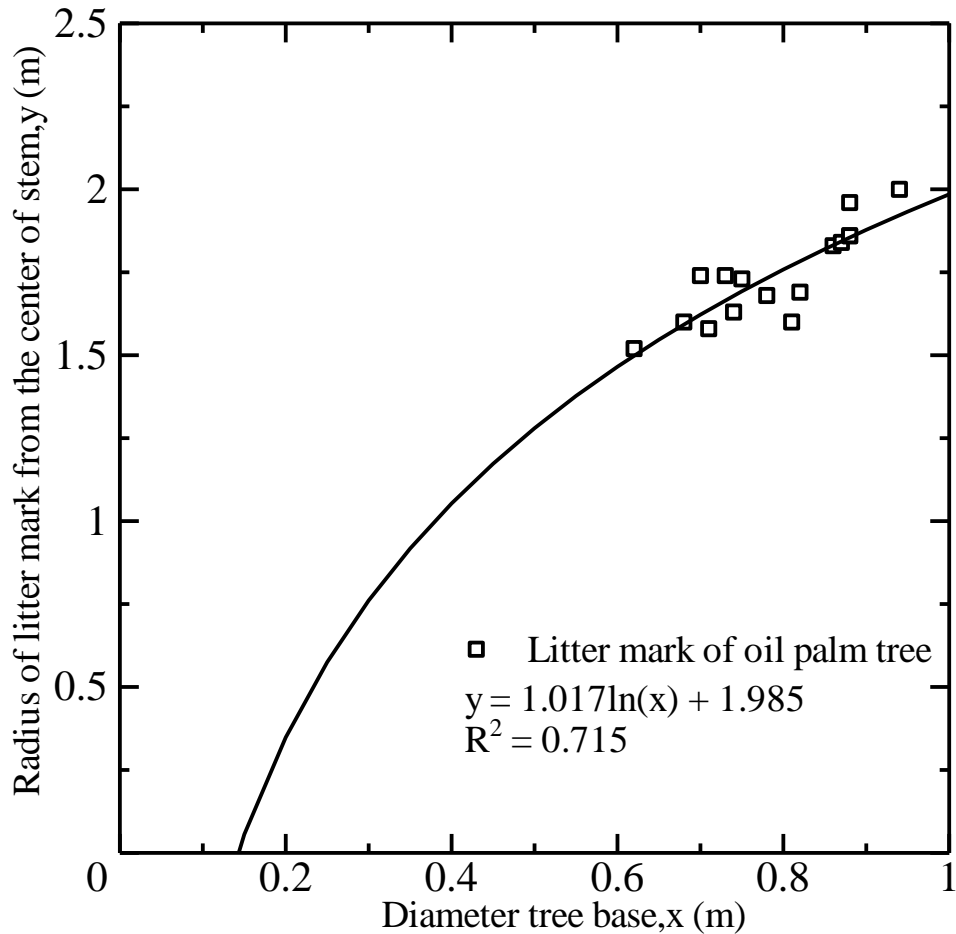
Figure 2 shows the relationships between the diameter at the tree base and the radius of litter mark from the center of the stem. It shows that the radius of litter mark,  $y$  was increased with increasing the diameter tree base,  $x$ . Rutter (1963) reported that stemflow increase linearly with the increasing square of stem diameter. The relationship between the diameter at the tree base and the radius of litter mark from the center of the stem showed a logarithmic curve as follows:

$$y = 1.0171\ln(x) + 1.985 \quad (1)$$

$$R^2 = 0.715$$

Figure 2: Relationships between the diameter at the tree base and the radius of litter mark or infiltration area mark from the center of the stem.

The regression,  $R^2$  obtained in this study was similar as Tanaka et al. (1991) and Iida et al. (2005) obtained even though type of vegetation was different. In this study, the range of diameter tree base of oil palm trees is 0.58 m to 0.97 m and the range radius of litter mark is 1.5 m to 2.0 m. Equation (1) indicates that no stemflow inputs occur close to the base small diameter trees of approximately 0.15 m. Hence, the litter mark around oil palm tree can be a useful indicator of  $A_i$ .
