Identification of acoustic signals of Internal Electric discharges on glass insulator under variable applied voltage

Nasir A. Al-geelani^{1*}, M. Afendi M. Piah¹ and Ibrahim Saeh¹

¹Faculty of Electrical Engineering, Universiti Teknologi Malaysia, 81310 Johor, Malaysia

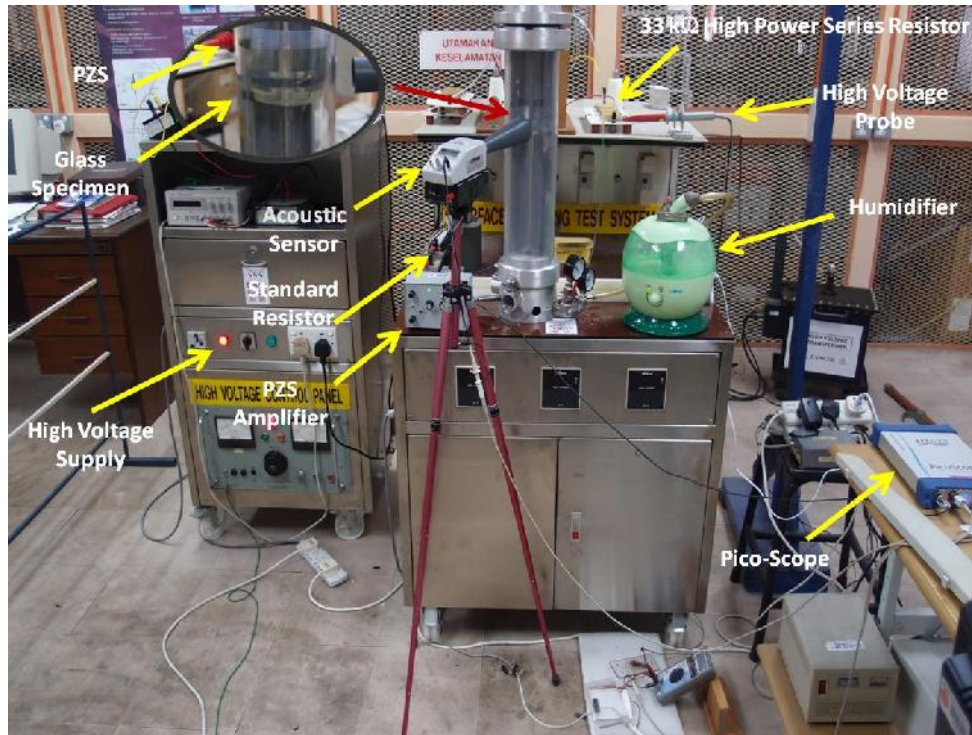
Figure 31 Experimental setup for generating ID

The test setup consists of two main parts: the circuit loop (AC source, transformer, connections and insulator), and the measurement and acquisition system (earthing resistor, wideband antennas). Figure 1 shows the experimental set-up for generating various types of discharges as well as detecting the consequent acoustic signal due to the PDs. The test cell was connected across a high voltage source.

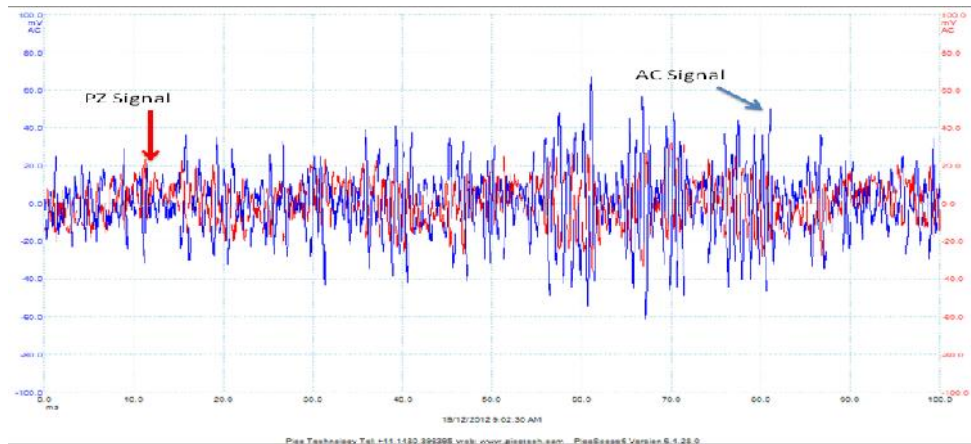
Figure 32 Internal discharges at 5 kV detected by piezo-electric (PZ) and acoustic sensors (AC)

Figure 2 shows the captured internal discharge PD signal under applied voltage of 5 kV; no contamination levels are used for this type of discharge since it is dipped in oil. Here two types of sensors were used, the acoustic and the piezo-electric sensor. The real PD signal due to internal discharge is very noisy, and it is difficult to distinguish between partial discharge pulses and noise, even by visual inspection and knowledge of internal discharge patterns. Thus PD due to internal discharge cannot be distinguished due to the heavy noise as shown in Figure 3, where the pattern captured under operating voltage of 15kV.

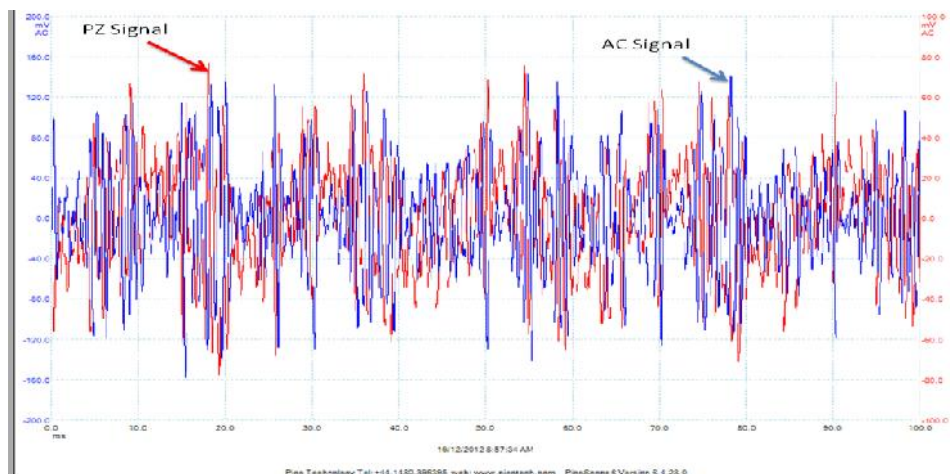
Figure 33 Internal discharges at 15 kV
