## APPLICATION OF SPOT5 SATELLITE IMAGE AND GIS FOR UPDATING ROAD NETWORK: TOWARDS BUILDING LANDSLIDE SPATIAL DATABASE

**Keywords :** SPOT 5, road network updating, GIS, landslide

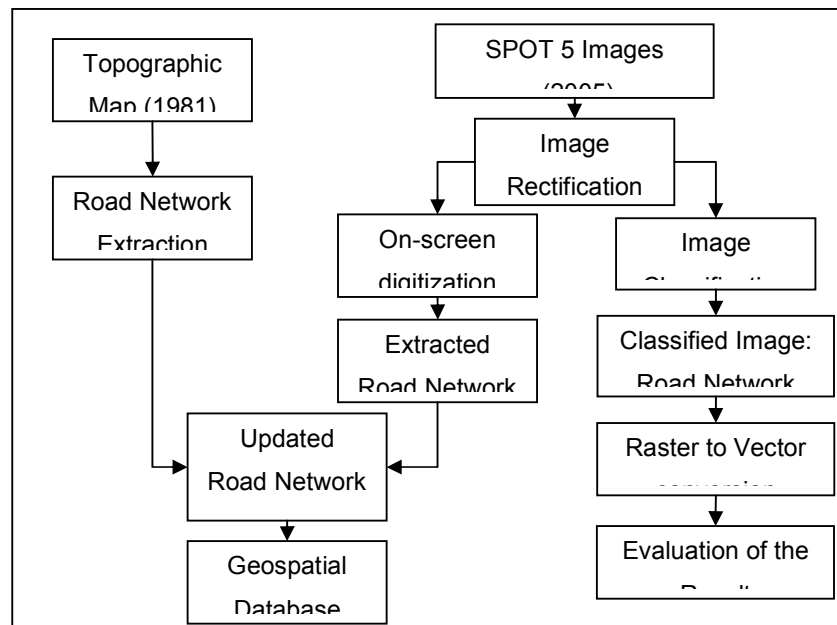
Figure 3. Road network extraction workflow

The works of this study can be divided into two main works, namely, road network extraction and GIS analysis. Figure 3 and 4 show workflows of both main processes respectively.

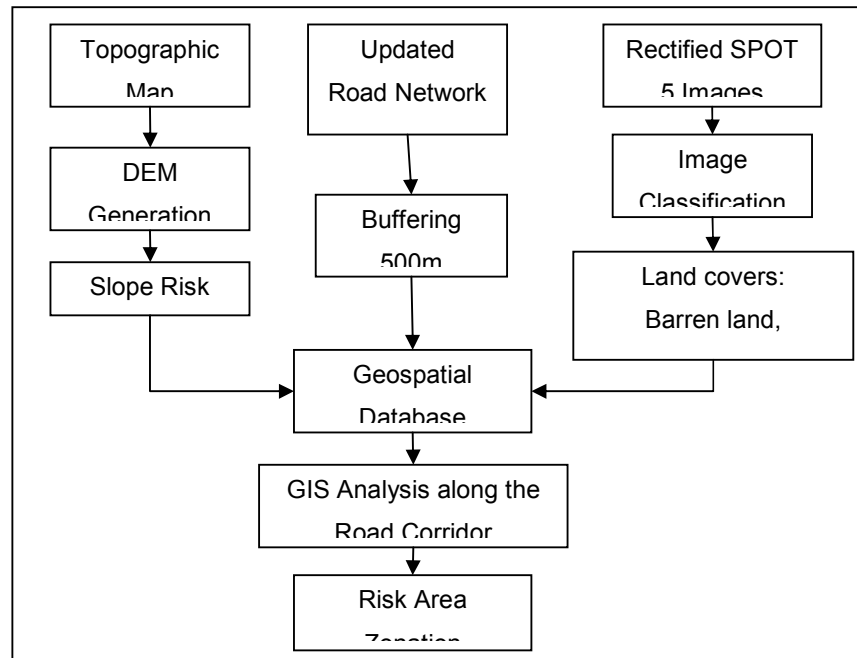
*Figure 4. GIS analysis of high risk area along the road*

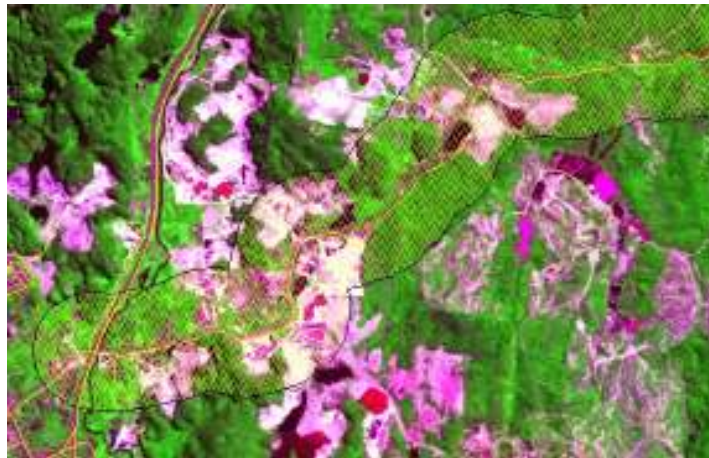
*Figure 9. Buffer zones along the road*

A 500m width corridor at both sides was defined for GIS analysis. Using buffering facility in Spatial Data Modeller Extension (Kemp et al., 2001),

a buffer zone was created (Figure 9). These buffer zones were used for cropping all spatial data required for GIS analysis.

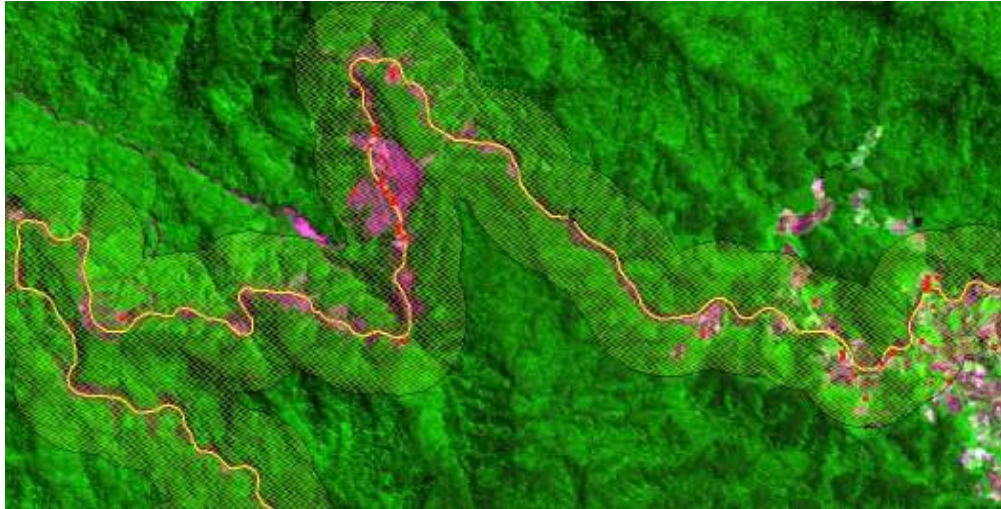
*Figure 15. High risk areas at landslide/slope failure locations (red dot)*

Figure 14a shows high risk area overlaid by road corridor map to yield high risk area map along the road corridor. While Figure 14b contains land cover (which is only barren land area) overlaid by road corridor to yield barren area map along the road corridor. Overlaying both spatial data and the road corridor yields (Figure 14c) would result is high risk map along the road (Figure 14d). The number of pixels occupying high risk area along the road corridor is 127 while the total pixel along the road corridor is 130.050. By comparing both values, the percentage of high risk area along the road corridor is 0.1%. Even though this value is considerably small for this preliminary GIS analysis, part of high risk areas agrees with the area where the landslide/slope failure occurs (Figure 14d). Figure 15 shows high risk area with the corresponding SPOT satellite image. High risk areas (shown in red dot) are located on landslide/slope failure locations. While on the right side of the picture, high risk areas occupy farming areas.
