Eur Spine J (2007) 16:1055–1061
DOI 10.1007/s00586-007-0311-4

ORIGINAL ARTICLE

Metal levels in corrosion of spinal implants

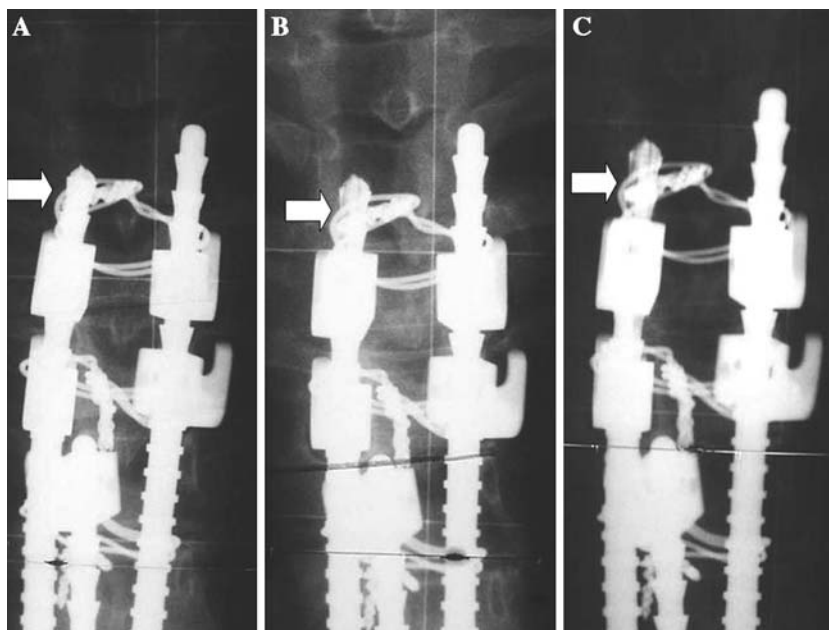
Fig. 1 Postoperative anteroposterior view of the proximal end of a stainless steel spinal instrumentation (a). Corrosion is observed as a progressive decrease in metal density of the rod 1-year (b) and 7 years after surgery (c) (arrows)

With the spinal instrumentation we use, radiographic signs of corrosion are very easy to diagnose if specifically looked for, as we did for this study. This is clearly seen in Figs. 1 and 3a. Localized decreased

density of the rod when compared to adjacent rods is evident. In fact, corrosion was confirmed during surgery in the eight cases that underwent implant removal. But with other types of implants this is not observed. Looking at the cases reported by Tezer [26] and Takahashi [25], with neurological symptoms in relation to corrosion, no radiological signs of corrosion are seen in plain radiographies. It is possible that for other kinds of instrumentations, like CD or TSRH, in which corrosion has been reported in the literature, metal levels can be more useful than looking for radiographic signs of corrosion.

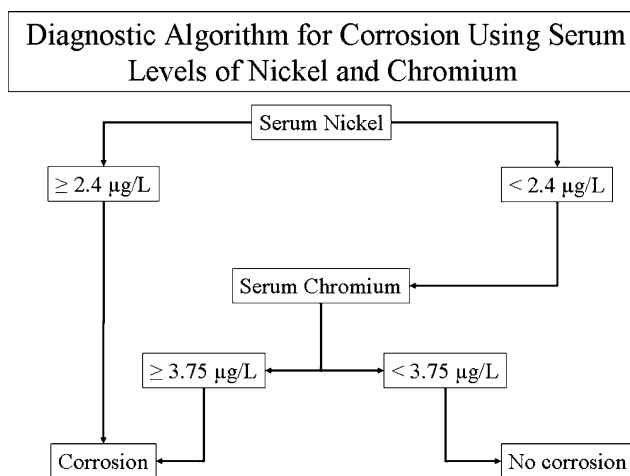
Fig. 2 This diagnostic algorithm using serum levels of nickel and chromium detects corrosion in all our patients without any false negatives or positives

According to ROC curves' results, the optimal values considered as the lowest limit for detection of corrosion are 2.4 $\mu\text{g/l}$ for serum nickel [ABC (ROC) = 0.981 (IC95%: 0.941; 1.000)], 8.4 $\mu\text{g/l}$ for urine nickel [ABC (ROC) = 0.959 (IC95%: 0.877; 1.000)], 3.75 $\mu\text{g/l}$ for serum chromium [ABC (ROC) = 0.981 (IC95%: 0.946; 1.000)] and 8.65 $\mu\text{g/g}$ creatinine for urine chromium [ABC (ROC) = 0.983 (IC95%: 0.950; 1.000)]. Values over these limits are highly suggestive of corrosion. For our patients the diagnosis of corrosion by metal level analysis proved possible, with no false positives or negatives, by combining the determination of nickel and chromium serum levels (Fig. 2).

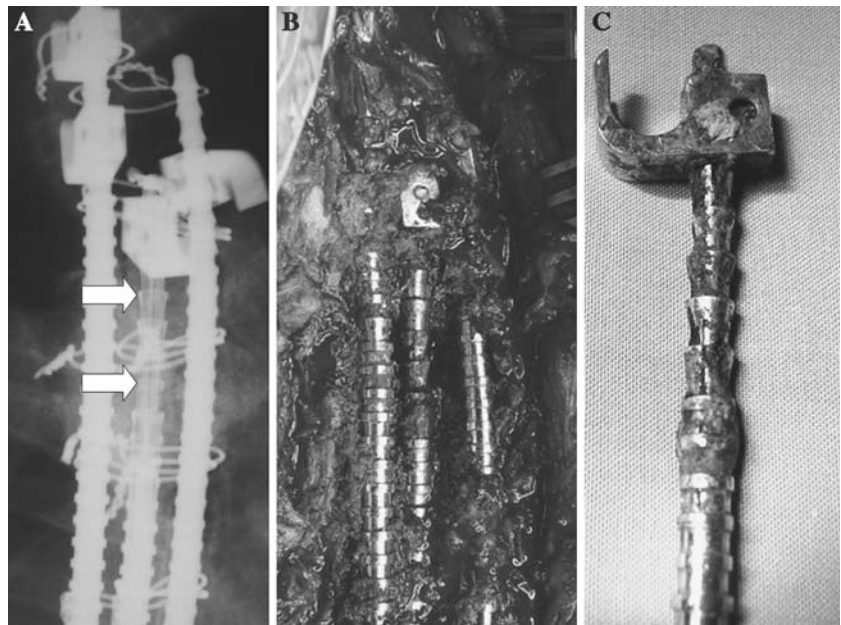
Fig. 3 Radiological signs of corrosion in the proximal end of the rod (a) (arrows). Macroscopic corrosion of the implant was evident during surgery (b) and in the examination of the retrieved instrumentation (c)

Eight of the 11 asymptomatic patients with radiological evidence of corrosion had their implants removed, 2 were lost to follow-up and 1 is still pending. During surgery, macroscopic corrosion, with partial

destruction of the rod, was observed in all these patients (Fig. 3). In these eight cases histological analysis of the samples obtained during surgery confirmed metallosis (Fig. 4). One patient had a positive intraoperative culture for *Propionibacterium acnes*. The 11 patients of Group 2 had routine blood analyses, including white blood cell count, erythrocyte sedimentation rate and C-reactive protein within the normal values. Ten of the 11 patients presented corrosion at the ends of the rods, in the rod-hook junction area. Alloy composition analysis of the retrieved instrumentations is shown in Table 3. All implants were made of austenitic stainless steel.

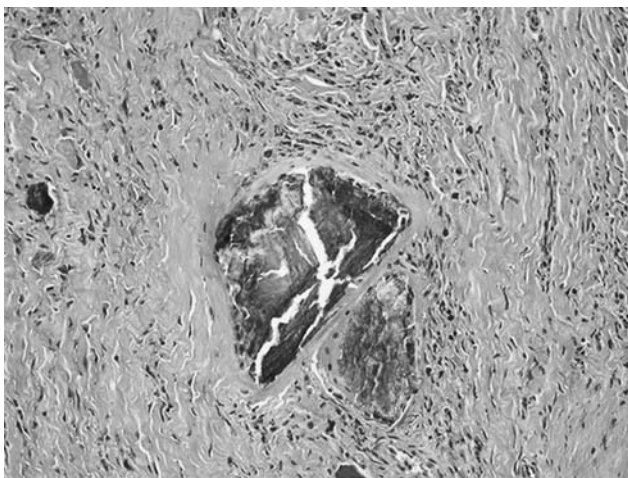
Fig. 4 Microscopic photography (H&E stain, ×100) that shows a multinucleated giant cell with foreign bodies (metallic debris)
