AN EVALUATION OF ENVIRONMENTAL HEALTH THREATS ASSOCIATED WITH STREAM DISCHARGE FROM TOWN CREEK IN GREENVILLE, NORTH CAROLINA

A Thesis

East Carolina University

Masters of Science in Environmental Health

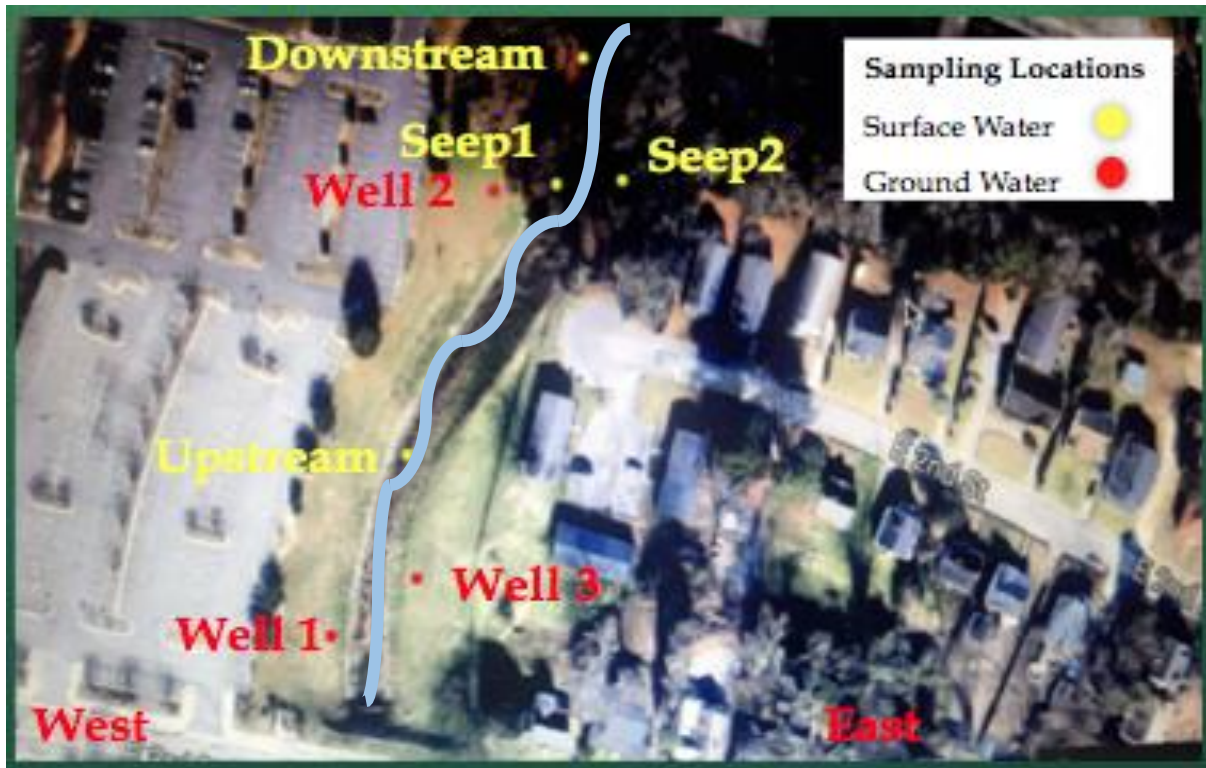
Figure 5. Water sampling locations used by ECU researchers in the Town Creek watershed.

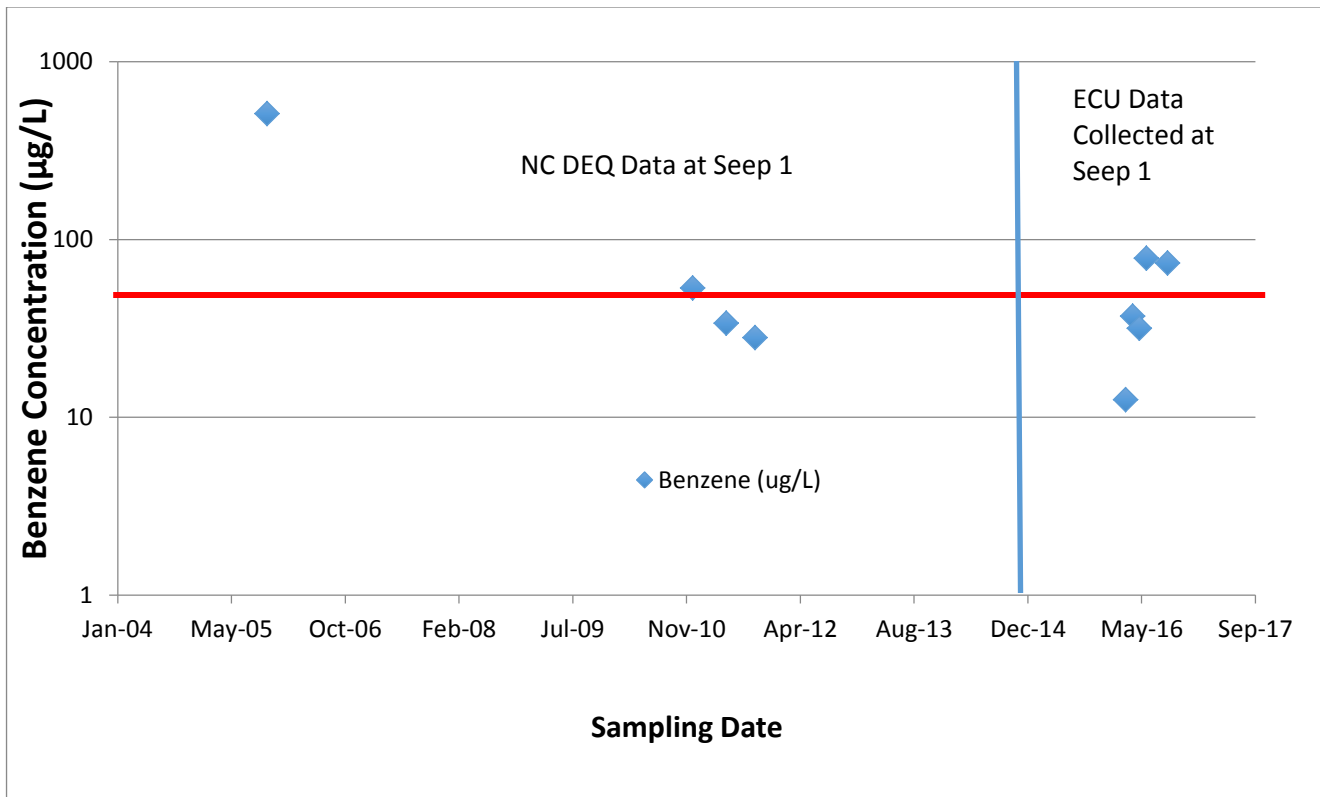
Figure 6. Benzene concentrations in water samples collected near Seep 1 along the banks of Town Creek between 2004 and 2016. Sampling for this study began in 2016, prior sampling was conducted by NC DEQ and engineering firms.

Sampling for this study began in March of 2016. Benzene was detected in all groundwater samples (n = 5) collected near the seep. The first sampling event for this study (March 2016) had the lowest concentration (12.55 µg/L). It should be noted that due to heavy rain, the Seep 1 area was flooded, possibly diluting the sample with rainwater. The week prior to sampling, there was approximately 12.9 cm of rainfall and the Tar River had risen from 182.9 to 350.5 cm (USGS, 2016). The next sampling two months (April and May), the benzene concentrations increased 2 to 3 times higher than in March. The April and May benzene concentrations were 37.05 µg/L, and 31.6 µg/L, respectively. During these sampling events, The Tar River had a gauge height of 137.2 cm (April) and 140.2 cm (May). These samples were

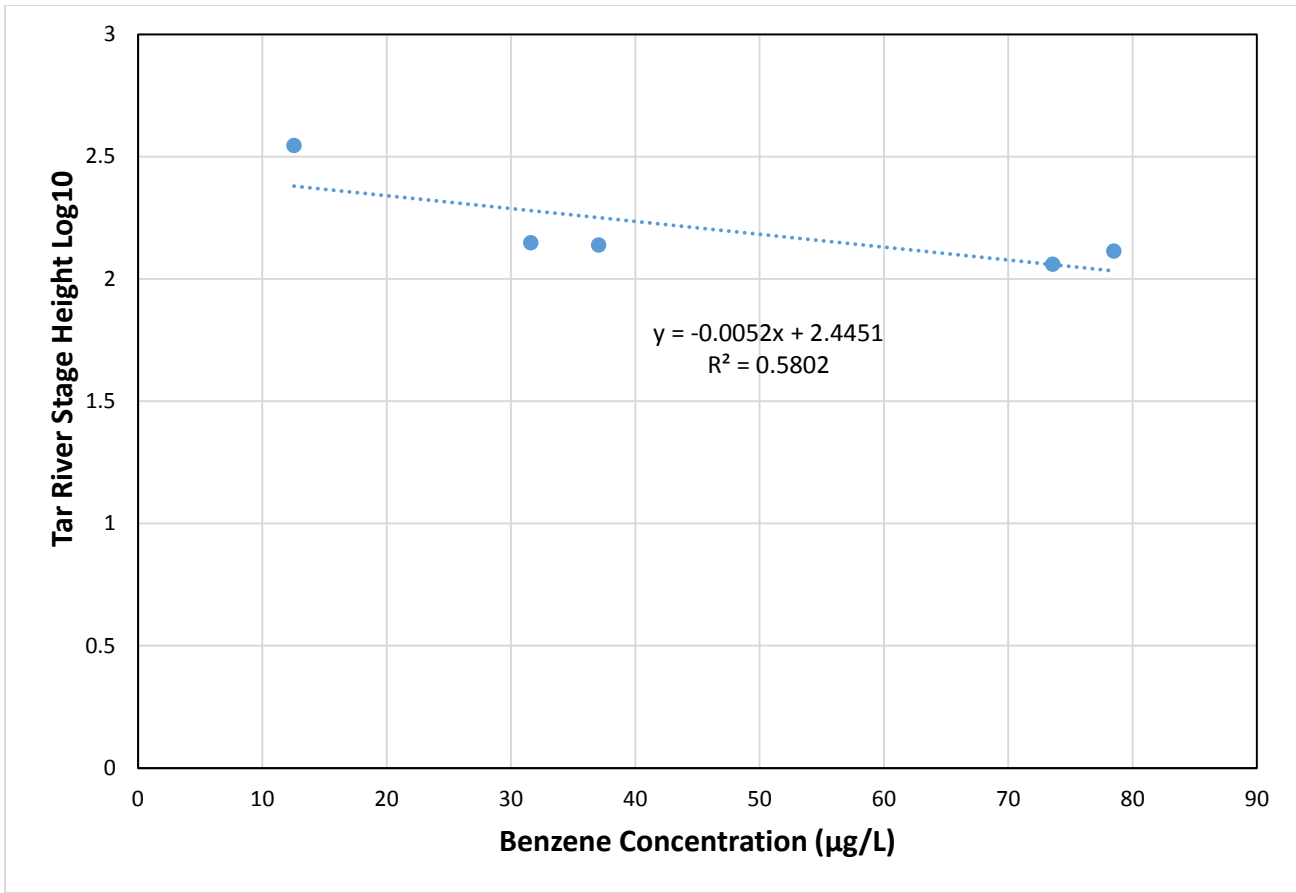
Figure 7. Tar River stage height (Log10 of cm) and benzene concentrations at Seep 1.

$$R^2 = 0.5802$$

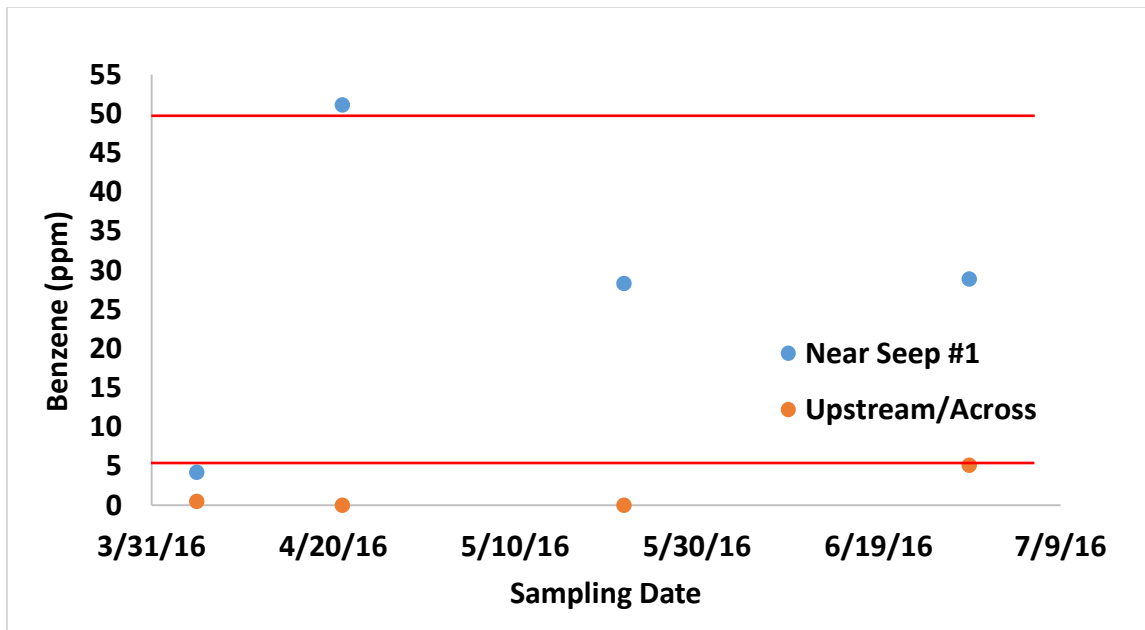
Figure 8. Benzene concentrations emitted into the air from soil samples collected near Seep 1 and on the opposite side (East) of Town Creek.

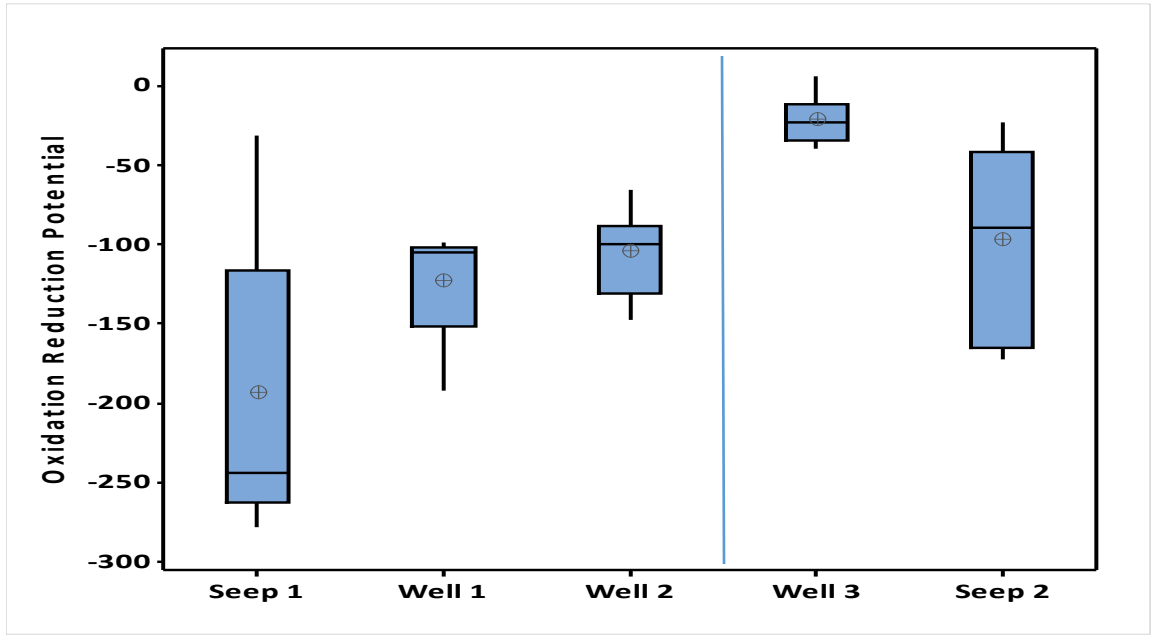
Figure 10. Oxidation-reduction potential in sampling locations on the east and west banks of Town Creek.

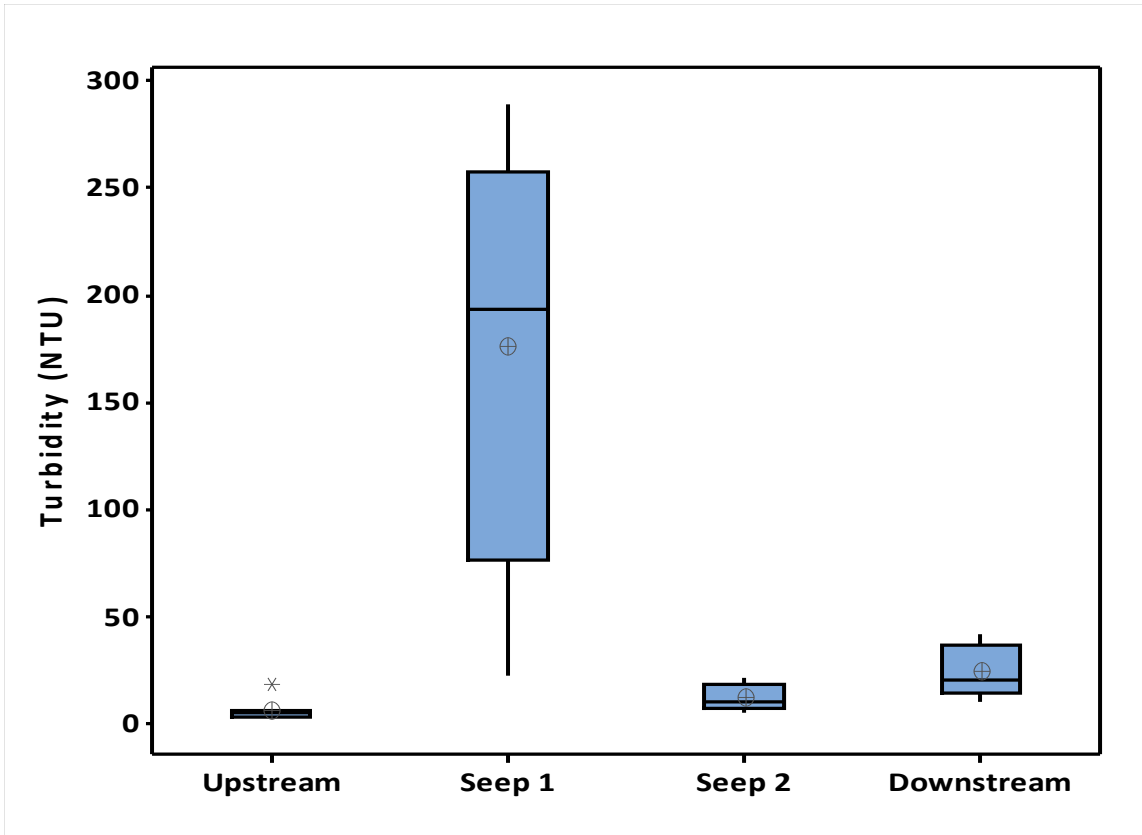
Figure 12. Comparison of turbidity in surface water sampling locations moving from upstream towards downstream.

There were many distinctions that were observed in surface water following periods of rainfall. During storm events, there were increases in water flow, turbidity, oxidation-reduction potential and temperature of surface waters (Table 3). The differences in stream discharge between base flow and storm flow were significant at $p = 0.002$. On average, the measured discharge during base flow was (5.4 ± 2.8 L/s) and storm flow was (28.8 ± 5.7 L/s). Stream turbidity followed a similar pattern of increasing during storm flow. The average turbidity during

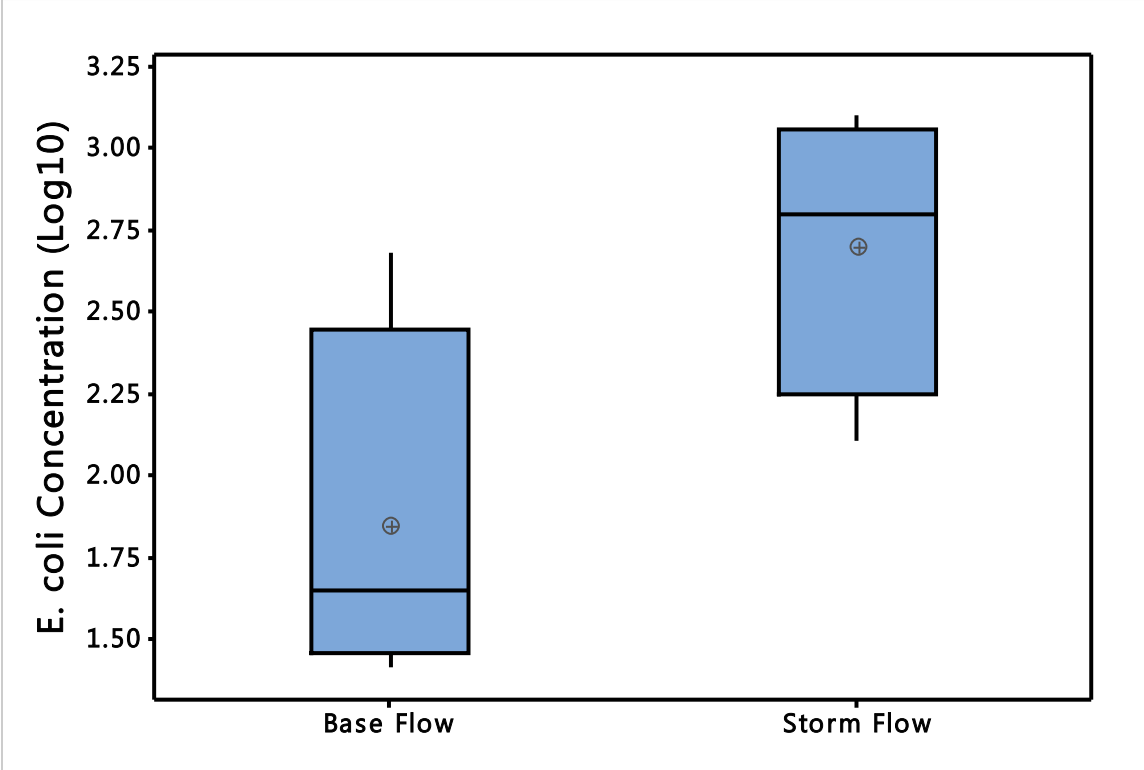
Figure 13. Comparison of the log₁₀ of MPN *E. coli* concentrations in Town Creek during base flow and storm flow.

To determine the impact that storm water runoff had on the microbial water quality of Town Creek, water samples were collected during 4 base flow and 4 storm flow events and compared. The bacteria concentrations increased during each storm flow relative to base flow conditions (Figure 13). For example during the July sampling event, base flow *E. coli* concentration was 480 MPN/100 mL, while the storm flow *E. coli* concentration was 1,248 MPN/100 mL. The second sampling event during early September had a base flow concentration of *E. coli* of 37 MPN/100 mL, while the storm flow concentration was 837 MPN/100mL. Later in the same month, the base flow *E. coli* concentration was 53 MPN/100mL and the storm flow concentration was 127 MPN/100 mL. Finally, in October the base flow concentration was 26 MPN/100 mL and during rainfall it increased to 467 MPN/100 mL. Therefore for every sampling event, the storm flow concentration of *E. coli* was elevated relative to the base flow concentration. The differences in the concentrations of bacteria during base flow and storm flow were significant with a p-value of 0.05. Similar trends were observed with the indicator bacteria enterococci. Specifically, the geometric mean of enterococci for two summer base flow events

was 52 MPN/100 mL while the geometric mean during two summer storms was 1194 MPN/100 mL. The results of this study proved that there was a significant increase in the number of the fecal indicator bacteria in Town Creek during storm events relative to base flow conditions. With the high percentage (50%) of impervious surface in the area, storm water runoff contributes to the increase in pathogens in Town Creek. Other research (Humphrey et al., 2015; Bean et al., 2016) conducted in the area has also shown this pattern.

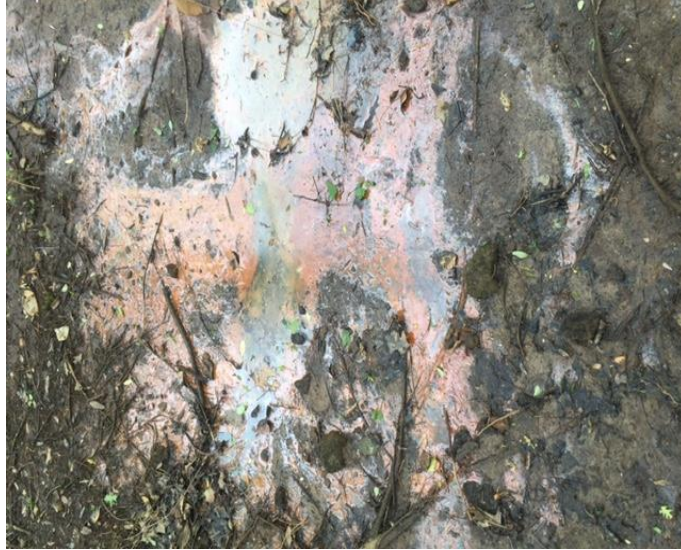
Oily Sheen Found at Seep 1

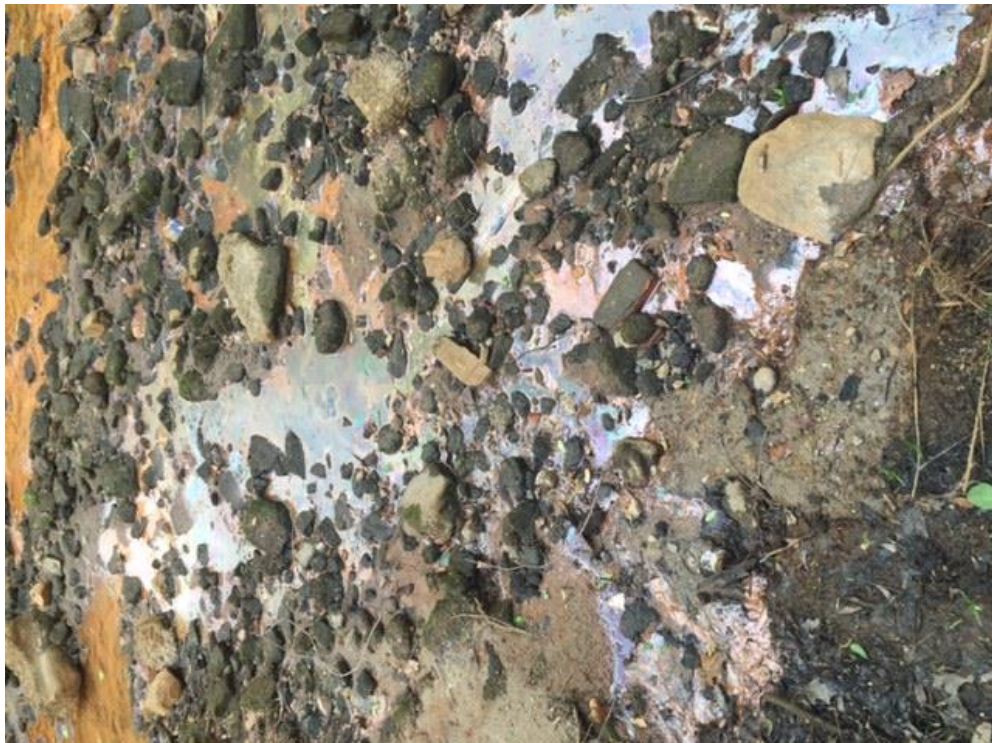
Groundwater Seeping into Town Creek
