Catastrophic failure of an uncemented acetabular component due to high wear and osteolysis: An analysis of 154 Omnifit prostheses with mean 6-year follow-up

von Schewelov, Thord; Sanzén, Lennart; Önsten, Ingemar; Carlsson, Åke

Published in:
Acta Orthopaedica

2004

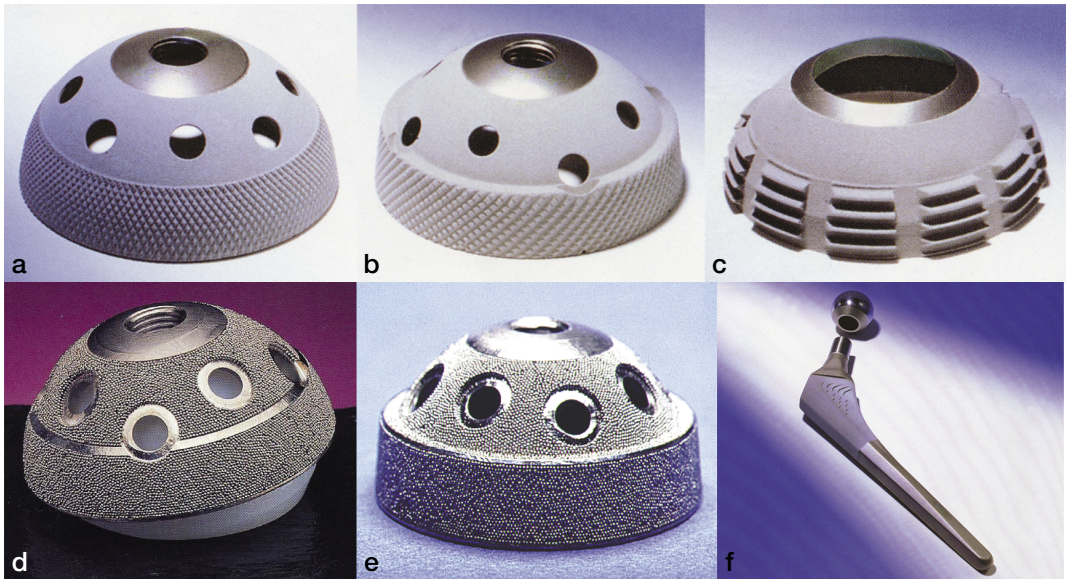
Figure 1. Omnifit HA-coated Dual radius (a), Dual geometry (b) press fit cups, HA-coated threaded cup (c) and porous-coated (microstructured) press fit cups, available as Dual radius (d) and Dual geometry (e) designs. Omnifit stem (f).

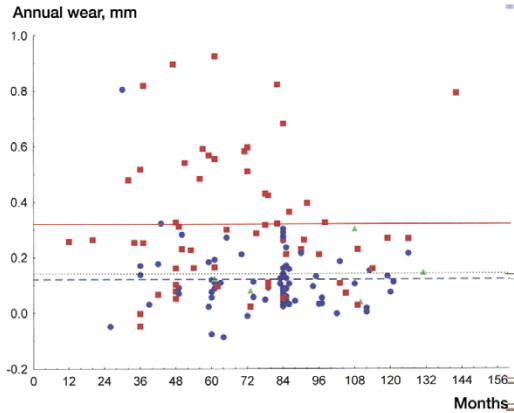
Figure 2. Annual wear in mm (Charnley-Duo) at last follow-up of 143 cups. The lines represent mean annual wear. Not revised (broken line), revised (full line), and pending revision (dotted line).

Wear. Using the Charnley-Duo method, the mean annual wear rate at the last follow-up examination ($n = 143$) was 0.20 (-0.09–0.92) mm/year. The mean annual wear rate in the non-revised group was 0.12, as compared to 0.32 mm/year in the revised hips ($p < 0.001$) (Table 4, Figure 2). Frequency distribution for annual wear as measured by the Charnley Duo method is presented in Figure 3.

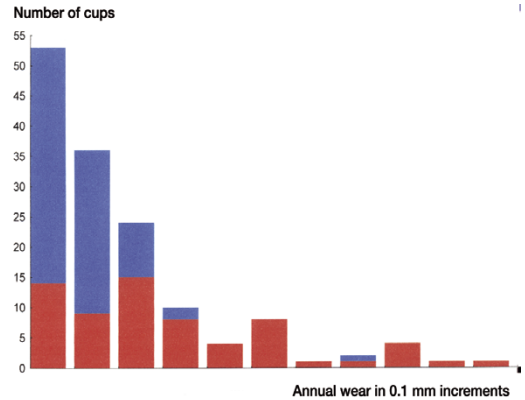
Figure 3. Annual wear in mm (Charnley-Duo) at last follow-up of 143 cups. Frequency distribution within 0.1 mm increments. Red part of bar represents revisions, or cases pending revision.

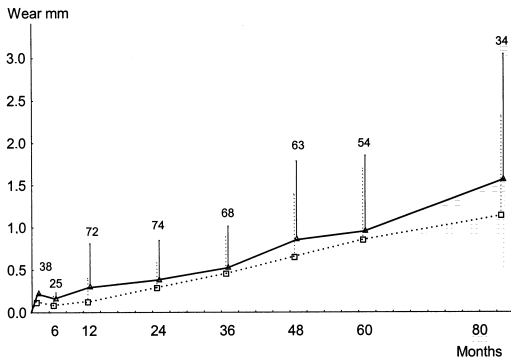
Figure 4. RSA values for wear along the longitudinal axis (full line, signed values). Total vector wear (dotted line). Whiskers represent 1 SD. The number above each whisker shows how many cases were measured after each time interval.

At the last follow-up investigation (mean 64 months, $n = 78$), the mean wear along the longitudinal axis (Y) was 0.90 (-1.04–5.89) mm and the total vector wear was 1.22 (0.09–6.08) mm. The annual total vector wear was 0.22 (0.02–0.88) mm/year (Figures 4 and 5).

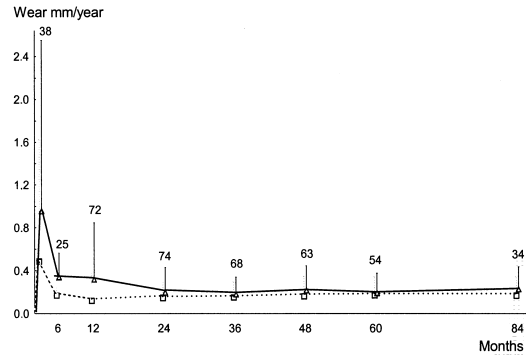
Figure 5. RSA annual wear in mm. Wear along the longitudinal axis (red, signed values). Total vector wear (blue). Whiskers represent 1 SD. The number of measured cases after each time interval is given above each whisker.

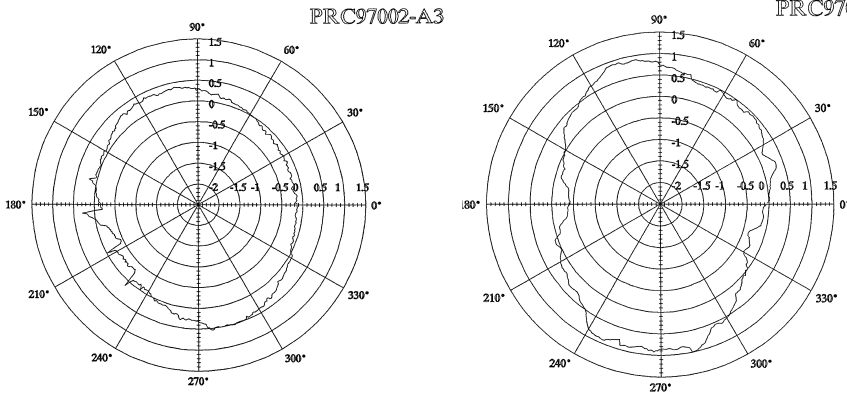
Figure 6. Diagram of roundness at the equator for new Charnley (left) and Omnifit (right) heads (micrometer).

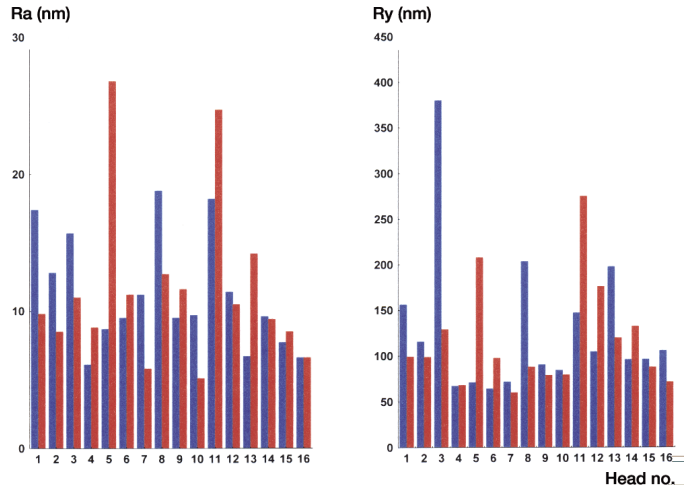
Figure 7. Mean surface roughness. Ra the arithmetic mean value of surface roughness with reference to a least squares plane. Ry difference between the lowest and the highest peak of the surface. Implants 1–12 are excised heads. Numbers 13–14 are new Omnifit and 15–16 are new Charnley heads.

In unused Omnifit and Charnley Elite femoral heads there was no difference regarding the surface roughness (Ra) (Figure 7), although SEM and AFM demonstrated a difference in surface texture. The Omnifit heads were characterized by polishing marks that were not as prominent on the Charnley heads. The Charnley heads were instead characterized by small holes. The EDAX analysis revealed particles of cobalt, chrome, iron and aluminum on both types of heads. Aluminum particles were probably remnants from the polishing process. Titanium particles were found on one Omnifit head.

Although microscopically undamaged areas on the excised Omnifit heads were selected, structural changes were present at the nanometer level (Figure 7). The profile analysis of the excised

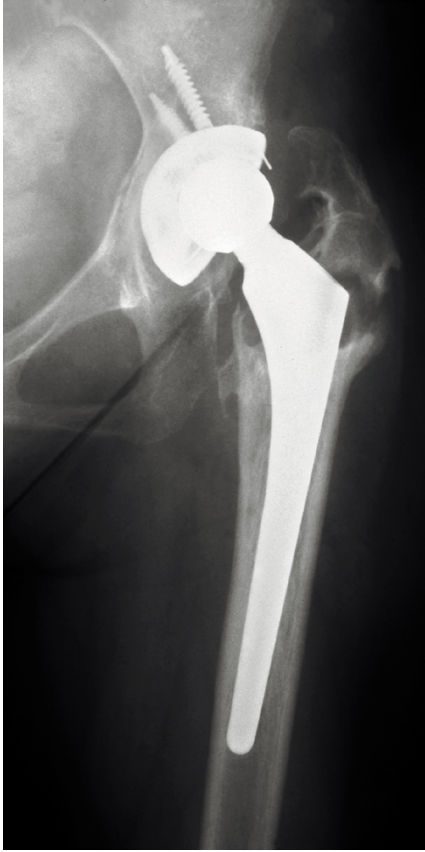
Figure 8. 11 years postoperatively, showing massive osteolysis in the pelvis and trochanter. The tip of the trochanter has fractured spontaneously.

In severe cases, the osteolysis had also advanced 1–2 cm down the proximal femur and also into the greater trochanter. The trochanter may even be transformed into a cyst-like formation with very thin walls, which may fracture (Figure 8). In our experience, the femoral osteolytic processes should be curetted and filled with morselized allografts, leaving the stem in place, whereas the cups should be exchanged and the defects packed with morselized allografts.
