Radiation hardness testing of an organic liquid scintillation detector for use in high dose rate accident response scenarios

Abstract – Organic liquid scintillation detectors offer the advantage relative to many alternatives that they are sensitive to both fast neutrons and γ rays, whilst radiation type can be discerned on the basis of pulse-shape discrimination. Mixed radiation fields of this type can arise in the context of reactor accidents via, for example, ^{137}Cs (γ) and ^{244}Cm (neutrons). However, performance degradation of such scintillators, such as EJ-301, is a significant possibility that might limit the use of this technology in accident response applications. The premise behind the high dose rate testing of such a liquid scintillator described in this paper is for fuel debris characterisation at Fukushima Daiichi, which has expected dose rates of up to 1000 Gy/hr in close proximity to fuel debris. The tests carried out for this investigation involved using the ^{60}Co gamma irradiation facility at the Dalton Cumbria Facility, Cumbria, United Kingdom to expose the detector to a similar dose rate to that which is estimated within the primary containment vessel for su

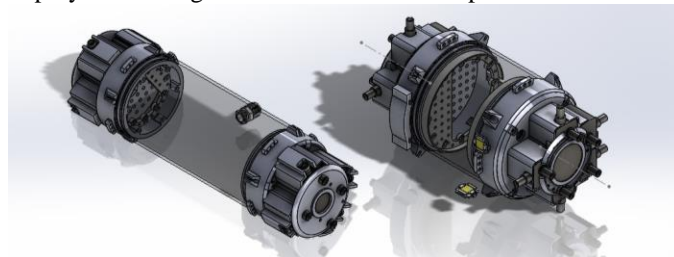
The ROV to be utilized is a modified version of the Aqua Vehicle Explorer for In-situ Sensing (AVEXIS) MiniROV [1, 2] developed by The University of Manchester. The AVEXIS MiniROV, Figure 1, measures 145 mm in diameter and 250 mm in length, and is designed for the inspection of legacy storage ponds. The modified version of this design developed specifically to inspect the PCVs at Fukushima Daiichi is the AVEXIS MicroROV, Figure 1, which measures 110 mm in diameter and 450 mm in length and has 5 degrees of freedom (DOF). This ROV has been designed specifically to carry a payload of detectors for the fuel debris identification and classification within the reactors at Fukushima Daiichi deployable through 115 & 150 mm access ports.

Figure 1. AVEXIS MicroROV (left) and AVEXIS MiniROV (right).

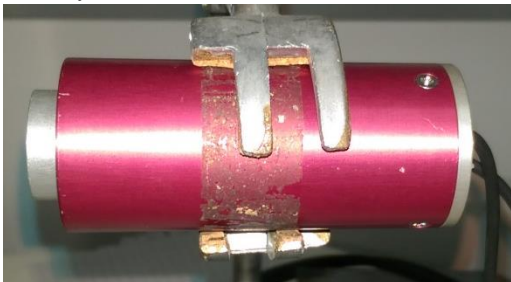
The detector used for this investigation consisted of a cell containing the EJ-301 liquid scintillant [3], coupled to an R-5611 PMT by Hamamatsu Photonics K.K. [4], the device in total measures 35 mm in diameter by 80 mm in height shown in Figure 2. This ability for mixed field radiation information and the small size makes it very desirable for use within the ROV system.

Figure 2. EJ-301 liquid scintillator detector, model type 19A15/0.75-E1-LS-Z-N supplied by Scionix, Netherlands [5]

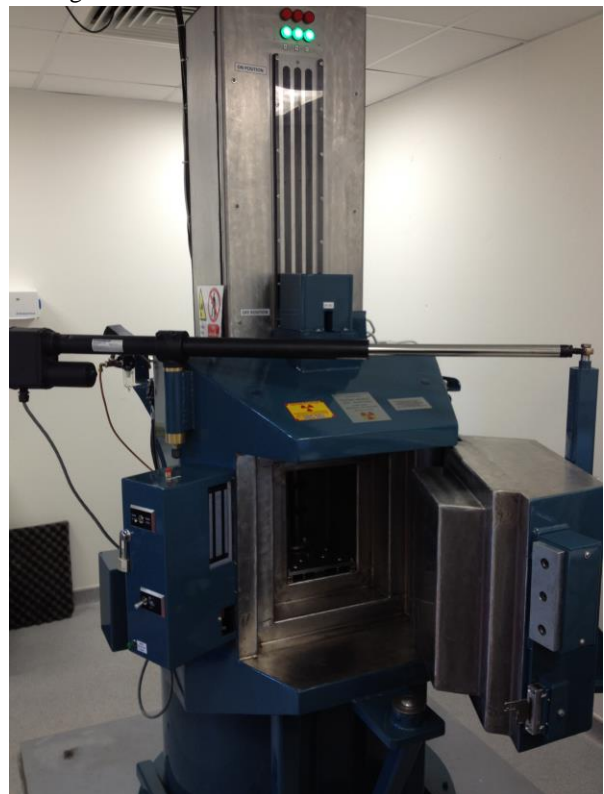
The irradiator facility houses a self-shielded model 812 ^{60}Co gamma irradiator that was developed and installed by Foss Therapy Services, Inc. [8] shown in

Figure 3. The irradiator is capable of supplying absorbed dose rates from 240 Gy/hr up to 27,000 Gy/hr. These dose rates can be attenuated and shielded to match desired experimental setups. The irradiator consists of three source rods of ^{60}Co that can be used simultaneously or individually depending on the desired dose. The irradiator chamber has two service ports of 19mm diameter to accommodate cables for power supplies and signals.

Figure 3. ^{60}Co gamma irradiator, Foss Therapy Service, Inc. [8]

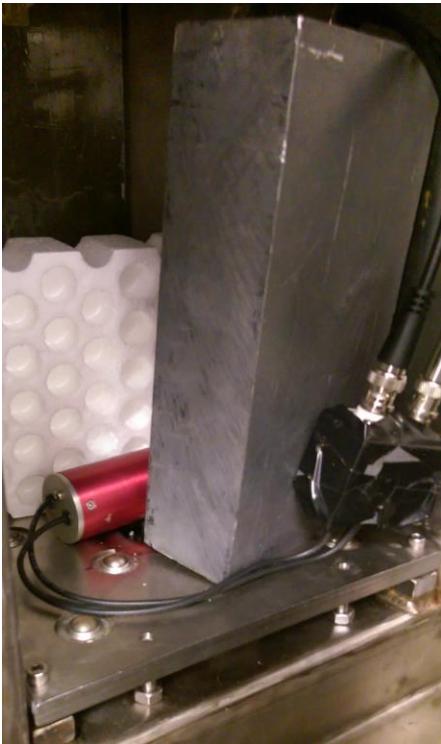
produced as well as the throughput of these. This dose rate was selected to simulate rough estimate of the highest possible dose rate within the PCV's at the reactors. The actual measured dose rate was $942 \text{ Gy/hr} \pm 2\%$, which was provided by using 2 of the source rods. It was expected to be able to observe degradation in either the pulse shape or throughput when radiation damage was starting to take place, at which point the dose would be terminated. The liquid scintillator was placed inside the irradiator as shown in

Figure 4, with the power supply control box shielded further still behind a lead block as shown. The high voltage was supplied via a coax cable through the side of the irradiator chamber similarly the signal was being fed back the same way.

The polystyrene in-front of the detector was to prevent the detector from moving whilst being investigated, polystyrene was used due to its lack of interaction. Once the setup was in place the irradiator was closed and the ^{60}Co rods were raised into place for exposure. It was observed that the instant the sources were raised the detector went dead, producing no pulses or signal. Upon the detector going dead, the sources were retracted and the detector became instantly operational again. This instant recovery of the detector suggests that the problem the detector exhibited was not due to damage, as this would have been expected to exhibit a gradual recovery if any at all. With this knowledge it was concluded that the detector must have become saturated due to the dose levels being used. To try and determine if there would be any radiation damage of the detector at this level of dose rate a long exposure was run, 50 minutes, giving a total dose of approximately 8 kGy, after this dose the detector was observed to still be operating as normal the instant after the sources were removed.

Figure 4. EJ-301 organic liquid scintillator inside the ^{60}Co irradiator.

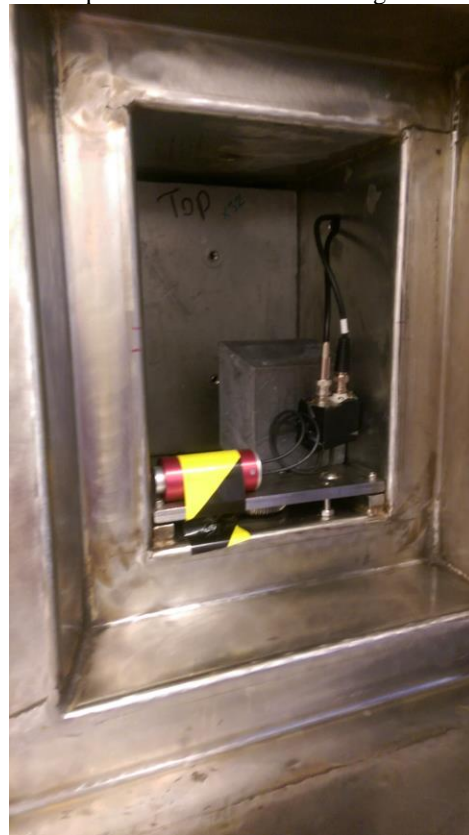
To try and corroborate this idea the dose rate was progressively reduced to try and find the point at which it saturated. Initially the dose rate was halved to $420 \text{ Gy/hr} \pm 2\%$ by only using one of the source rods, this exhibited the same result as previously with the detector instantaneously producing no pulses or signal output and hitting its saturation point. To find a dose rate that the detector could withstand more attenuation was added inside the irradiator. The final setup in which the detector was operational is shown below in Figure 5.

The dose rate was reduced to the minimum obtainable within the irradiator facility by adding the maximum number of attenuation plates with additional lead shielding within the chamber. This was measured using the ion chamber to be $9.9 \text{ Gy/hr} \pm 2\%$. at this dose rate the detector remained operational for the first few seconds of exposure, with intermittent count readings through exposure. It is presumed that this dose rate is just above the upper saturation limit of the detector. Looking at the DAQ readout from the first few seconds of irradiation after the experiment had been completed gave a scatter plot as shown in Figure 6. This shows a lot more noise than would normally be expected, this can be associated to both radiation effects imposed upon the cables that are feed through the service ports and the detector being on the verge of saturation.

Figure 5. EJ-301 organic liquid scintillator inside the ^{60}Co irradiator.

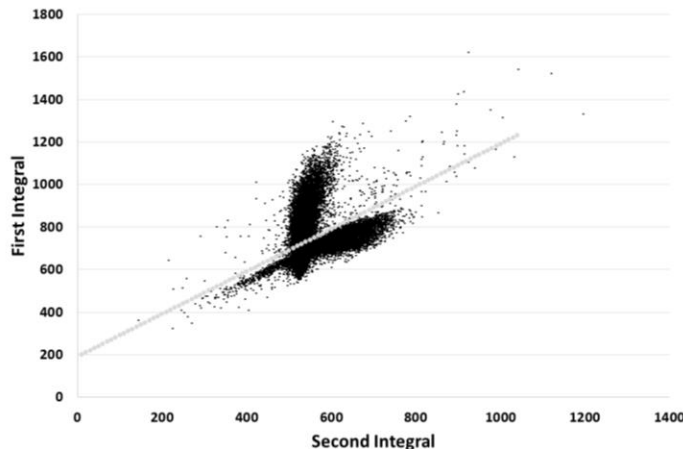
purpose of post processing. The post processing allows a picture of the pulses to be built up into a scatter plot of two different integrals, one of these being the peak of the pulses that are being seen by the detector, the second being a set user defined time after this peak amplitude. The scatter plot can be seen in Figure 6.

Figure 6. Scatter plot showing gamma radiation and noise threshold line (grey) for the 30 minute exposure run, (arbitrary units).

With the radiation field associated with this experiment it would be expected to view one clear plume of data, as can be seen above two plumes are visible. This second plume has been isolated by the addition of a threshold $y=x+c$ line. The second plume that has manifested is associated with saturated or clipped pulses and noise. When a pulse is processed if the pulse is of greater amplitude than is observable through the system it will produce a flat top at the maximum observable amplitude. The effect this flat top has on the processing is that the peak amplitude sample and the discrimination amplitude sample are either identical if the pulse is very large, or very similar depending on the time this flat top is maintained for, producing this second plume around the $y=x$ line as shown above.

Each of the three tests showed a prominent plume of gamma counts as well as noise. This is suggestive that the detector is on the verge of saturation at 9.9 Gy/hr for these first few seconds, before becoming fully saturated.
