Damage detection and quantification in composite beam structure using strain energy and vibration data

Abstract. In this research paper, the damage in Carbon Fibre Reinforced Polymer (CFRP) laminate beams under free vibration and simply supported conditions, is investigated numerically by Finite Element Method (FEM) using Matlab program. The developed Cornwell Indicator, which is based on strain energy fraction, is used for damage detection and quantification in the considered composite beams. The data was acquired by developing a software that performs dynamic analysis of composite beams based on FEM. The results show the efficiency of the developed indicator to detect and quantify damage for single and multiple damage scenarios.

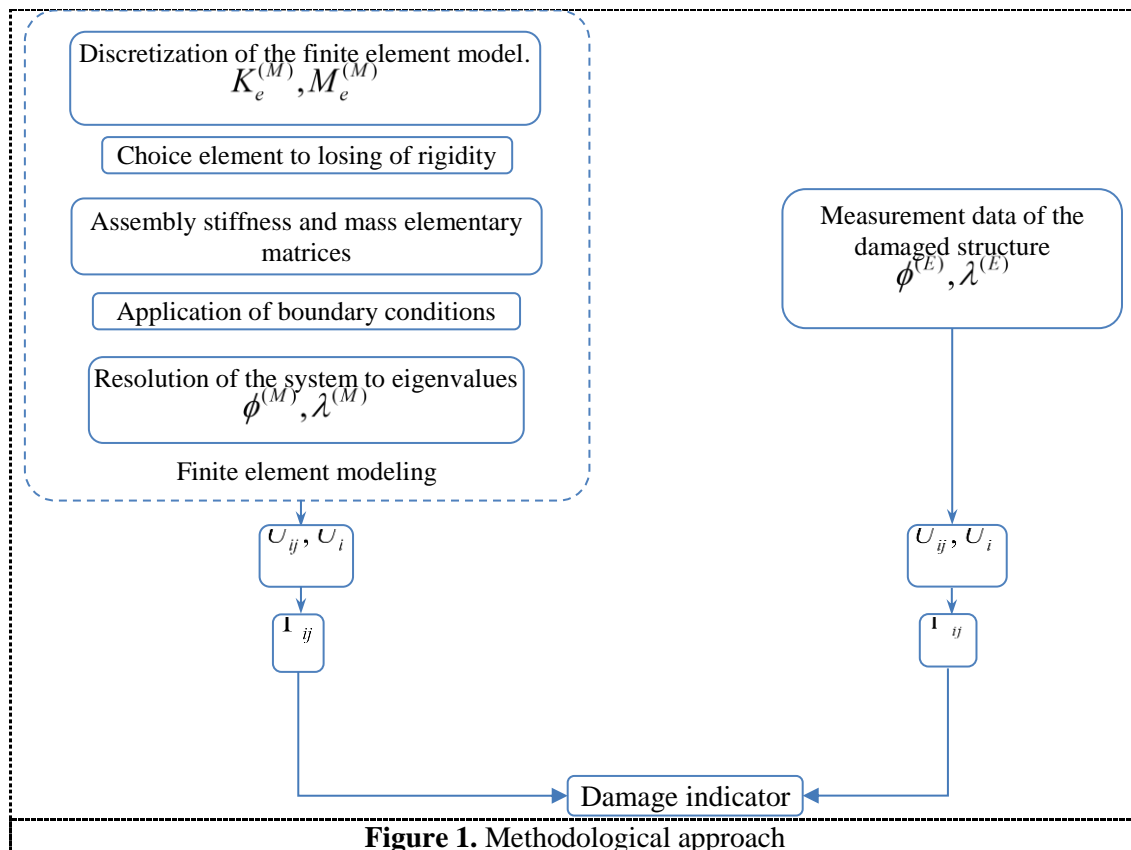
The Methodological approach for damage detection used in this paper is illustrated in Figure 1.

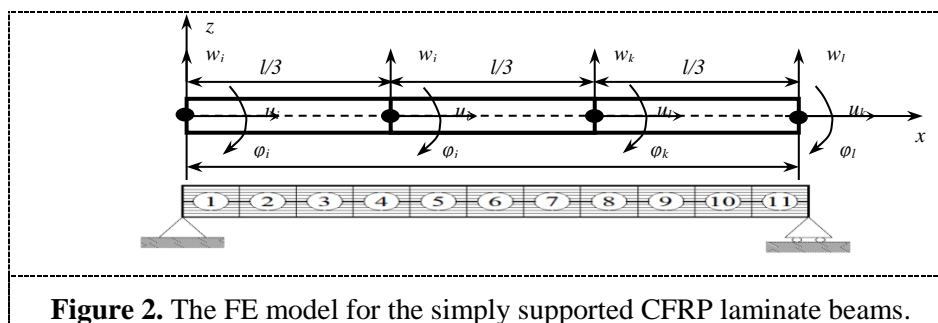
A Carbon Fibre Reinforced Polymer (CFRP) material simply supported discretized into 11 elements. The characteristics mechanics and geometrics are given in table 1.

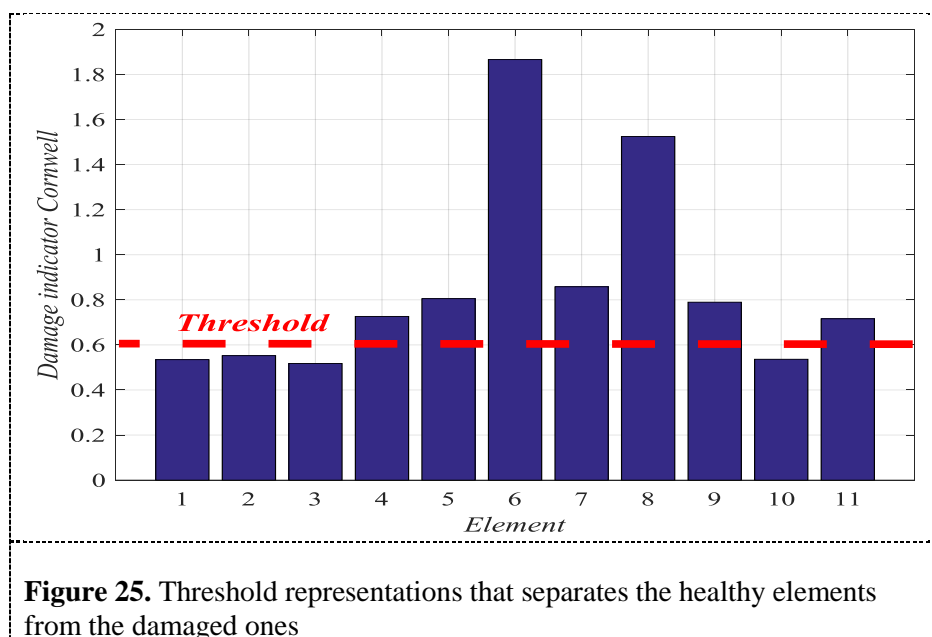
In the Cornwell indicator method, a threshold that separates healthy and damaged components must be fixed (see Figure 25). We notice the existence of several elements which are not damaged, for example, apart from the damaged elements 5, 6 and 8, we note the existence of other damaged elements which are 4, 7, 9, 11. The use of the Cornwell indicator to locate several damages present in the structure studied is conditioned by the determination of a certain threshold separating the damaged state from the healthy state. This threshold is determined by numerical simulations and probabilistic statistical analysis. The proposed indicator facilitates the location of damage, since its concept is qualitative: when the indicator of damage is non-zero, it indicates the presence of damage.

Through the results found by two indicators in all case, we notice that the first indicators have difficulties to locate a damage compared with proposed indicator.
