# Tape as a means to ensure air- and watertightness of building joints – experimental assessment

Van Linden, Stéphanie<sup>1, a \*</sup>, Maroy, Katrien<sup>2, b</sup>, Steeman, Marijke<sup>3, c</sup> and Van Den Bossche, Nathan<sup>4, d</sup>

<sup>1,2,3,4</sup> Faculty of Engineering and Architecture, Ghent University, Sint-Pietersnieuwstraat 41 B4 9000 Ghent, Belgium

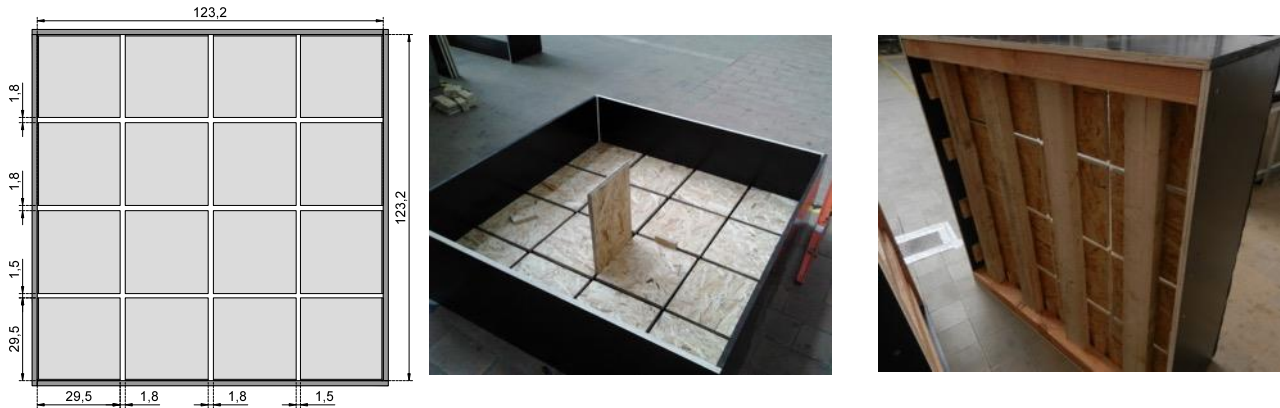
**Test setup.** Laboratory measurements were performed by means of three test setups in order to investigate the airtightness and watertightness of the different tapes and silicone strips on three different substrate materials. The three test setups are all built in the same way and consist of 16 panels with a size of 29,5 x 29,5 cm which are screwed onto a wooden structure surrounded by a

Fig. 1: Test setups: left: dimensions of the setups in cm; middle: 16 panels screwed onto structure; right: wooden structure surrounded by framework at the back of the test setup

framework of plywood. The inner size of the framework is 1,232 x 1,232 m. The perimeter joints between the framework and the panels are made airtight by means of caulking. Between the 16 panels, 3 vertical joints and 3 horizontal joints are created. Two vertical joints have a width of 18 mm. The other vertical joint has a width of 15 mm. The same principle is applied for the horizontal joints.

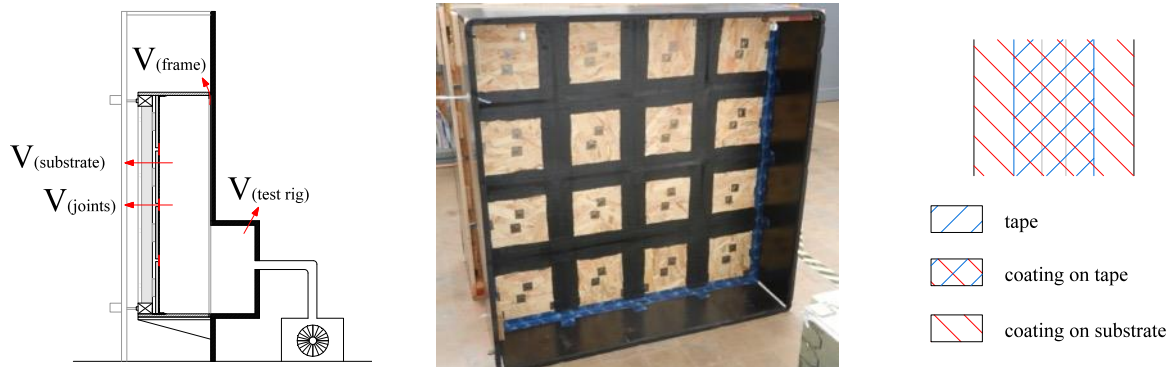
The airflow through the sealed joints ( $V_{\text{joints}}$ ) is derived by subtracting the air leakage through the substrate ( $V_{\text{substrate}}$ ), the frame surrounding the test panels ( $V_{\text{frame}}$ ) and the air leakage through the test rig ( $V_{\text{test rig}}$ ), from the total measured air flow ( $V_{\text{total}}$ ):

The total air leakage through the substrate, the frame and the test rig is measured by covering the joints between the panels of the test setup with a liquid fibre reinforced polymer emulsion which is applied with a paintbrush and dries to a permanent flexible airtight membrane (the airtightness of this coating is tested by means of a smaller test setup with an OSB substrate):

Fig. 2: Calculation of air leakage sealed joints; left: different air leakages through test setup; middle: covered joints; right: covered part of substrate

It should be noted that by applying the coating on the joints, also a part of the substrate is covered to include the lateral air leakages (2 cm on each side of the tape). As the initially flowing air through the covered part of the substrate (red hatched part of fig. 2 right) is not part of the airflow through the joints, a correction needs to be made by means of  $V_{\text{substrate correction}}$ . These measurements are performed for each test setup. The error on the leakage through the tested sealing material will thus be a combination of two measurements. The total error is calculated by the adding in quadrature of the absolute errors of both measurements. Summarized, the total error is a combination of a relative error (3,965%) of the measuring equipment, the propagation error by curve fitting the 8 measurements, the extrapolation of the curve to one air leakage at 50 Pa and the effect of subtracting two airflows.

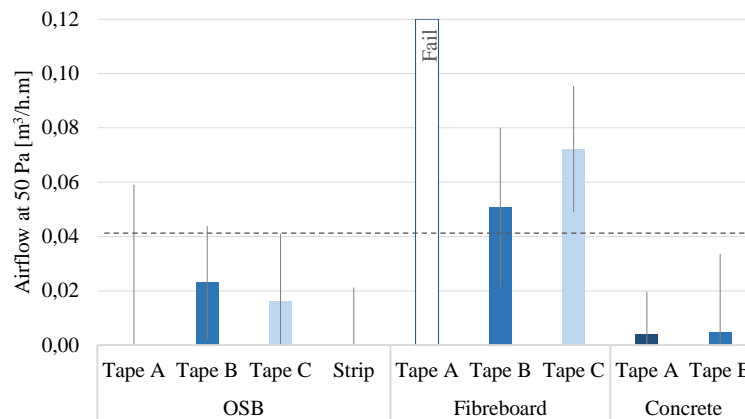
**Airtightness.** The air leakage through the different sealing materials ( $V_{\text{joints}}$ ) is derived from the subtraction of the air leakage of test 10 (sealed joints covered with an airtight coating  $V_{\text{joints covered}}$ ) from the total air leakage of test 7 (after a drying period of 24h  $V_{\text{total}}$ ), and by means of eq. 3. This results in relatively large 95% confidence intervals (represented by the error bars in fig. 4). Figure 4 shows the final airflow per meter joint of the different tapes and silicone strip at a pressure difference of 50 Pa. The dashed line in figure 4 represents the requirement for a very good airtightness according to SBR ( $0,042 \text{ m}^3/\text{h}\cdot\text{m}$ ) [14].

Fig. 4: Final airflow joints sealed with tapes and silicone at 50 Pa pressure difference

These measurements show that tapes adhered to a concrete substrate and silicone strips applied to OSB-panels were the most airtight. In contrast, the largest air flow rates were recorded for the tapes on bituminous impregnated fibreboards. Tape A and B were applied to fibreboards which were first treated with a primer to create a better bonding of the fibres and a hardened surface. Tape C was applied to fibreboards with an additional airtight layer. Even with the primer or the additional layer, the adhesion forces between the glue of the tape and the fibreboard and the adhesion forces between the fibres were low which even caused failure of tape A. A reduced bonding of tape A at the crossings was visible after wetting and a drying period of 24 hours. When pressure was applied, adhesive failure occurred at the crossings. For both the OSB substrate and concrete substrate the better adhesion of the tape resulted in lower airflows. Tape A ( $0,004 \pm 0,016 \text{ m}^3/\text{h}\cdot\text{m}$ ) and B ( $0,005 \pm 0,029 \text{ m}^3/\text{h}\cdot\text{m}$ ) applied to the concrete substrate both meet the requirement for a very good airtightness according to SBR ( $0,042 \text{ m}^3/\text{h}\cdot\text{m}$  dashed line in fig. 4). Also for the silicone strip adhered to the OSB substrate, low air flow rates were recorded. As the silicone layer could be pressed to fill the imperfections of the OSB surface, a low contact angle between the silicone molecules and the OSB could be obtained which resulted in a good bonding. For all of the sealed joints of the OSB substrate (tape A:  $-0,004 \pm 0,063 \text{ m}^3/\text{h}\cdot\text{m}$ ; tape B:  $0,023 \pm 0,021 \text{ m}^3/\text{h}\cdot\text{m}$ ; tape C:  $0,016 \pm 0,025 \text{ m}^3/\text{h}\cdot\text{m}$ ; silicone strip:  $-0,002 \pm 0,023 \text{ m}^3/\text{h}\cdot\text{m}$ ), the absolute measurements are below the maximum air leakage for a very good airtightness according to SBR.

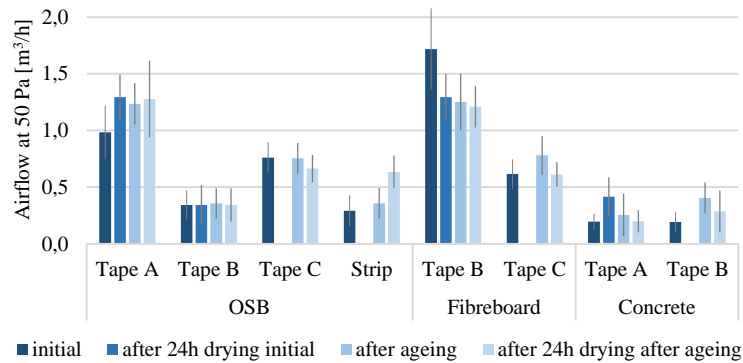
Figure 5 shows the initial airflow of the test setups (1), the airflow after a drying period of 24 hours after wetting during a watertightness test (initially (3) or after mechanical ageing (7)) and the airflow after mechanical ageing (5). The airflow of the entire setups includes the airflow of the substrate ( $0,5\text{-}0,6 \text{ m}^2/\text{setup}$ , depending on the width of the tape) and the airflow of the sealed joints ( $6 \times 1,232 \text{ m}$ ). Tape A was applied to OSB panels with a measured air leakage of  $1,15 \pm 0,31 \text{ m}^3/\text{h}\cdot\text{m}^2$  at a pressure difference of 50 Pa. It is clear that this airflow is much larger than the maximum air leakage provided as a guideline by WTCB ( $0,1 \text{ m}^3/\text{h}\cdot\text{m}^2$ ). It should be noted that the airflow of the OSB was measured after wetting and a drying period of 24 hours at 50 Pa pressure difference, which results in an increase of the air leakage due to swelling of the OSB fibres. However, the increase in air leakage is not large enough for the initial air leakage to fulfil the requirement of WTCB. Tape B, C and the silicone strip were applied to another brand of OSB with a recorded airflow of  $0,28 \pm 0,07 \text{ m}^3/\text{h}\cdot\text{m}^2$  at a pressure

difference of 50 Pa. On the one hand this value is less than half of the air leakage of the previous OSB but on the other hand the recorded air leakage is still larger than the maximum air leakage of WTCB. Therefore, it can be stated that OSB is not always a reliable air barrier material. Tape B was applied to the bituminous impregnated fibreboard treated with a primer and an additional bituminous coating is situated on the backside of the panel. An airflow of  $0,73 \pm 0,19 \text{ m}^3/\text{h}\cdot\text{m}^2$  at 50 Pa was recorded. In contrast, tape C was applied to the additional bituminous coating of the fibreboard and an airflow of  $0,075 \pm 0,187 \text{ m}^3/\text{h}\cdot\text{m}^2$  at 50 Pa was measured, which is ten times smaller than the airflow of the previous setup. If the tape is applied to the additional bituminous coating, a continuous air barrier layer is created. In contrast, when the tape is applied to the other side, the air can flow through the substrate and a larger air leakage is recorded. For the concrete panels, no airflow was recorded.

Fig. 5: Airflow of test setups at 50 Pa initially, after wetting/drying and after ageing

For tape A, an increase of the airflow was recorded after the first time of wetting and a drying period of 24 hours, as a result of a reduced adhesion of the tape on the substrate. For tape B and C, the opposite effect occurs, in particular on the fibreboard substrate. The increased airflow of the test setup with silicone strip is mainly due to the swelling of the OSB fibres. After mechanical ageing no remarkable difference of the air leakage was measured if this ageing was preceded by wetting and drying. When the mechanical ageing was performed right after the initial airtightness test, only a small significant increase of the air leakage through tape C on the fibreboard substrate and tape B on the concrete substrate was measured. The second time of wetting and a drying period of 24 hours has no impact on the air leakage of the setups.

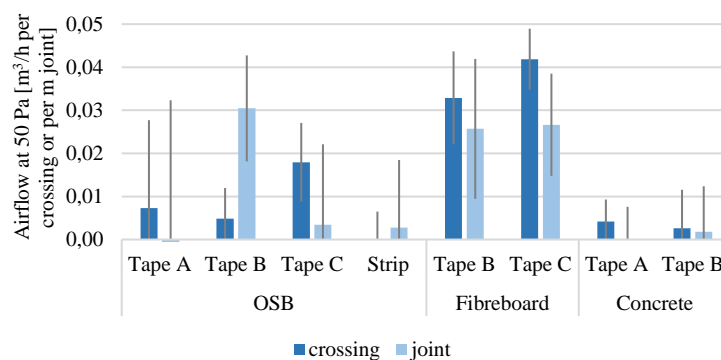
Furthermore, the impact of 9 crossings on the overall air leakage in comparison with the impact of the intermediate parts of the joints (4,9 – 5,2 m depending on the width of tape) is tested by covering the crossings and afterwards the sealed joints with an airtight coating. Next to that, 2 cm of the substrate on each side of the tape was covered to include lateral air leakages. Figure 6 shows the air flow per crossing and per m joint at 50 Pa pressure difference. The error bars in figure 6 represent the 66% confidence interval.

Fig. 6: Airflow of crossings and intermediate joints at 50 Pa

For tape B applied on OSB, the impact of the joints on the total air leakage is larger than the impact of the crossings. For tape B applied on the fibreboard substrate this difference was not observed. In contrast, for tape C the impact of the crossings is larger for both the OSB and fibreboard substrate. However, due to the relatively large absolute errors of the measurements, no conclusive observations could be made.

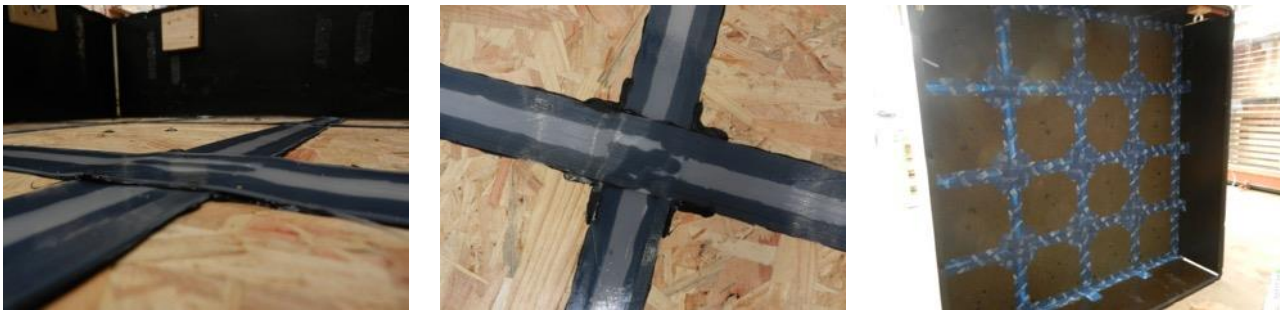
Since the different panels are not situated perfectly in the same plane, the tape needs to bridge small differences in height. This results in a reduced adhesion between the tape and the substrate mainly at the crossings. At these crossings a vertical tape needs to overlap a horizontal one which results in an additional difference in height and a reduced adhesion. Due to the thickness of the silicone strip, the adhesion between the strip and the silicone was insufficient at some locations of the crossings. Therefore, the addition of silicone at the 9 crossings resulted in a large decrease of the air flow (initially:  $1,50 \pm 0,17 \text{ m}^3/\text{h}$  - after addition of silicone:  $0,29 \pm 0,15 \text{ m}^3/\text{h}$ ). Also the application of additional crosses of tape diagonally adhered over the crossings of tape C to the bituminous impregnated fibreboard reduced the air leakage with more than 50% (initially:  $0,58 \pm 0,10 \text{ m}^3/\text{h}$  – after addition of cross:  $0,24 \pm 0,12 \text{ m}^3/\text{h}$ ).

Fig. 7: Impact of crossings; left: openings at crossings silicone strip; middle: addition of silicone at crossings; right: addition of crosses of tape at crossings

Both tapes and silicone strip are pressure-sensitive adhesives, which means they need pressure to ensure bonding. Therefore, attention must be paid to pressurize the tape and silicon strip sufficiently especially at the crossings where an overlap of a vertical and horizontal tape exists to ensure a good adhesion.

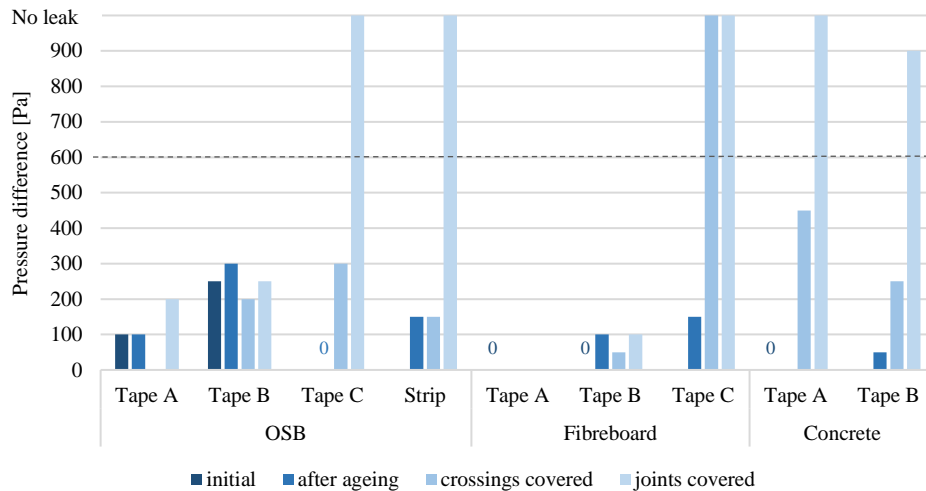
**Watertightness.** Figure 8 shows at what pressure difference the first water leak was observed for each setup. The dashed line represents the requirements of class 9A (height of 25-50 m and near the sea or open terrain) according to the classification of NBN B 25-002-01 for windows [18].

Fig. 8: Pressure difference first observed water leaks

In the test sequence, the horizontal joint is always sealed first and thereafter the vertical joint. The results show that the watertightness of the tapes and silicone strips is rather poor. Even at small pressure differences or without a pressure difference leakages were observed, mainly at the crossings. The watertightness of the tapes and silicone strip is initially not sufficient to meet the requirements of a class 9A according to NBN B 25-002-01 for windows [18] which corresponds to no water leakages at a pressure difference of 600 Pa (represented by the dashed line in fig. 8). However, in reality an airtight layer on the inside of the building envelope will reduce the pressure difference (partially) over the watertight layer. In addition, water is sprayed directly onto the sealed joints. In reality, a cladding is usually installed in front of these joints. The watertightness test is therefore a worst-case scenario. As a result, these requirements are perhaps too severe to compare with the obtained results. When the watertight layer has an airtightness similar to the airtightness layer, half of the wind load will act on the watertightness layer. If the air barrier is 10 times more airtight than the watertight layer, a pressure equalization above 90% is typically obtained [23]. Assuming a conservative and safe approach, one might adopt 300 Pa as a reasonable generic performance requirement if no further information is available.

The first time of wetting and drying has an impact on the performance of the tested materials. The bonding of the adhesive of tape B on the substrates for example improves after wetting and drying and therefore results in an increased watertightness. The first leaks occur at the same location but at a higher pressure difference: first leak OSB initial: 250 Pa – first leak OSB second time of wetting: 300 Pa; first leak fibreboard initial: 0 Pa, first minute of test – first leak fibreboard second time of wetting: 100 Pa. Furthermore, the subsequent times of wetting and drying also have an impact on the performance of the materials as well as the duration of wetting. It is therefore not possible to make conclusive observations on the impact of mechanical ageing (200 pulsations of 1000 Pa).

When the crossings of a vertical and horizontal tape are covered with a coating, the watertightness of tape A and C improves since initially most water leakages were observed at these crossings: tape A OSB: from 100 Pa to 200 Pa, tape A concrete: from 0 Pa to 250 Pa, tape C OSB: from 0 Pa to 300 Pa, tape C fibreboard: from 150 Pa to no leaks at 900 Pa. Tape C on the bituminous impregnated fibreboard therefore meets the requirement for a watertightness class 9A. The performance of tape B on OSB and fibreboard does not improve by application of a coating. This tape absorbs the coating partially and therefore influences the performance. The addition of a coating on the crossings of the silicone strip does not improve the watertightness explicitly since leakages at the joints still occur. It was observed that the effect of an extra cross of tape adhered diagonally over the crossings of tape C to the bituminous impregnated fibreboard is equal to the effect of the coating: no water leakages were observed at a pressure difference of 900 Pa and therefore the setup meets the requirements of a
