Journal section: *Clinical and Experimental Dentistry*
 Publication Types: *Research*

A clinical longitudinal study 323 porcelain laminate veneers. Period of study from 3 to 11 years

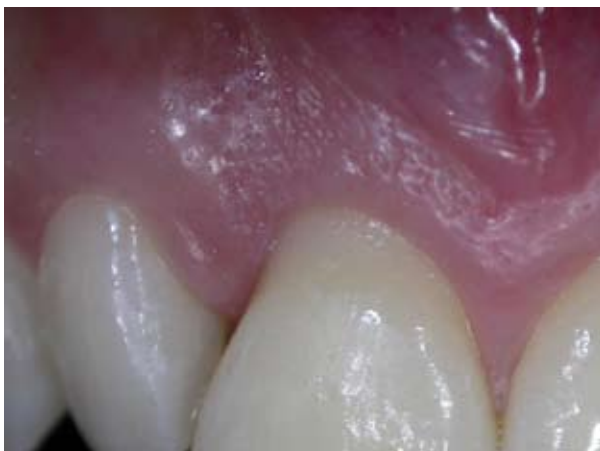
Fig. 1. Image prior to treatment with four porcelain laminate veneers.

Currently, the use of porcelain laminate veneers is almost routine for patients with alterations in the shape and color of their teeth, as well as in slight malpositions, closing of gaps, etc., a set of indications that are modified and broadened as dentists acquire more confidence in the technique and as the ceramics improve in their esthetic and resistance properties (2,3). (Fig. 1 and 2)

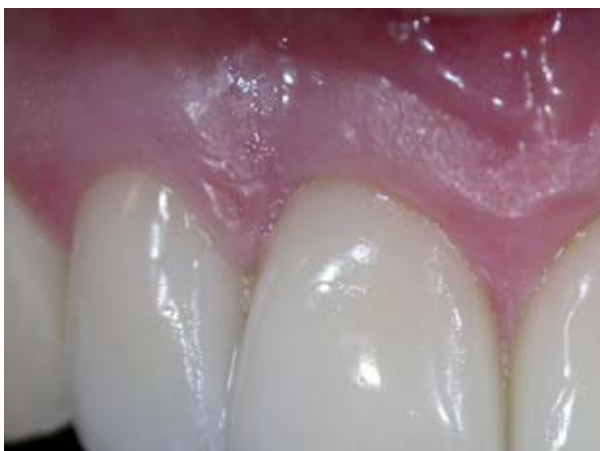
Fig. 2. Case resolved with four porcelain laminate veneers.

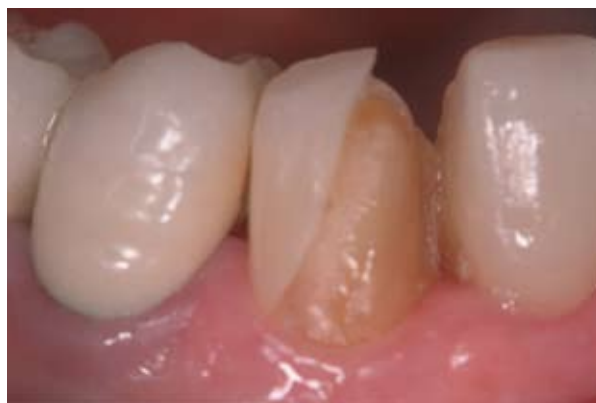
Fig. 3. Fracture of a front porcelain laminate veneer.

Fractures: We observed a total of 13 fractures (4%), which included 11 in functional design restorations (corresponding to 84.6% of the fractures) and 2 in simple design restorations (corresponding to 15.4% of the fractures) (Fig. 3).

Decementations: The total number of decemented restorations observed in this study was 29, which represents 9% of the sample. They were distributed homogeneously, given that 14 were in functional design restorations and 15 were in simple design restorations (Fig. 3).
