Enamel loss and adhesive remnants following bracket removal and various clean-up procedures *in vitro*

Sacha Ryf*, Simon Flury**, Senthamaraiselvi Palaniappan***, Adrian Lussi**, Bart van Meerbeek*** and Brigitte Zimmerli**,***

SUMMARY This study evaluated the enamel loss and composite remnants after debonding and clean-up. The tested null hypothesis is that there are no differences between different polishing systems regarding removing composite remnants without damaging the tooth surface. Brackets were bonded to 75 extracted human molars and removed after a storage period of 100 hours. The adhesive remnant index (ARI) was evaluated. The clean-up was carried out with five different procedures: 1. carbide bur; 2. carbide bur and Brownie and Greenie silicone polishers; 3. carbide bur and Astropol polishers; 4. carbide bur and Renew polishers; and 5. carbide bur, Brownie, Greenie and PoGo polishers. Silicone impressions were made at baseline (T0) and after debonding (T1) and polishing (T2) to produce plaster replicas. The replicas were analysed with a three-dimensional laser scanner and measured with analytical software. Statistical analysis was performed with the Kruskal–Wallis te

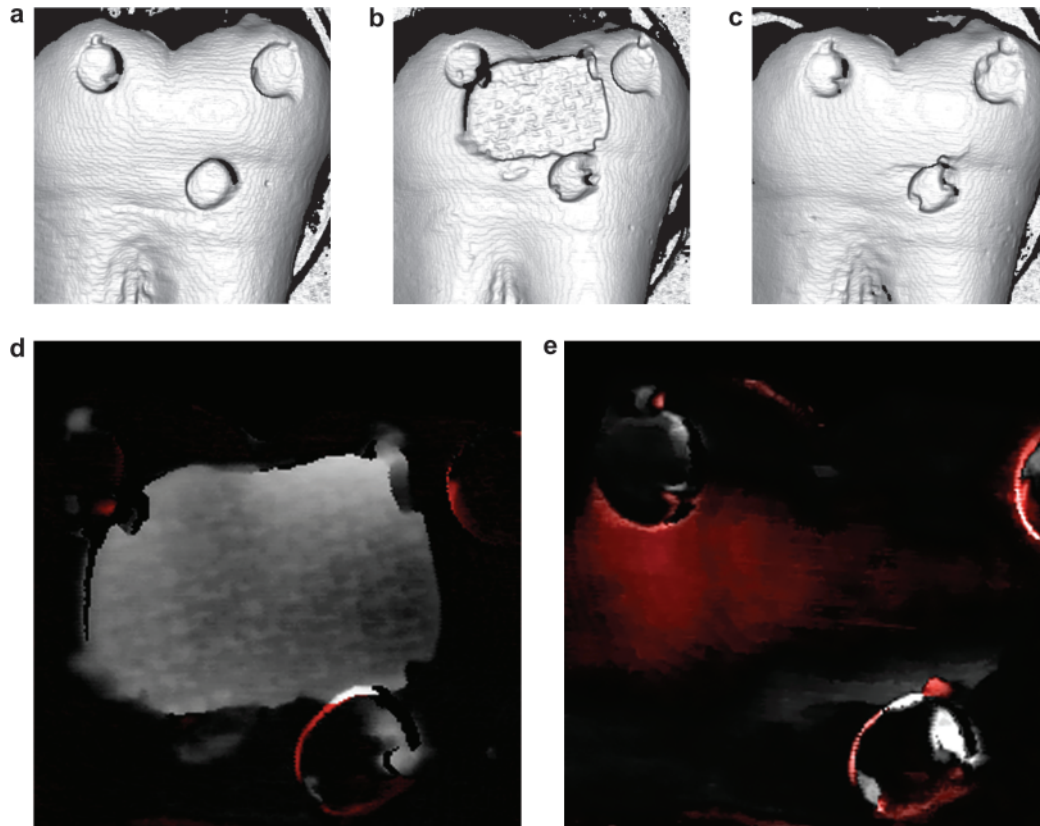
Figure 1 Images at baseline (T0). (a), after bracket removal (T1) (b) with a clearly visible resin remnant, after clean-up (c) and differences after overlapping baseline T0 and T1 (d). Resin remnant is shown (white) and (e) T0 and T2. Loss of surface substance (red) and resin remnants (white) are visible.

Silicone impressions (President microSystem light/regular body; Coltène/Whaledent AG, Altstätten, Switzerland) were taken of the buccal surfaces of the teeth. Baseline models (T0) were produced in dental stone (Fuji Super Hardrock, GC, Leuven, Belgium) and scanned with the 3D imaging device (Laserscan 3-D Pro; Willytec GmbH, Gräfelfingen, Germany) to establish T0 data (Figure 1a).

The brackets were debonded by gently squeezing with Weingart pliers (3M Unitek). A second impression was taken of the buccal surfaces of the teeth after debonding (T1), and replicas were made in dental stone (Figure 1b).

A third impression (T2) was then taken of the surface of every tooth (Figure 1c).

By matching T1 to T0, the height and volume of composite remnant was recorded (Figure 1d). If present, enamel defects were recorded in terms of depth of lesion and volume loss. Therefore, the areas of interest analysed from the differential image were selected and separately measured. Comparing the T2 with the T0 models, vertical and volumetric changes in surface geometry were measured (Figure 1e). However, enamel breakouts that were recorded by superimposing T1 on T0 were always at the margin of the area of interest and excluded from further surface analysis. If defined, composite remnants were left, and the height and volume of the remnants were separately recorded.

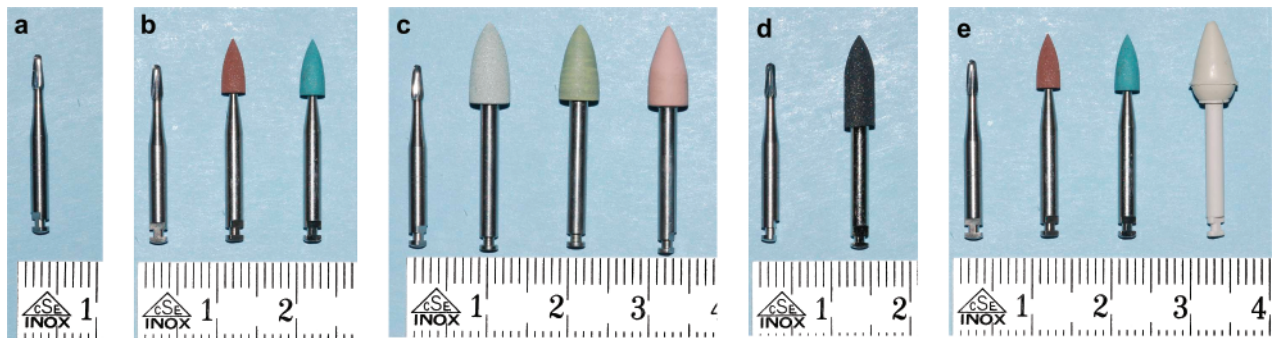
Figure 2 (a) Group 1 (carbide bur). (b) Group 2 (carbide bur, Shofu Brownie and Shofu Greenie). (c) Group 3 (carbide bur, Astropol polishing system: F, P, and HP). (d) Group 4 (carbide bur, Renew System). (e) Group 5 (carbide bur, Shofu Brownie, Shofu Greenie, and PoGo polisher).

The residual adhesive on each tooth in the five groups was removed using one of the five following protocols: group 1, carbide bur (Figure 2a); group 2, carbide bur followed by Brownies and Greenies (Figure 2b); group 3, carbide bur followed by Astropol F, P, and HP polishers (Figure 2c); group 4, carbide bur followed by the Renew System (Figure 2d); and group 5, carbide bur followed by Brownies and Greenies and finished with a PoGo polisher (Figure 2e).

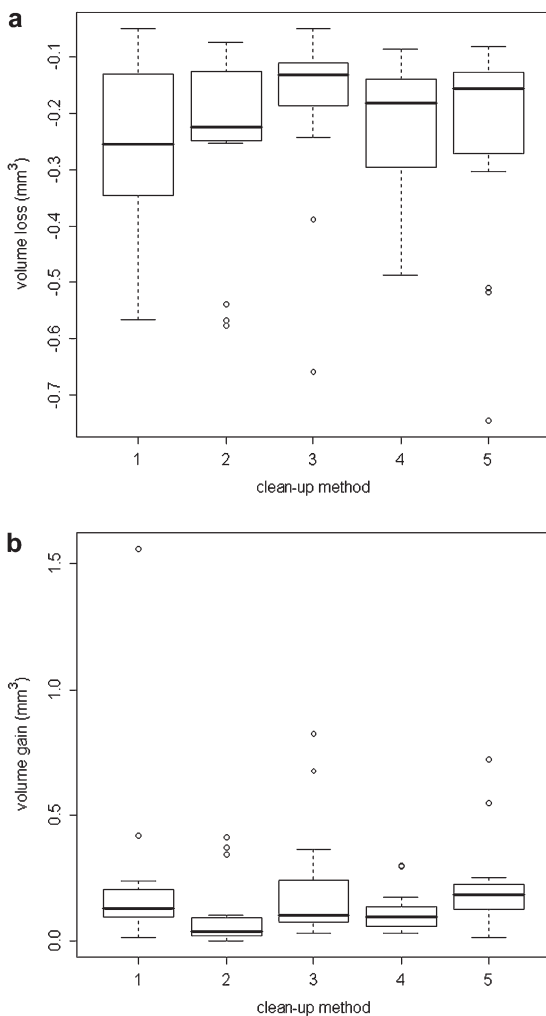
Figure 4 Loss of volume (a) and composite remnants (b) after clean-up with five different methods. Groups as listed in Table 2.

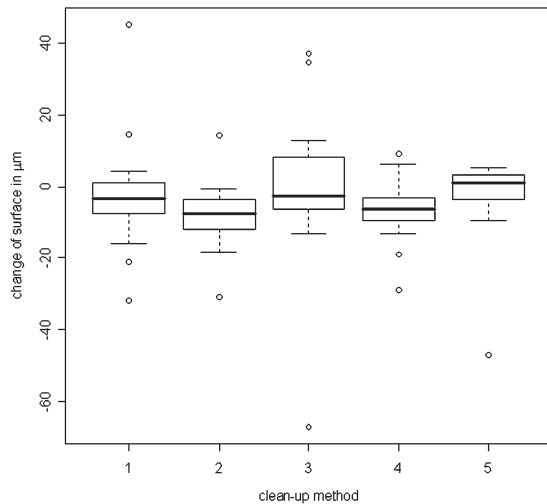
Figure 5 Surface alteration after clean-up with five different methods. Groups as listed in Table 2.

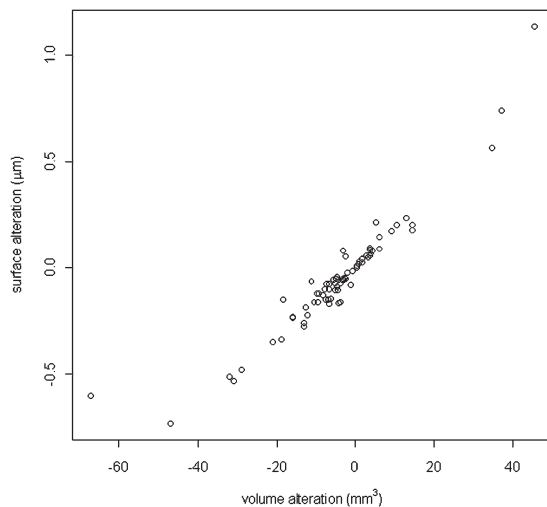
Figure 6 Correlation of linear versus volumetric surface changes. Spearman rank correlation coefficient = 0.95.

other groups showed no significant differences, although the difference between groups 4 and 5 was almost significant ($P = 0.04$; but not significant due to Bonferroni correction). Comparisons of the variances of the different clean-up procedures' total volume loss and composite remnants showed that there were differences, although not significant, between the groups (Figure 4a and 4b). The least aggressive method for enamel, with minor removal of hard dental substance, was found in group 3. The method in group 1 seemed to be more aggressive. However, all methods left some remaining composite on the tooth surface, with group 5 leaving the most. Spearman correlation showed a clear linear correlation of volume alteration to linear surface alterations (correlation coefficient: 0.95; Figure 6).
