SOME THOUGHTS ON AVOIDING METALLURGICAL FAILURES

by
Paul S. Gupton
Metallurgical Consultant
An-Tech Laboratories, Inc.
Houston, Texas

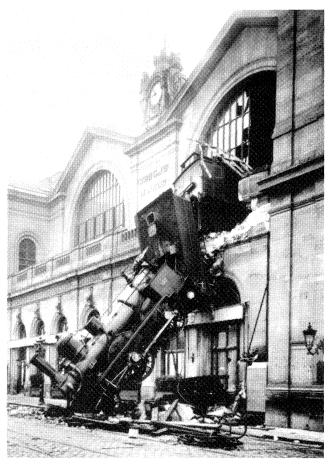
Figure 1. Mechanical Failure or Human Error?

In service failures of most equipment are, in the majority of instances, directly attributable to the failures of *people* and in most cases easily *preventable*, as demonstrated in Figure 1. Fundamental factors that lead to failures of mechanical equipment are:

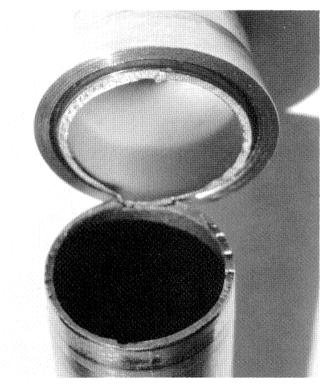
Figure 10. Compressor Lube Oil Line Failure Resulting in Plant Shutdown.

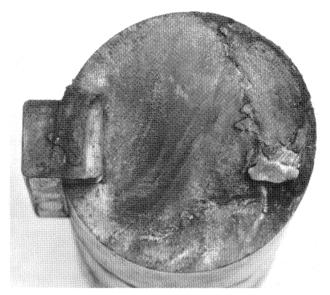
Figure 12. Bending Fatigue Failure of a Pinion Gear Shaft Due to Improper Alignment.

Stress overloads (Figures 12, 13, and 14), excessive temperatures (hot or cold), inadequate lubrication, abnormal corrosive environments, excessive speed, shock, both thermal and mechanical, and excessive wear are all common misuse or misoperations that can promote premature component and material failures. Abnormal wear from erosion, galling, seizing, gouging, or cavitation are all too common. Loss of metal from corrosion including chemical attack, liquid metal corrosion, stress accelerated corrosion, corrosion fatigue, and metallurgical changes by corrosion such as dezincification or graphitization. Inadequate or improper maintenance such as poor lubrication, weld repairs, contamination, cold straightening without thermal stress relieving and routine wear compensation can lead to accelerated wear resulting in deformations that promote fatigue of rotating and stationary components.
