# DATA COLLECTION FOR DEVELOPMENT OF ASSESSMENT METHODS OF FIRM ROOF FAILURE BASED ON MINE SURVEYING OBSERVATIONS

Eva JIRÁNKOVÁ<sup>1</sup>, Jitka MUČKOVÁ<sup>2</sup>

For these reasons, in order to assess the roof failure an optimum time interval has been proposed of periodic height measurements of stabilized points of the surface observation station in the area of the 9<sup>th</sup> block of the Karviná Mine, Lazy Plant. The surveying work is funded by the GA CR grant project 105/09/P277, dealing with the issue solution.

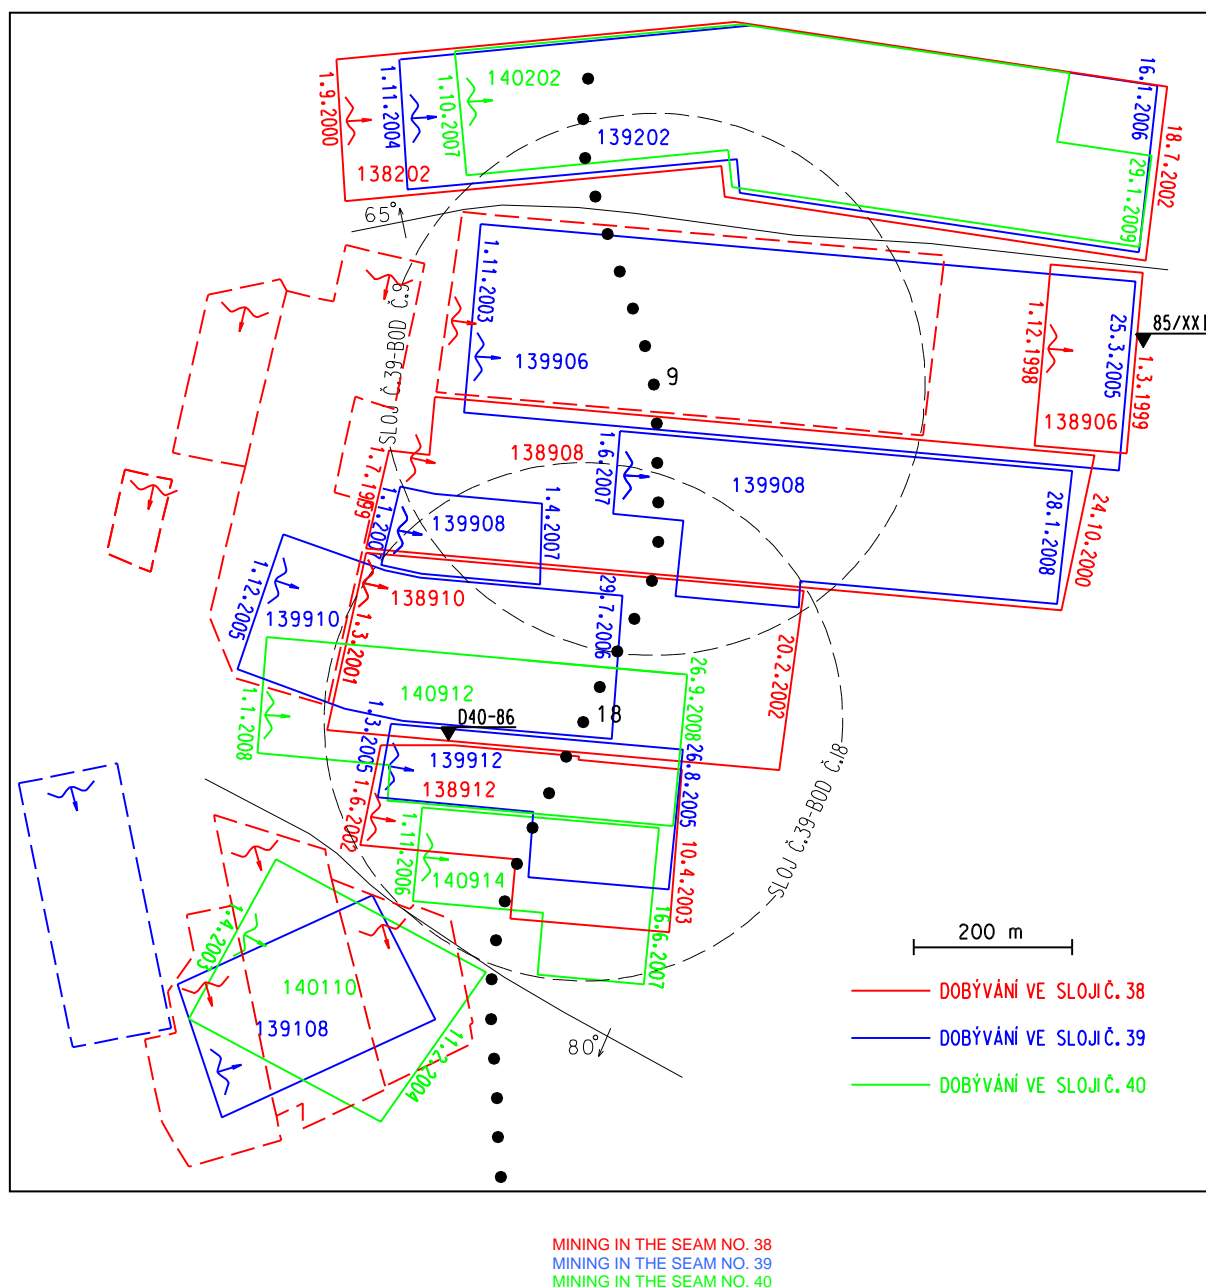
**Fig. 1** Overview of mining in seams No. 38, No. 39 and No. 40 in the area of the 9th block of the Karviná Mine, Lazy Plant

In the area of the 9th block of the Karvina Mine, Lazy Plant, the extracted part of the seam No. 38 is located at an average depth of 625 m, the seam No. 39 at a depth of 640 m and the seam No. 40 at an average depth of 708 m. The mentioned seams belong to saddle strata of the Karvina strata series. The general dip of strata of the 9th block is 6 - 7° towards NNE. The mining is performed by the method of longwall mining along the strike with roof control [2].

The first assessed seam No. 38 is situated ca 115 m under the previously extracted seam No. 37. The extracted thickness of the seam No. 38 varied from 4.55 to 5.65 m. The intermediate stratum of the seams No. 37 and No. 38 is formed predominantly by sandstone.

The seam No. 39 is situated ca 15 m under the seam No. 38. The extracted thickness of the seam No. 39 varied from 4.10 to 5.80 m. The intermediate stratum of the seams No. 38 and No. 39 is formed predominantly by sandstone.

Currently the mining is performed in the seam No. 40 with an average thickness of 4 m. The intermediate stratum of the seam No. 40 and No. 39 has a mean thickness of 60 m and is created predominantly by sandstone [3].

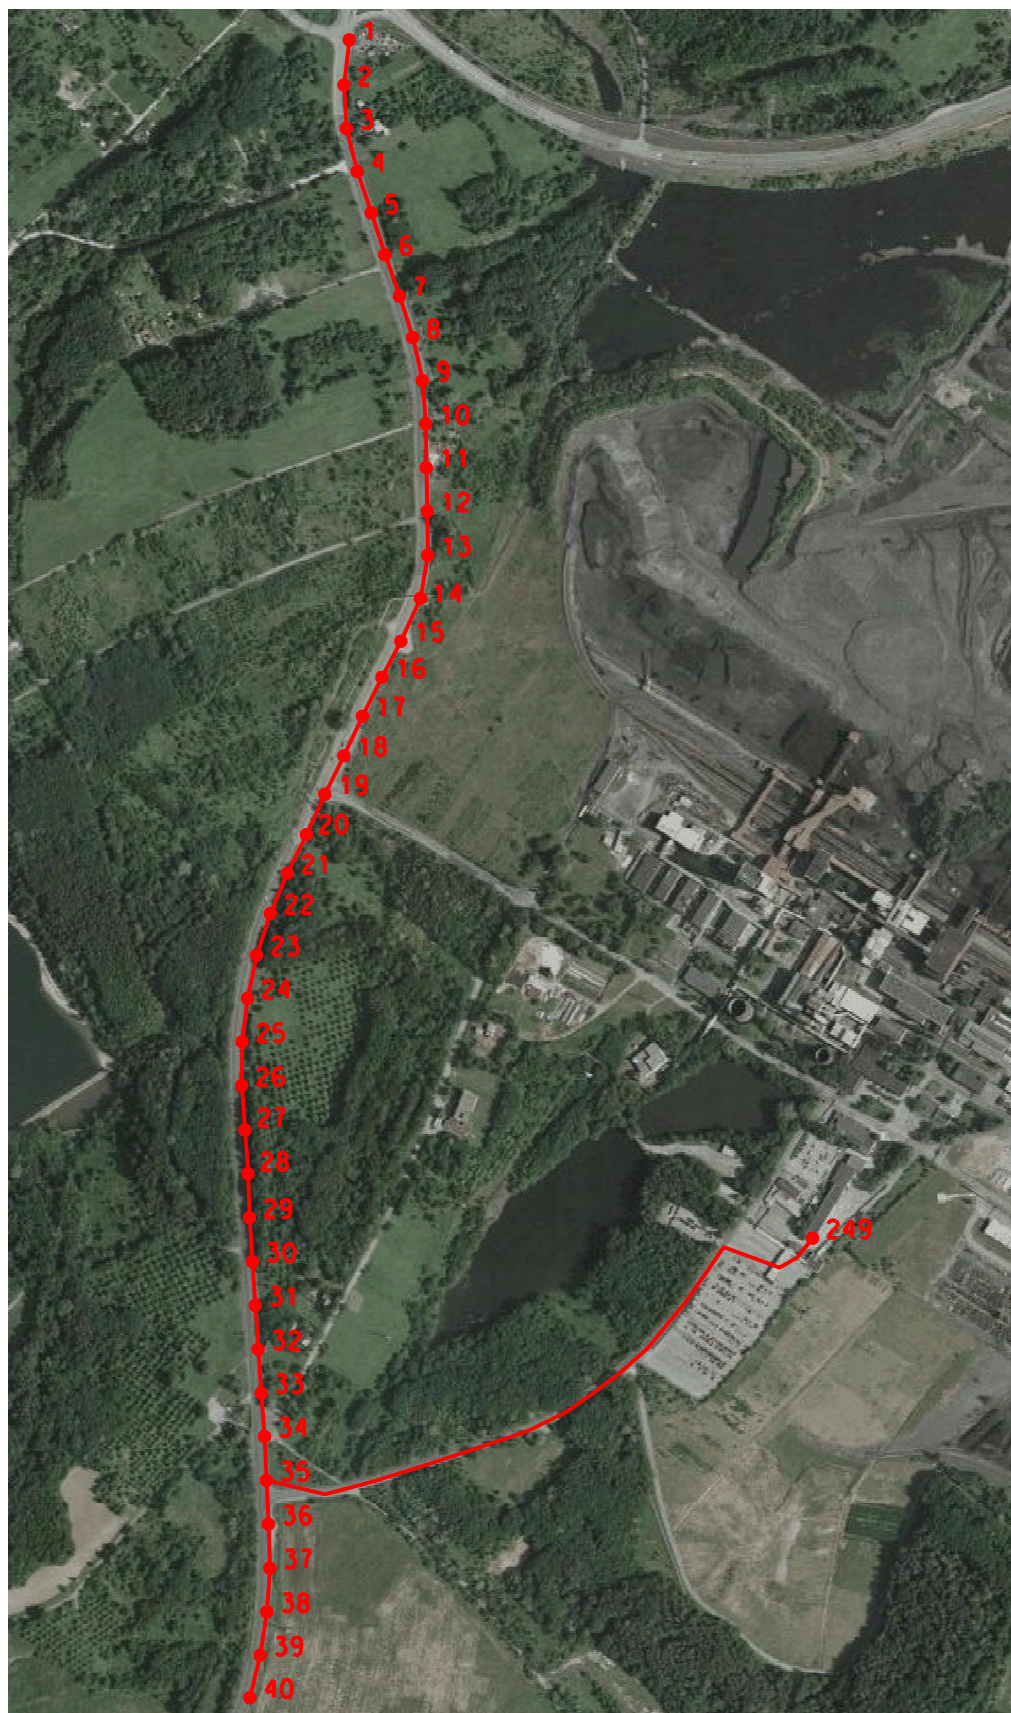
**Fig. 2** Height attachment of the line observation station

Surface measurements of heights of the survey line points have been performed so far in six-month intervals. Individual points of the survey line (line observation station) are stabilized at the edge of a road and their distance is ca 50 m. Mutual positions of the points of the line observation station and the individual mined-out stopes is illustrated in Fig. 1. The height attachment of the survey line is realized by a connecting traverse between the initial point No. 249 stabilised by a rivet on a garage building of the Lazy Plant and the point No. 35 of the survey line, Fig. 2. The length of the connecting traverse is ca 0.75 km. The height of the starting point is determined in two- to three-year intervals by a coal field levelling. The subsidence of the starting point No. 249 varies from 10 to 60 mm in two to three years, the last coal field levelling was performed in autumn of the year 2008. The calculation of the heights of the survey line points results always from the new determined height of the initial point No. 249. The formation of a subsidence trough is obvious from Fig. 3, where also individual areas of stopes in the survey line are represented as well.

The own periodic height measurements with a monthly interval is realized at the surface points of the original line observation station in the area of the 9th block of the Karviná Mine, Lazy plant. At the same time the way of the attachment of the survey line to the point No. 249 was maintained, in order to be possible to resume the results of earlier measurements at this observation station and use, during the calculation of subsidence from own measurements, initial point heights determined during the first height measurements at this observation station accomplished on October 19, 1998. It is thus ensured that the results of own measurements can be interpreted in assessing the roof failures in relation to the earlier assessments.

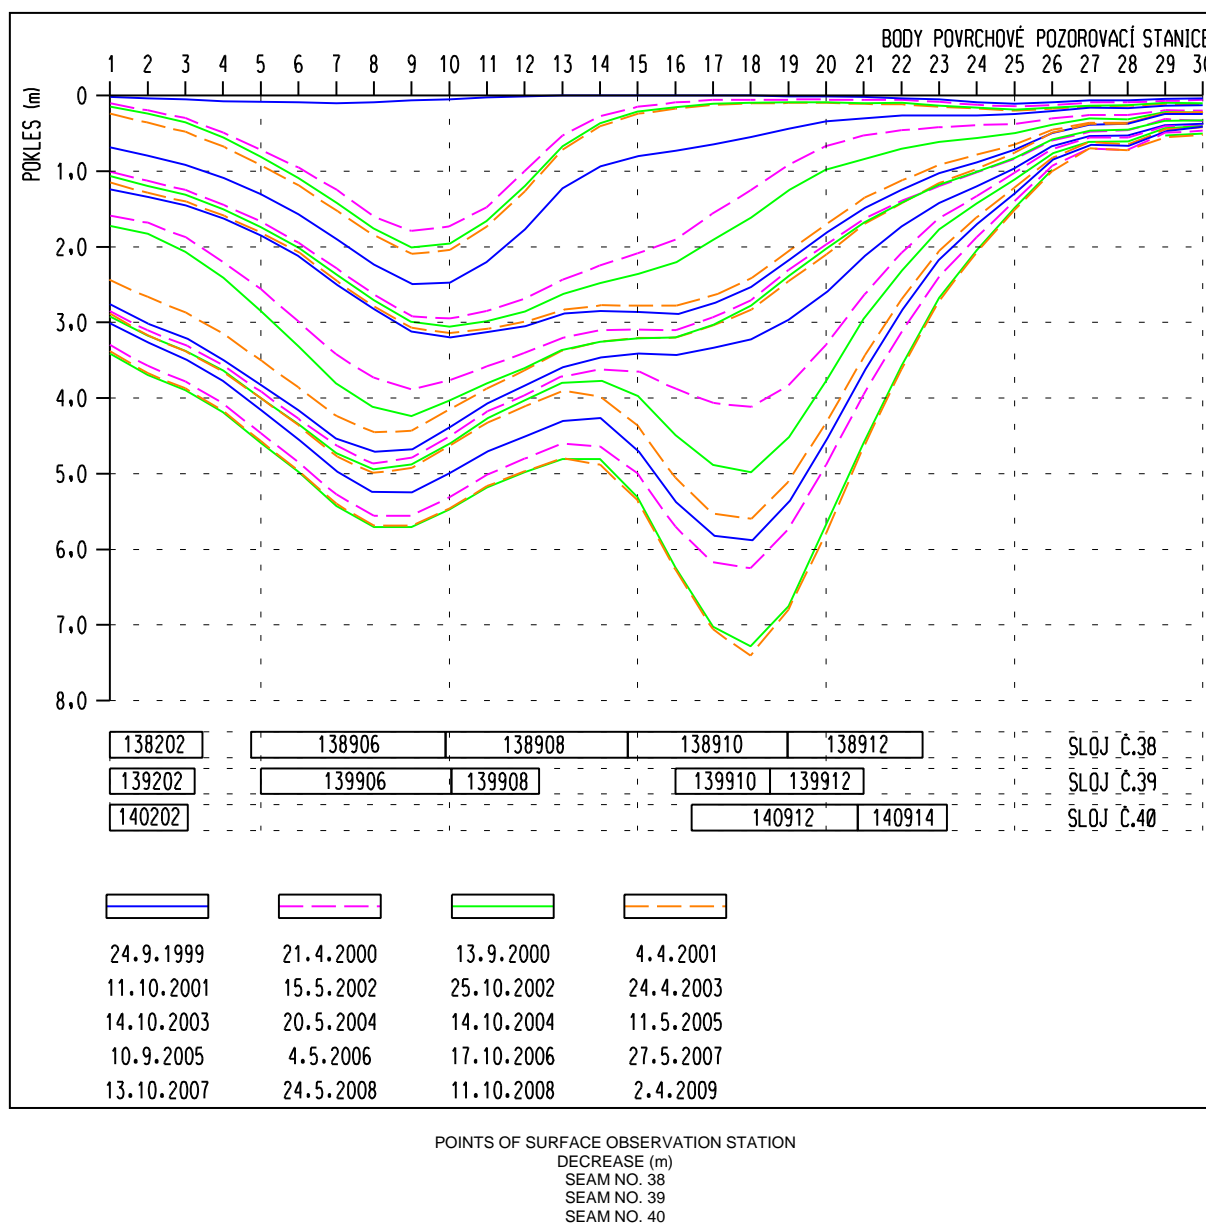
**Fig. 3** Formation of the subsidence trough in the line of the observation station

The balanced point heights of the survey line are used for the calculation of subsidence relating to the first measurement at the observation station as mentioned above. The graphic representation of subsidence as of April 2<sup>nd</sup>, 2009 and previous development of the subsidence trough are represented in Fig. 3. The subsidence resulted from the following measurements on April 30<sup>th</sup>, June 4<sup>th</sup> and July 9<sup>th</sup>, 2009 was not processed graphically, because there was practically no gradual growth of subsidence from the measurement accomplished on October 11<sup>th</sup>, 2008, and by plotting of all curves of subsidence of all measurements Fig. 3 would become confused.
