## INTRODUCTION

## MATERIALS AND PROPERTIES

## EXPERIMENTAL METHOD

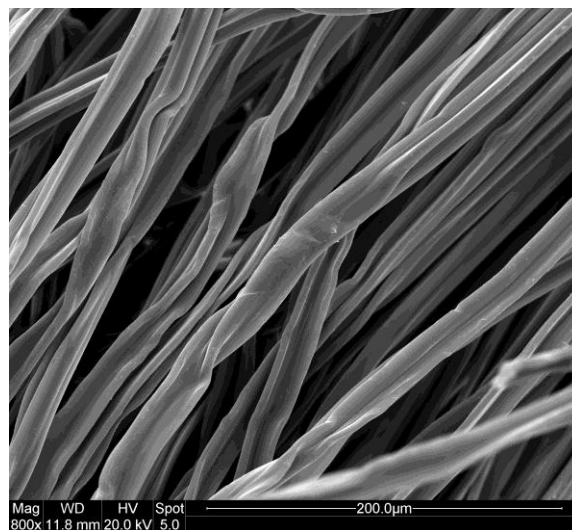
Figure 1 Cigarette filter fibre (800x magnification) – source Northumbria University laboratory

The cellulose acetate fibres are white colour, and packed tightly together to form a filter and they look like cotton. Seeing the white faced cigarette filter with the naked eye and compression of the filter column with the fingers, would suggest that the filter is made of sponge like material. Nevertheless, opening of the cigarette filter by cutting it in lengthwise in razor shows that it consists of a fibrous mass. Teasing apart the fibre matrix would reveal more than 12,000 white fibres per cigarette filter. Microscopically these fibres are Y shaped [4] and the fibres as used in this test are shown in Figures 1 and 2.

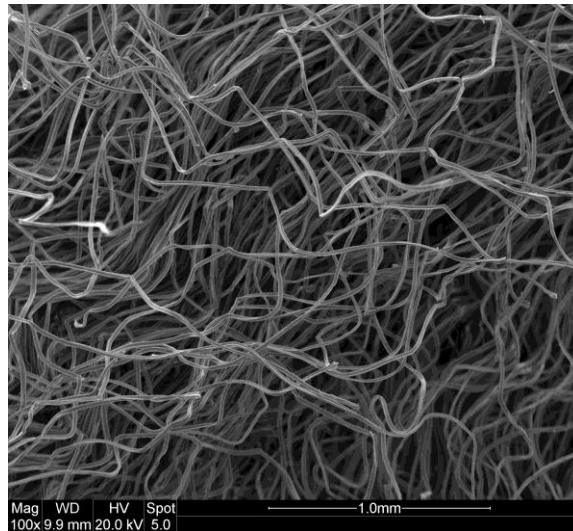
Figure 2 Cigarette filter fibre (100x magnification) – source Northumbria University laboratory.

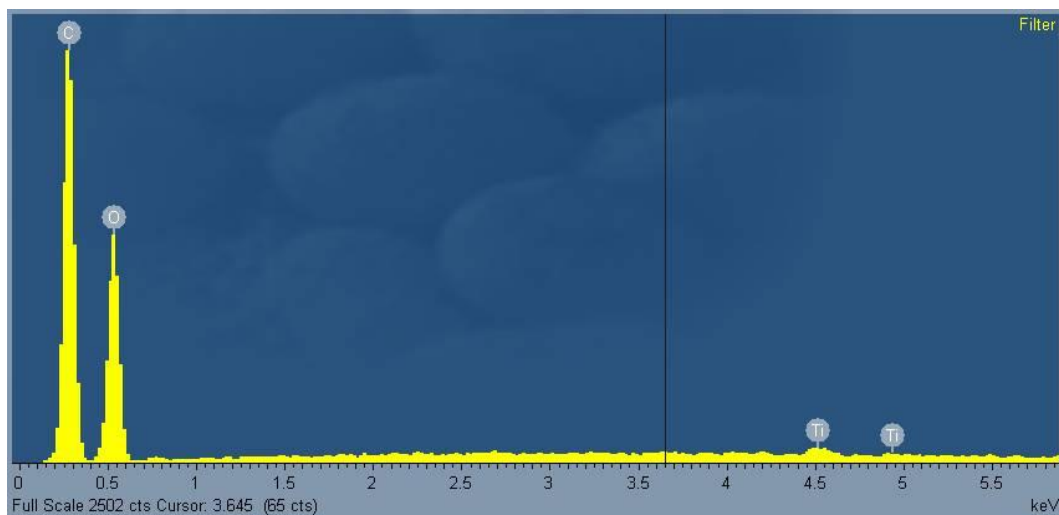
The cigarette fibres were teased apart to separate the filter material prior to being added to the concrete mix to allow the individual stands to be coated and react with the cement paste. Fig 3 illustrates the Energy Dispersive Spectroscopy (EDS) image analysis of cigarette filter which shows the main chemical constituents as being carbon and oxygen.

Figure 3 EDS Image of cigarette filter – source Northumbria University laboratory

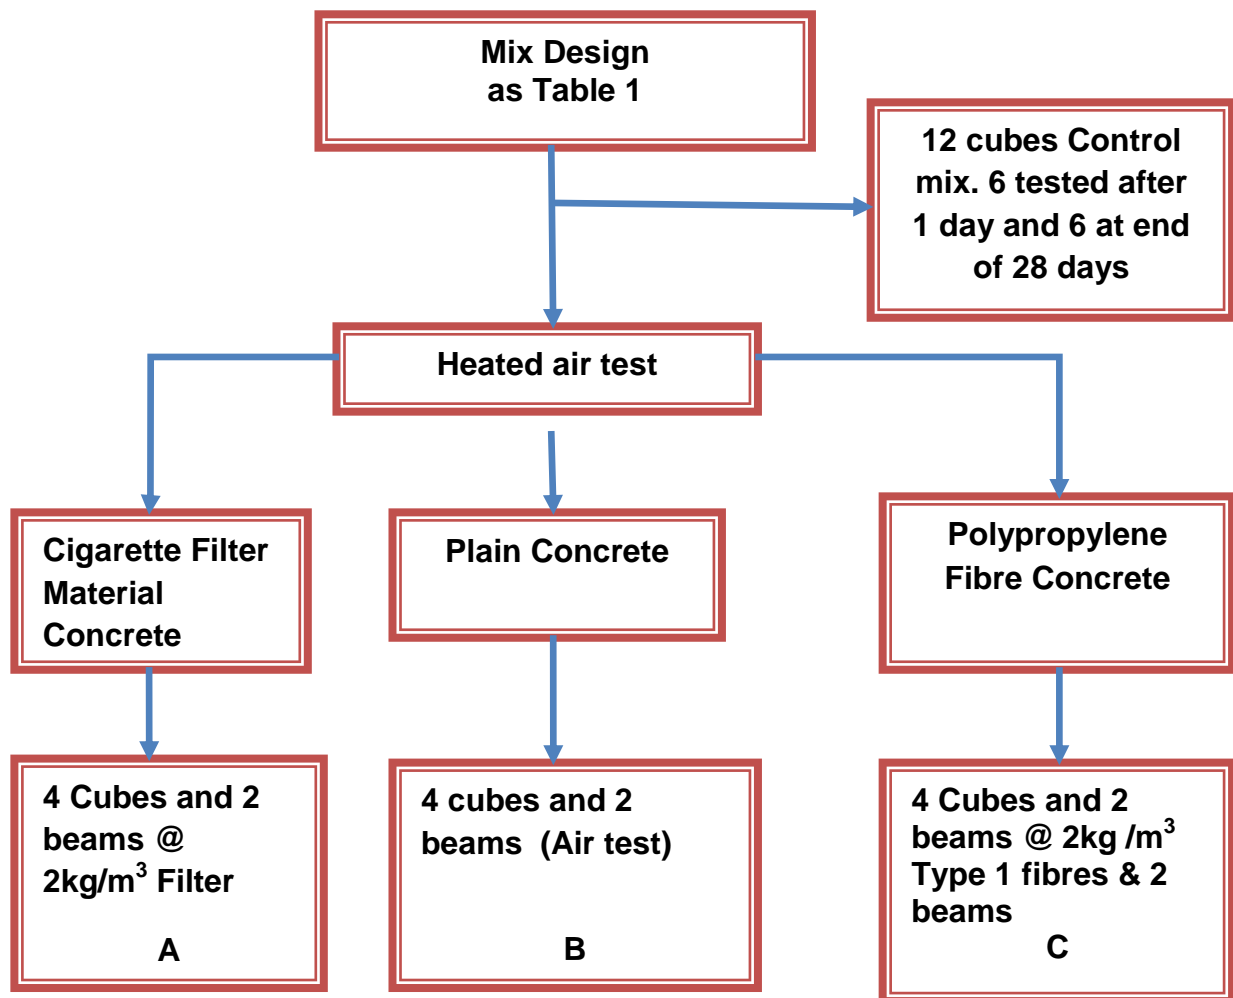
Figure 4 Test programme

The total of large aggregate within the mix was kept to a minimum to prevent aggregate segregation during the plastic phase. The water cement ratio was 0.45. Figure 4 illustrates the test program for this research.

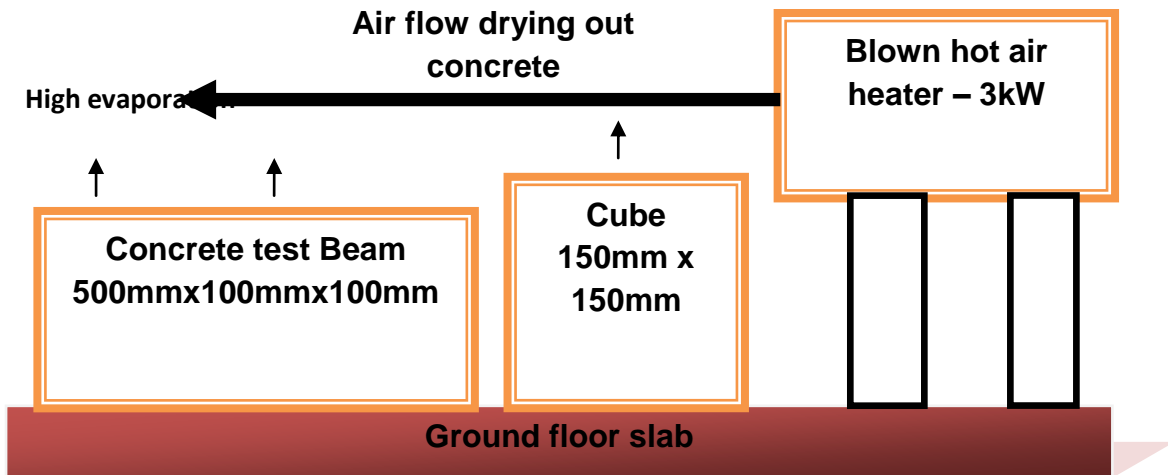
The drying shrinkage test was conducted as described in Figure 5. Cast the beams and cubes and start heater once the slab is towelled and leave for 6 hours with the blown air heaters on. The heater was positioned 600 mm from the nearest cube. The next day the cracks were measured with an optical microscope (Surveying type). Compressive strengths were taken at 1 day and 28 days. Conclude as to the effect of fibres with regard to drying cracking compared to plain concrete.

Figure 5 Test method for drying shrinkage

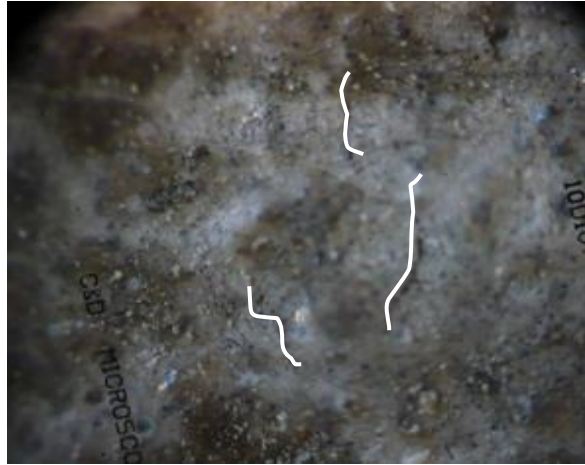
Figure 6 Shrinkage cracking on cigarette filter concrete

The slump for the plain concrete was 70mm whereas the fibre concrete produced a slump of 20 mm. The concrete test showed that there was not a great deal of shrinkage cracking on the surface of the concrete between 1 and 28 days. The cracking was not significant and the main reason for this was the low water cement ratio and saturated aggregates. Fig 6 – Fig 8 shows the images of shrinkage cracking which was taken with a crack detection microscope (CDM). The greatest degree of shrinkage cracking was observed mainly on plain concrete with 15% more cracks being observable when compared to the fibre concrete. The cracking was of a greater width than the fibre concrete. Shrinkage cracking which occurred was barely noticeable with the naked eye and it was only defined with crack detection microscope (CDM). This microscope is a high definition instrument which is operated with an adjustable light source. Measurement of the surface cracking was a superficial means of comparing data as no account was taken of crack area or depth, the frequency of the crack occurrence was the main characteristic measured.

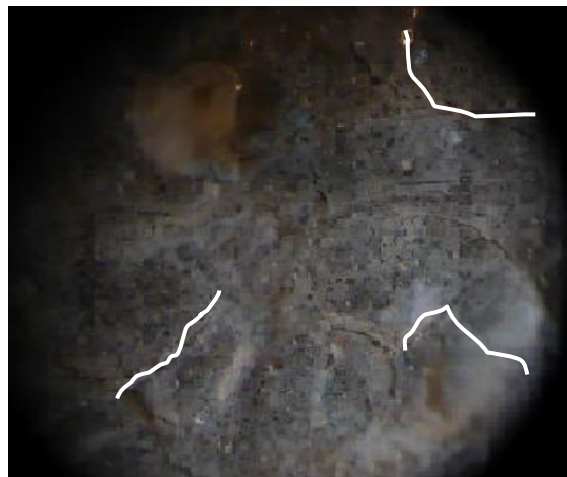
Figure 7 Shrinkage cracking on polypropylene fibre concrete

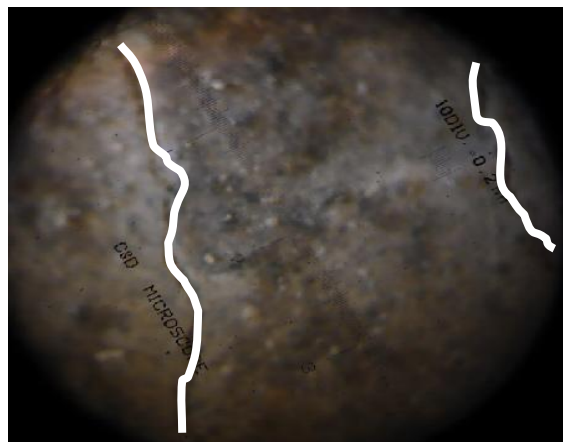
Figure 8 Shrinkage cracking occurrence on plain concrete
