EXPERIMENTAL VERIFICATION OF SELECTED RISK FACTORS DISRUPTING ECALL SYSTEM FUNCTION

Review article

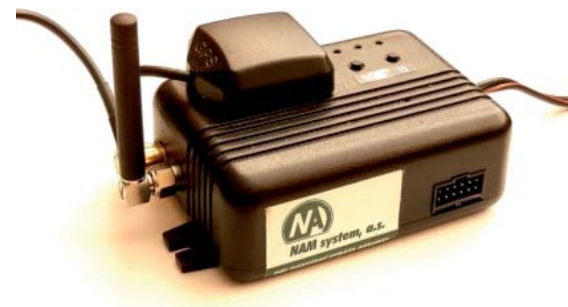
All the measurements were performed on *ONI System monitoring* on-board unit:

Fig. 1 ONI System on-board unit (author)

The on-board unit, used for all experiments mentioned in this article, has proved its ability to operate with very low intensity signal due to an external antenna and high sensitive GSM receiver. However, there still cannot be given any guarantee of no signal losses, because of landscape character and partially inhomogeneous signal coverage (relates to the Czech Republic), which is fortunately still improving.

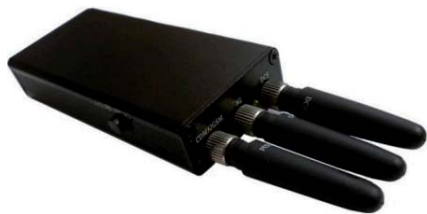
Jammed spectrum: 850 - 894 MHz, 925 - 960 MHz,
 1805 - 1880 MHz, 1900 - 1980 MHz,
 2110 - 2170 MHz
Output power: 0,5 W
Effective range: 2 - 8 m

Fig. 4 The jammer (author)

The third experiment was performed to evaluate the possibility of intentional GSM signal jamming by a device generating disturbing low-power signals in the spectrum of frequencies equal to mobile phone network. Such device prevents the communication between the on-board unit and an emergency call center, so at the moment of a traffic accident it is not possible to transfer any information about the situation, even though the capability of on-board unit to detect the accident stay retained. Moreover, usage of the jammer may also cause malfunction of
