On the robustness to corrosion in the life-cycle assessment of an existing reinforced concrete bridge

Eduardo S. Cavaco^{a,b}, Luis A. C. Neves^{a,c}, Joan R. Casas^{d,*}

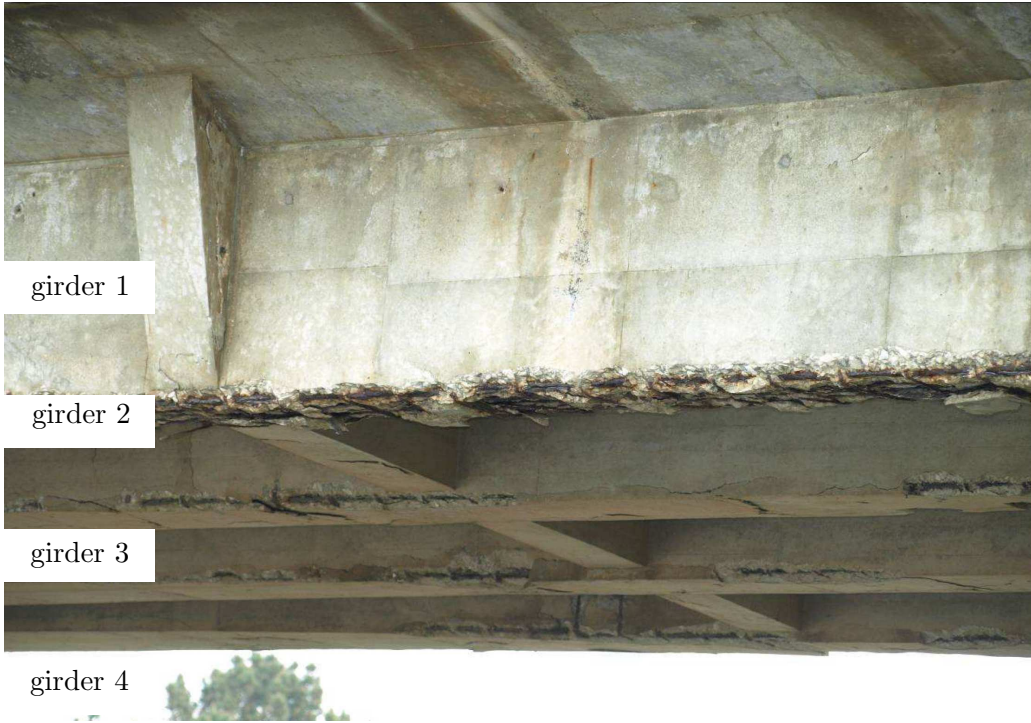
Figure 4: Corrosion affecting girders 1 to 4.

safety. In March 2011, Jacinto (2011) carried out a detailed visual inspection of Tercenas bridge, having found the most concerning pathology to be the generalized corrosion of the bottom reinforcement of deck girders. Although no chemical tests were performed, probably corrosion was due to chloride contamination due to the bridge proximity to the coast. Figure 4 shows a photo taken from the west-side of the bridge. It is possible to observe generalized corrosion in all girders, and concrete cover cracking and spalling, in some cases. Figure 4 and Figure 5 also show corrosion on girder 1 to be more advanced than that observed in the remaining girders.

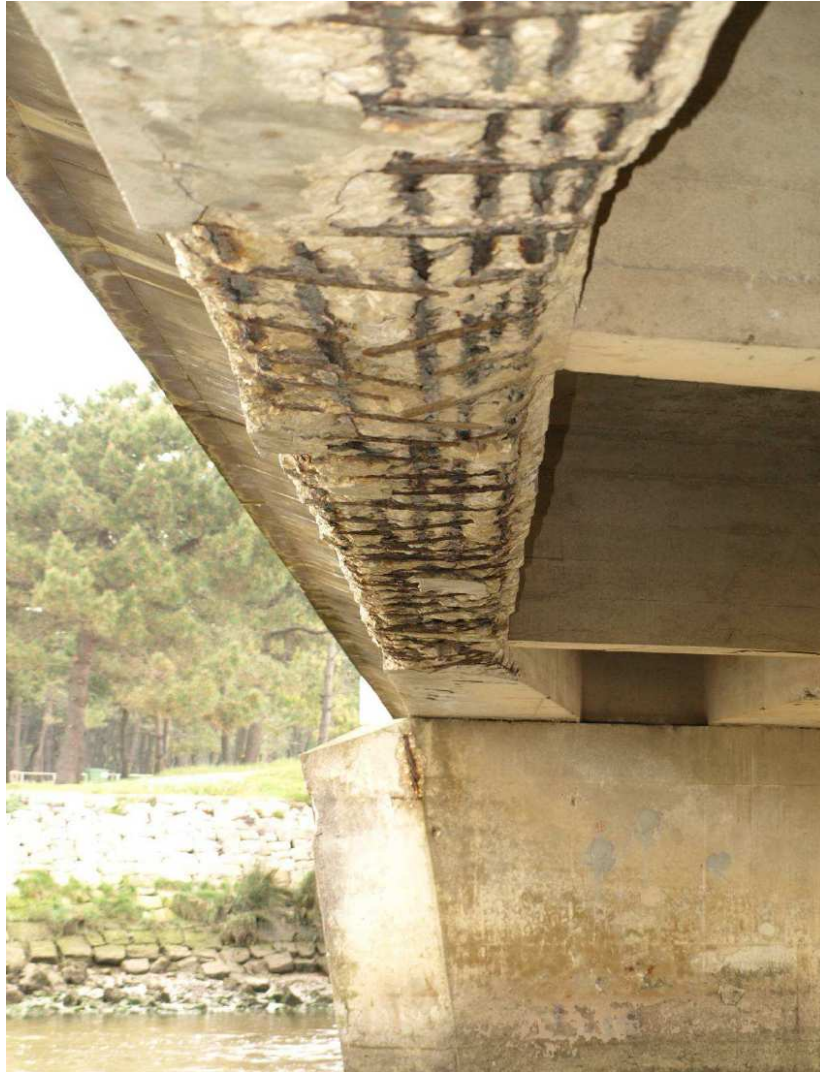
Figure 5: Exposed reinforcement on Girder 1.

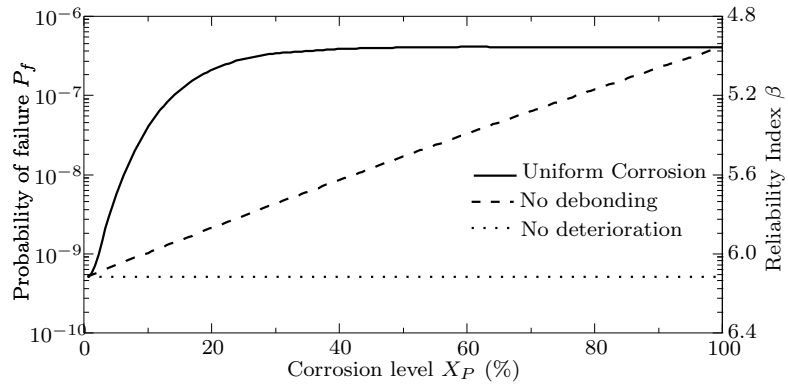
Figure 7: Probability of failure of Tercenas Bridge and reliability index, depending on the corrosion level.

Figure 7 show the time-independent probability of failure and the reliability index of Tercenas bridge, depending on corrosion level and assuming a deterministic deterioration rate. Corrosion was considered up to 100%, for the outmost reinforcing steel, although it is believed that in practice this is unrealistic. The goal was to depict the minimum possible safety threshold if any repair works are carried out during the process. Although girder 1 had been detected with severe damage, corrosion, for the remaining girders, was considered, in this stage, the same. Corrosion was considered to affect only the first layer of the bottom reinforcement as the inner layers were expected to keep intact, resulting in a maximum possible lost of 1/3 and 1/2 of the total bottom reinforcement, for the lateral and central bridge spans, respectively. Corrosion on top reinforcement was considered negligible due to bituminous protection and correct waterproofing.

For the uncorroded structure the probability of failure within the period of 6 months resulted in 5×10^{-10} which correspond to a reliability index of 6.1. For a period of 1 year the bridge reliability resulted in 6.0 which is above the Eurocode recommendation (5.2) for structures within the higher class of consequences.

Figure 7 also show the safety levels reduction to be more pronounced for corrosion levels below 40%. At the time the bridge was demolished, corrosion on girder 1 was estimated to be around 50% which correspond to a probability

of failure equal to 4.7×10^{-7} and a reliability index of 4.9, within the period of half a year.

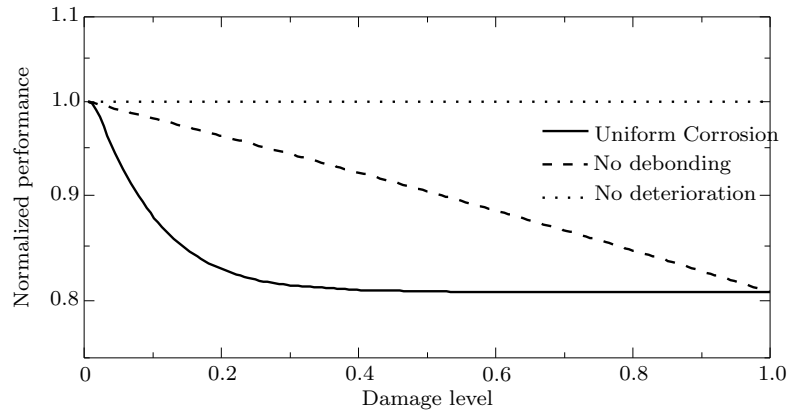
Figure 9: Tercenas Bridge normalized performance depending on damage level.

Figure 9 shows the normalized performance (reliability index) as a function of the damage level (corrosion on the reinforcement). Robustness was computed according to Equation (6) and resulted in 0.82, which represents an average ratio between the performance of the damage and the intact structure, considering corrosion as unpredictable and ranging from [0-100]%. As referred, this is supposed to be a relative measure developed having in the mind the comparison between the tolerance to different corrosion scenarios and/or different structures. Figure 9 also shows the case where no deterioration and no debonding have been considered. Robustness results equal to 1 and 0.90, respectively, which depicts approximately the same relative importance of both the deteriorating mechanisms, the loss of cross section

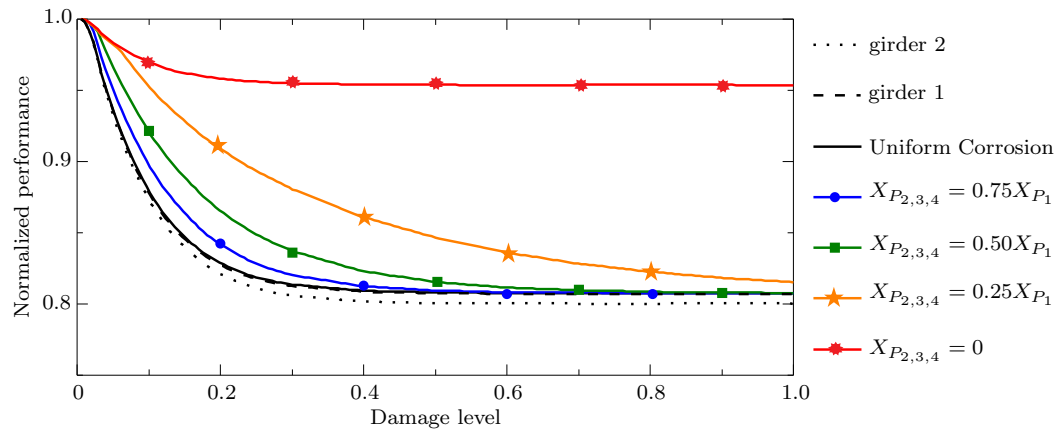
Figure 10: Performance of Trecenas Bridge under different corrosion scenarios.

Figure 10 shows the normalized performance as a function of the damaged level for the same cases of Figures 8. Table 2 summarizes the calculations of robustness following Equation (6).

Effects of system transverse redundancy can be observed by observing robustness increasing (up to a maximum of 0.95) as less corrosion is being considered on the girders adjacent to girder 1. Robustness of single girders resulted similar to that of the bridge deck when all the girders are equally corroded since only residual load transference between girders is possible.
