RESEARCH ARTICLE

# Setup of a sustainable indoor cleaning methodology for the sculpted stone surfaces of the Duomo of Milan

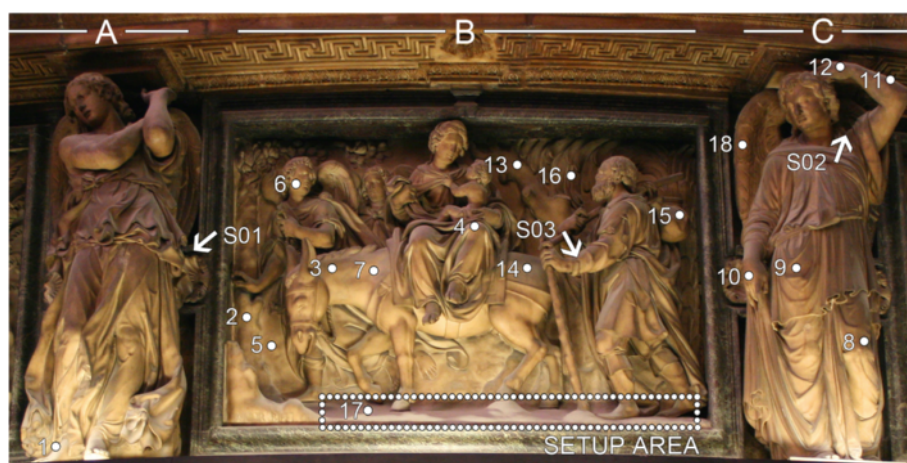
**Figure 1** Photographic documentation of the high-relief (B) and of the angels (A, C). The setup area for the pilot applications is defined by the dotted frame; arrows indicate the samples' location (S01-S03); dots indicate the colour measurement areas (1-18).

Incoherent powder samples of the superficial deposit were sampled by brushing the stone surface. Micro-fragments of the stone substrate were collected by means of a steel scalpel and were chosen in order to be representative of different substrate conditions. In particular, three samples were selected and are discussed in the present work: sample S01 is representative of the incoherent grey powder deposit; sample S02 was collected prior to the cleaning to document the initial condition of the stone substrate, whereas sample S03 belongs to a cleaned area after the treatment. All samples were immediately stored in polyethylene containers until diagnostic. The samples' locations and the colour measurements areas are indicated in Figure 1. All the details of the colour measurements areas are reported in Table 1.

The morphological characterization by ESEM-EDX of the stone surface before cleaning (sample S02, see Figure 1) is reported in Figure 3. It can be observed that the superficial deposit was mainly composed by aggregates of fine grained crystals, with an average size lower than 10  $\mu\text{m}$  (Figure 3A). Few coarser particles can also be observed. The deposit showed a limited compactness due to the presence of voids and discontinuities. Its finer fraction was particularly rich in S and Ca (Figure 3B) which are related to the presence of gypsum, as previously discussed. The larger Si-rich particles belong to soil dust, as well as those containing aluminium and potassium. The stone substrate appeared completely covered by an irregular layer of deposit (Figure 3C). The observation of the polished cross sections indicates that its average thickness was generally below 20  $\mu\text{m}$ . In presence of discontinuities of the substrate this value could increase as the deposit tended to fill holes and gaps of the stone material (Figure 3D). The overlapped deposit layer was strongly attached to the substrate from which can be discriminated by the depletion of the Ca content and the enrichment of both S and Si. The sulphur presence was concentrated within this layer alone and no transition in its concentration is observed at the stone interface. This indicates that gypsum comes from an external source and no significant

Optical microscopy and ESEM-EDX documentation of the stone substrate after cleaning (sample S02, see Figure 1) is reported in Figure 11. The superficial deposit, which previously covered the marble, is almost completely removed, so that the compact surfaces of the mineral grains are exposed (Figure 11A). Inside the stone discontinuities (small superficial cracks and partially eroded grain boundaries) some residues of soil dust and particulate matter are still present and can be identified by the smaller and irregular morphology of the crystals. Sulphur, silicon and aluminium can be traced in this location and belong to the remains of the deposit (Figure 11B).

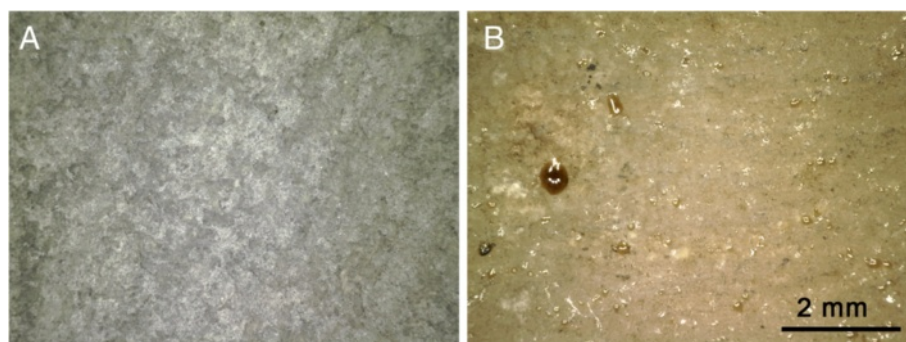
**Figure 2** Onsite microscopic documentation of the surface before cleaning, showing a predominant grey (A) to dark brown/yellow (B) colour of the deposit.

After preliminary visual observation, the sculpted surface showed a particularly dark and dull appearance. This was due to the ubiquitous presence of two different types of superficial depositions: an incoherent, grey in colour deposit which was scarcely bonded to the stone and could be partially removed by mild mechanical actions and a compact and thin deposit strongly attached to surface. As a result, the overall colour of the stone substrate varied from grey to dark brown/yellow areas (Figure 2). In particular, the grey appearance mostly characterized the semi-horizontal area in which the normal dust deposition is favoured by gravity. In all the surfaces having an almost vertical orientation or partially protected by dust deposition, a more dark-brown to yellow colour was observed. Moreover, the stone material was irregularly covered by a diffused pattern of yellow drops of translucent materials (Figure 2B), which could be observed by naked eye.

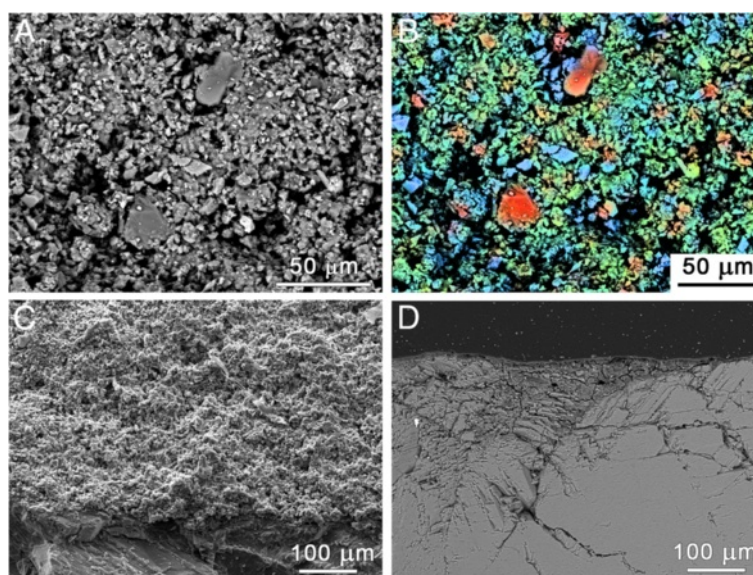
**Figure 3** ESEM-EDX characterization of the stone surface (A-C) and of the polished cross-section (D) before cleaning. False colour image (B) indicates the prevailing distribution of calcium (blue), sulphur (green) and silica (red) in the surface deposit.

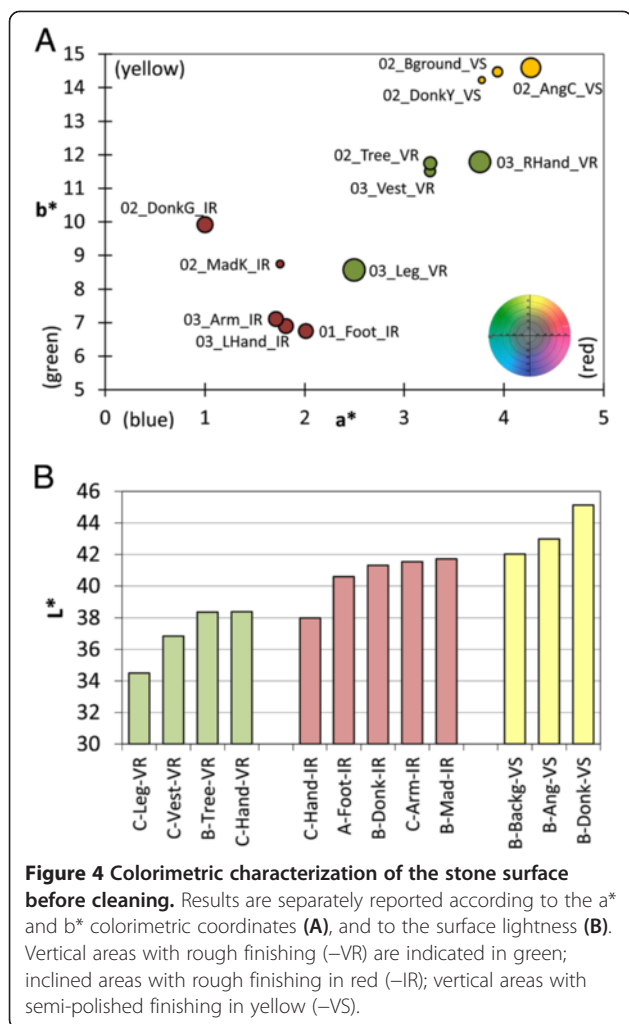
The colorimetric characterization of the stone surface is reported in Figure 4. It can be observed that the results tend to be differently located respect to the colorimetric coordinates ( $a^*$  and  $b^*$ ) although a clear distinction cannot be made. In order to highlight the presence of any possible

yellow/brown colour compared to the inclined ones which show lower values for both coordinates (Figure 4A). As previously discussed, the superficial yellowing related to the presence of organic compounds is diffused all over the sculpted surface, whereas soiling is more efficient on the inclined areas. This last degradation mechanism therefore plays a major role in differentiate the colour appearance of vertical and inclined surfaces.

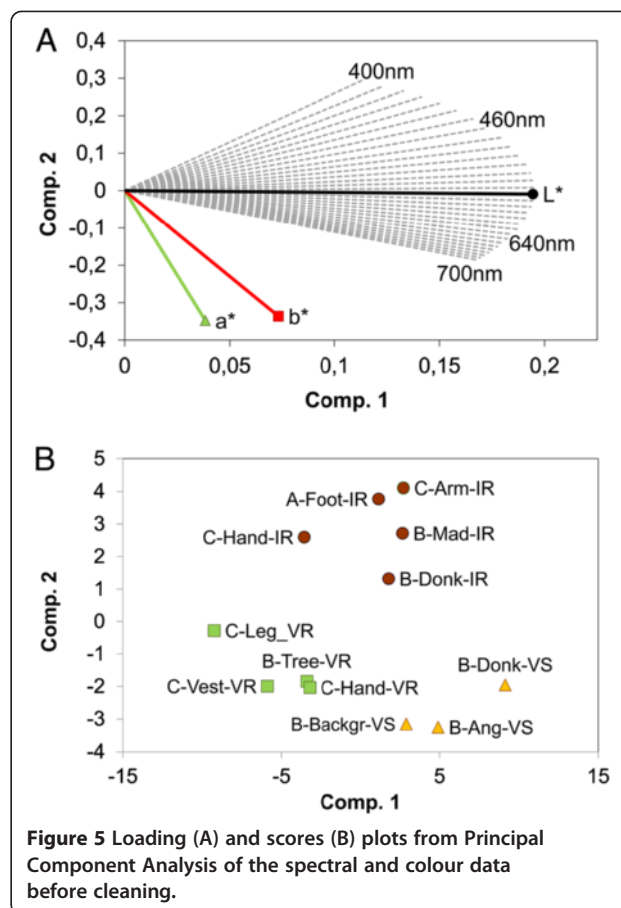
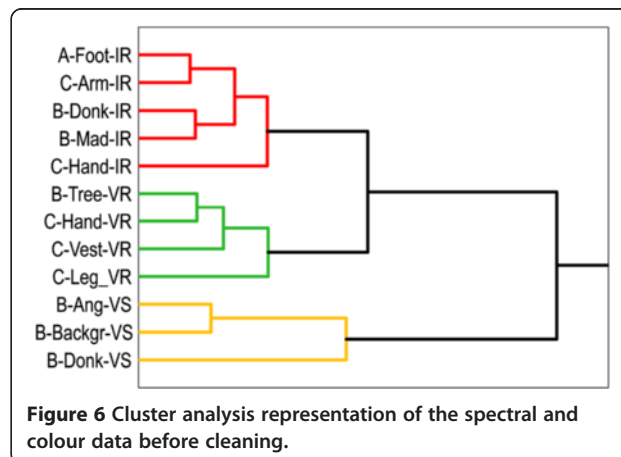
PCA score plot (autoscaled data) for the not cleaned surfaces are shown in Figure 5B. PCA and cluster analysis revealed the existence of three main clusters: VS, VR and IR. As it can be observed in Figure 5, the surface orientation proved to be the most relevant factor influencing the colour of the not-cleaned material. As a matter of fact, data belonging to the vertically orientated surfaces (suffixes -VS and -VR) are clearly separated after the PCA and cluster analysis. This depends on the rather different saturation of the  $a^*$  and  $b^*$  values. The vertical areas are generally characterized by a more intense

As far as the vertical surfaces are concerned, it can be noticed that the measurement areas can also be distinguished according to the stone finishing (Figures 5 and 6): rough areas (-VR) belong to a separated cluster respect to those showing a semi-polished appearance (-VS). The latter ones are characterized by higher  $L^*$  values and by a

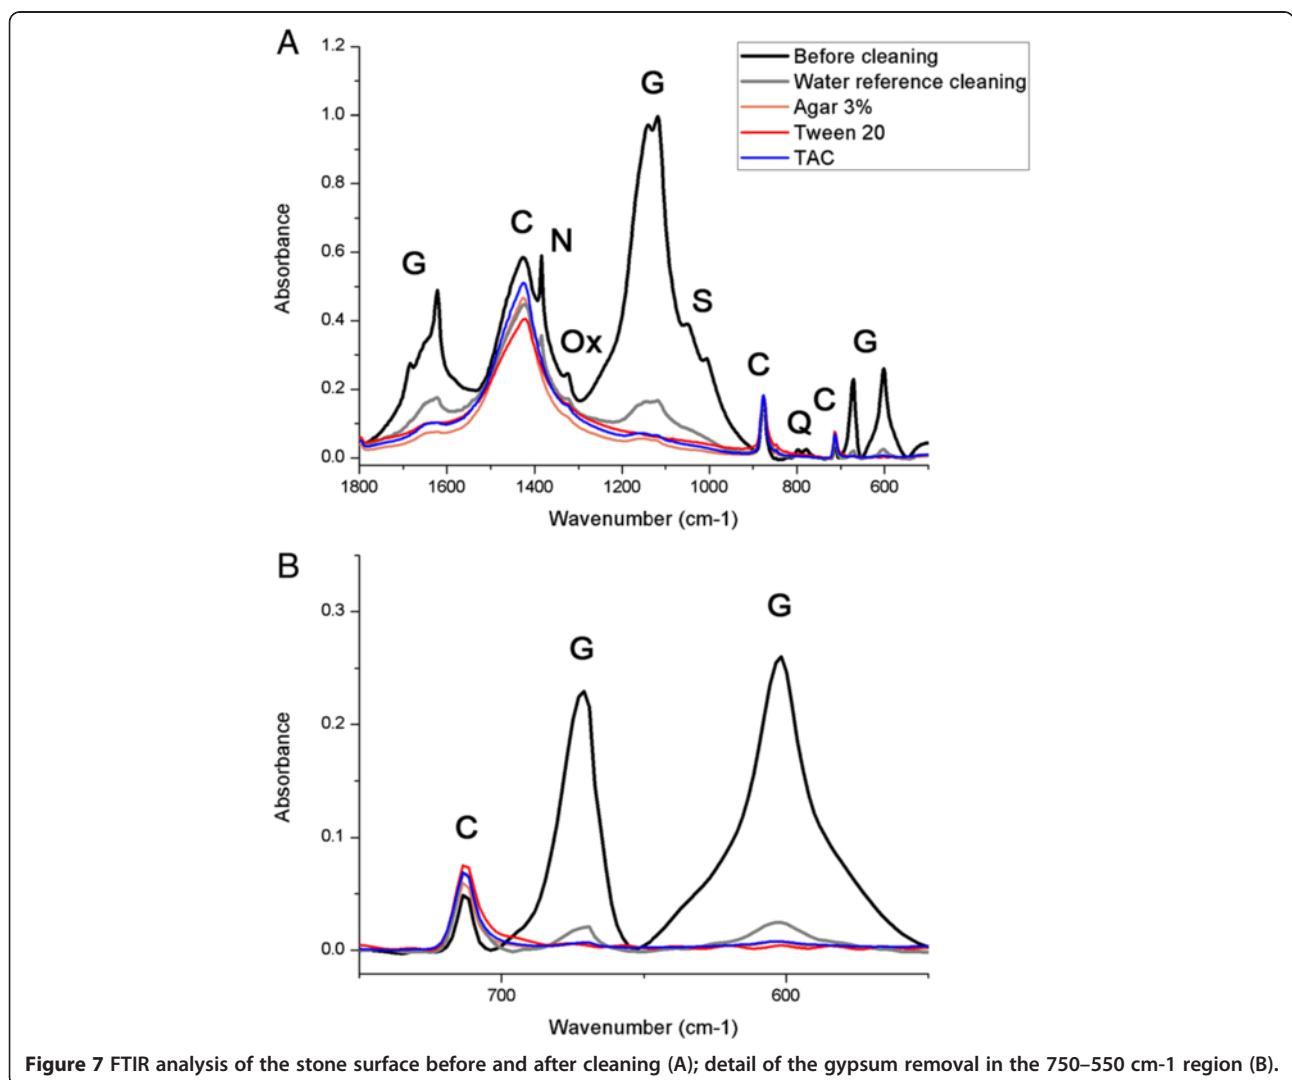
**Figure 7** FTIR analysis of the stone surface before and after cleaning (A); detail of the gypsum removal in the 750–550 cm<sup>-1</sup> region (B).

cases the agar gels demonstrate a good removal result (Figure 7A). The gypsum content is strongly reduced and only a limited residual presence is evidenced by the small and broad peaks in the  $1600$  and  $1100\text{ cm}^{-1}$  regions. The same applies to the  $1324\text{ cm}^{-1}$  peak of calcium oxalate, which belongs to the deposit composition and is therefore reduced as well after gel application. The gypsum minor peaks in the  $600\text{ cm}^{-1}$  region are no longer detectable after the treatment (Figure 7B). Agar gels are particularly efficient in nitrates removal. The high volume of free liquid water entrapped in the gel is able to easily dissolve these salts, thanks to their high solubility, and to drain them into the poultice. Quartz-siliceous and other insoluble compounds are removed as a result of the dissolution of the gypsum matrix in which they are initially embedded. Once the sulphates are drained into the poultice, most of the soil dust particles tend to be bonded at the agar-stone interface of the gel. The few remains of deposit material, after the gel removal, have no residual adherence to the stone substrate and are then removed after the final mild brushing of the surface. As far as the deposit removal

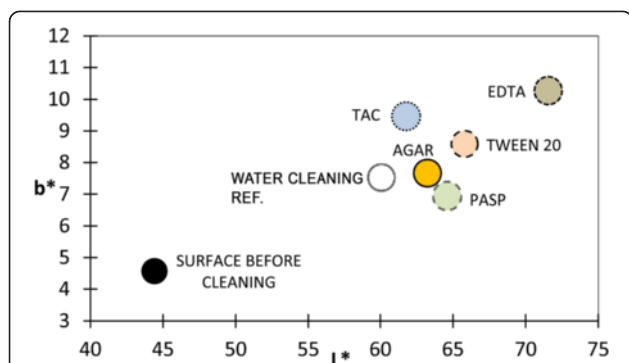
**Figure 8** Colorimetric characterization of the pilot areas after different cleaning methodologies. The with dot indicates the application of the reference water cleaning reference; the yellow dot labelled "agar" refers to the agar gel with no additive; in all the other case the name of the additive alone has been reported to indicate the type of gel.

The final aesthetic appearance of the test areas is a relevant parameter in order to evaluate the compatibility of the cleaning procedures. The colorimetric results are reported in Figure 8, in which the  $L^*$  values are plotted versus  $b^*$ . In such way the expected increase in the surface brightness can be monitored together with the variation of the saturation of the yellow colour due to the warm hue of the stone material. Furthermore, the PCA analysis has shown that the first two components are strongly correlated with  $L^*$  and  $b^*$  respectively. As previously discussed, the almost horizontal orientation of the setup area results in a more intense accumulation of particulate matter and dust. As a consequence, the  $b^*$  values of the surface before cleaning is lower compared to all the other not cleaned areas.

All agar gels show rather comparable colorimetric results, expect for the agar plus EDTA which will be discussed separately. The  $L^*$  values range between 62 and 66, as a result of the efficient removal of the dark deposit. The  $b^*$  values vary within a very limited interval

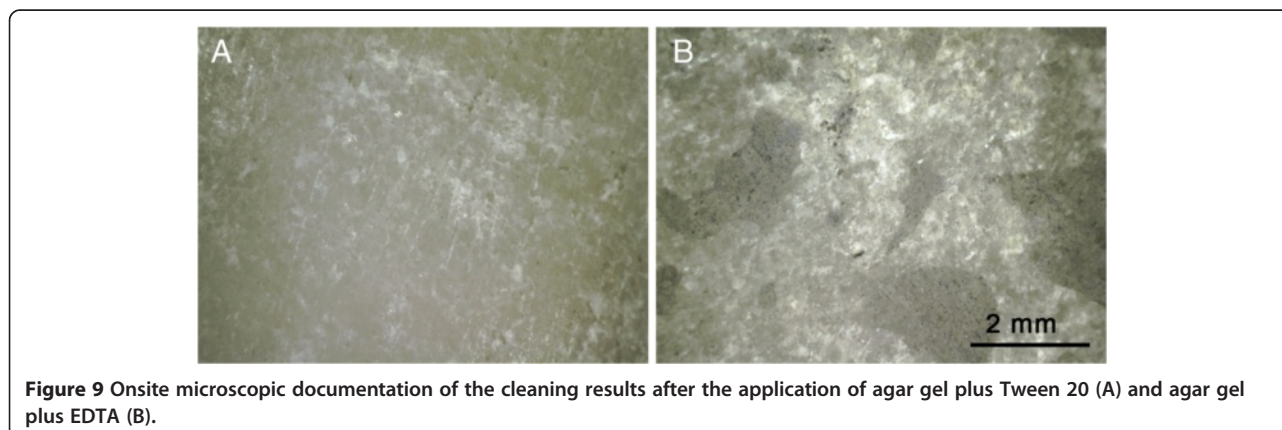
**Figure 9** Onsite microscopic documentation of the cleaning results after the application of agar gel plus Tween 20 (A) and agar gel plus EDTA (B).

sharp separation between cleaned and not completely cleaned areas (Figure 9). The use of Agar gel with EDTA addition has been therefore discarded.

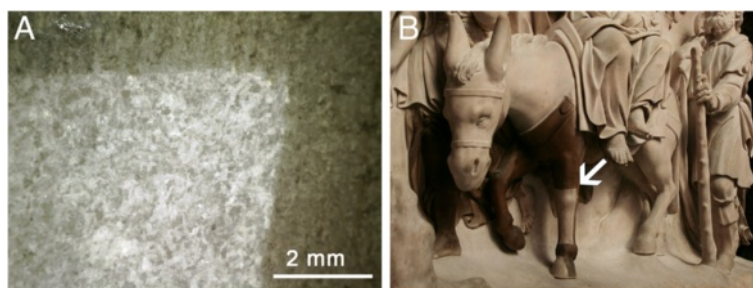
**Figure 10 Onsite microscopic observation.** Border area between the cleaned and the not cleaned stone surface (A). Working traces and barely visible surface details covered by the deposit are preserved and unveiled after the treatment. The location of the area is indicated by the white arrow in (B).

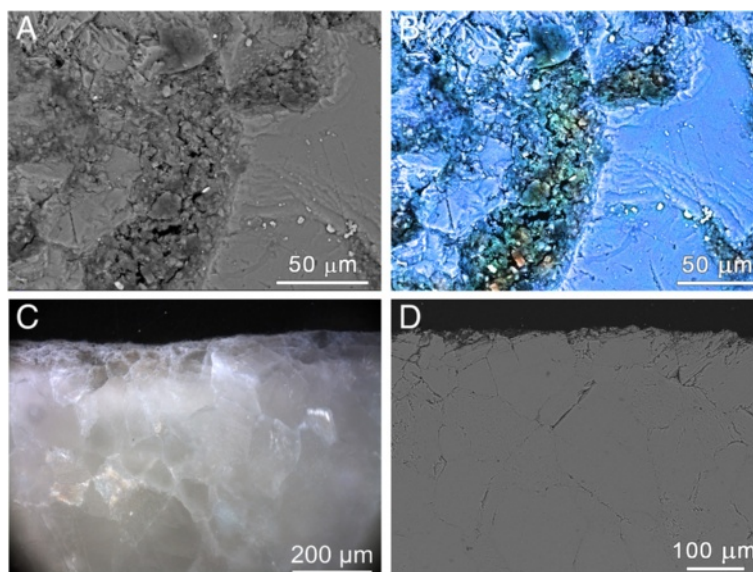
**Figure 11 Characterization of the cleaned stone surface (A-B) through ESEM-EDX, and of the polished cross-section through optical microscopy (C) and ESEM (D).** False colour image (B) indicates the prevailing distribution of calcium (blue), and of the residual sulphur (green) and silica (red).

Polished cross-sections observation reveals a good and homogeneous cleaning result (Figure 11C, D). The microstructural features of the marble are preserved and no significant differences can be observed respect to the section of the not cleaned material. The mineral matrix is still rather compact. Neither newly formed cracks, nor intergranular corrosion of the stone material can be detected. Some residues of the deposit are present along the upper border of the section, inside the substrate discontinuities, as previously discussed. This indicates that

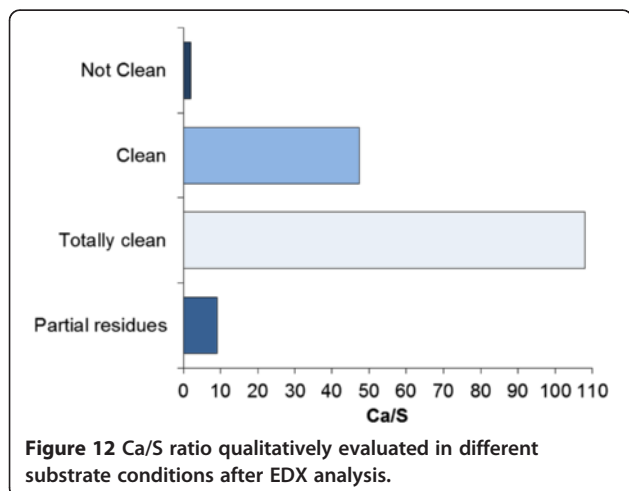
In order to qualitatively evaluate the cleaning efficacy the Ca/S ratio has been calculated in three different conditions (Figure 12) according to the EDX results: clean areas (in which cleaned surfaces and residual deposits are both present in the same area); totally clean areas

(no residual traces of deposit); partial residues area. A significant reduction of sulphur always occurs as a result of the removal of the gypsum deposit. This reduction is already evident in the clean areas and becomes particularly remarkable in the totally clean areas, in which sulphur is almost completely removed. Even in areas in which the removal is not complete (the partial residues areas), the sulphur content is significantly reduced to approximately 4 times less respect to the not cleaned reference area.

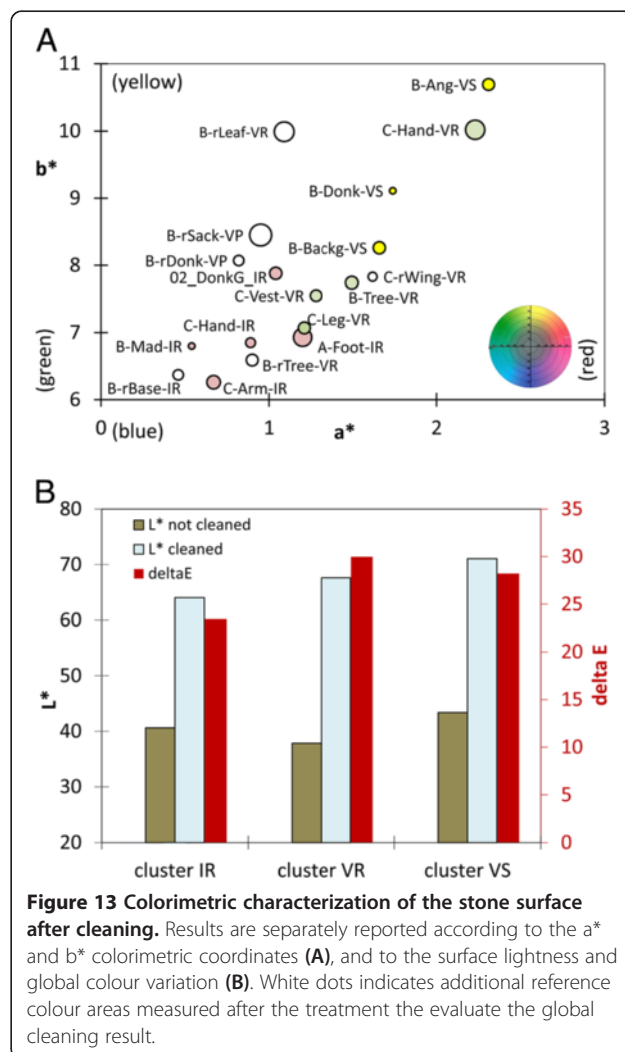
Colour analysis after cleaning did not allow the identification of any group of data. Even after PCA and cluster analysis, the only cluster that could be evidenced was the one including the two polished areas. This is most probably due to the fact that, after cleaning, the finishing and the typical texture of the marble are unveiled, so that the orientation is no longer a key factor determining the colour appearance. As a result, the inherent stone features (i.e. natural colour variability, presence of veins, etc.) prevail over environmental factors. The marble texture becomes an additional factor contributing to the apparently more random distribution of the data. The cleaned results show a lower dispersion in the CIE Lab colour space respect to the untreated surface (Figure 13A).

In order to better evaluate the cleaning methodology in relation to the initial condition of the surface, the average  $L^*$  and  $\Delta E$  of the three cluster defined by analysing the data collected before cleaning are reported in Figure 13B. It can be observed that inclined surfaces are characterised by a lower variation of  $L^*$  and colour ( $\Delta E$ ). It is worth nothing that soiling was more evident on these areas and in general particulate matter and dust remain longer on non-vertical surfaces, thus allowing a deeper penetration within the stone matrix. Their removal is therefore more difficult. Considering that the overall appearance of the clean surface is homogenous as evaluated both by naked eye and by the lower dispersion of the colour data, the cleaning result has been judged satisfactory.
