Block Movements in the Pennines and South Wales and their Association with Landslides

L. J. Donnelly*‡, K. J. Northmore‡ & H. J. Siddle†

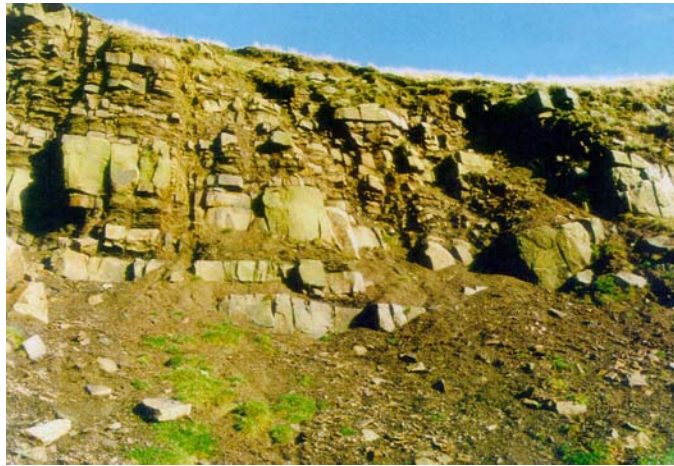
Figure 3. Vertical displacement along two faults exposed in the backscarp of the Gillot Hey Landslide. These correspond to scarps (5 and 6 on figures 2 and 4) on the plateau beyond the landslide crown.

Graben B, is located at the crown of the landslide and comprises two fault scarps, 5 and 6, approximately 1m high. The fault scarps are slightly divergent, separated by a distance of 6 m where exposed at the landslide backscarp, increasing to 15 m separation 30 m beyond the crown. The faults are vertical with 1m of normal displacement and are each defined by a 0.1-0.5 m wide weathered and disintegrated seepage zone of closely-spaced interlocking fissures. A 60 mm wide central zone of wet clay and oxidised, clayey sand represents fault gouge. The faults reduce the strength of the rock mass, enable groundwater to be channelled onto the face of the backscarp and may have been a significant factor in the initiation of a landslide at this locality and influencing subsequent stability conditions (Figure 3).

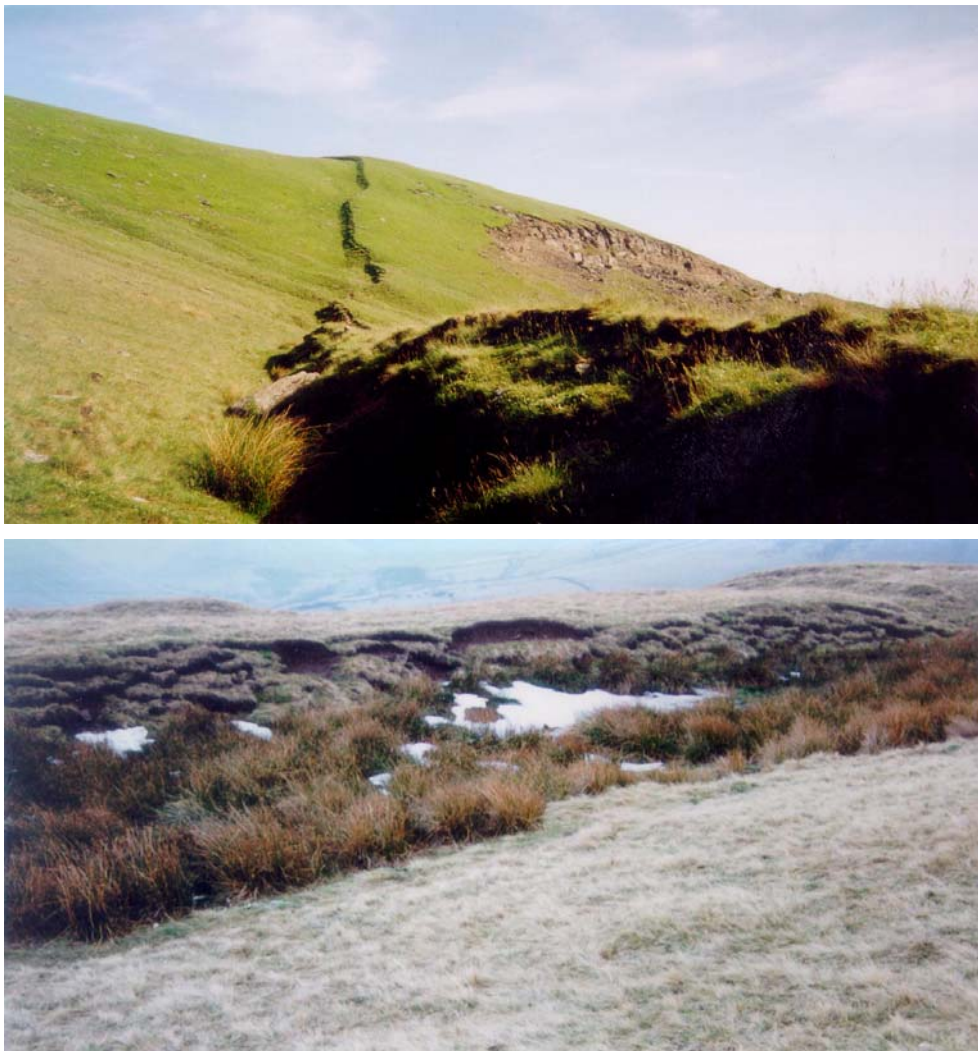
Figure 5. (Upper) A typical South Wales reactivated fault scarp (the Tableland Fault), 3-4 m high and 4 km long, an uphill facing scarp on moorland plateaux beyond the crown of the Darren Goch Landslide in the Garw Valley. This may have been exacerbated by mining subsidence. (Lower) A high-angled, distinct 2 m high and 400 m long, uphill facing fault scarp on moorland plateaux beyond the crown of the Gillot Hey Landslide in the Derbyshire Pennines. This area has not been undermined and therefore other mechanisms must be involved. Graben B (faults 5 and 6 on figures 2 and 4) can be seen in the middle distance beyond the fault scarp.

glacial retreat. Evidence also exists which suggests that some scarps were responsible for palaeo-seismic events, (Davenport et. al. 1989 and Ringrose 1987). It is possible that the features described in this paper are of a similar origin. In the case of South Wales, these features may have been exacerbated by subsidence induced by relatively recent mining (Figure 5).
